Park Street Bike Link
South Melbourne

Road Safety Audit

Audit Stage: Concept design

Report for SMEC

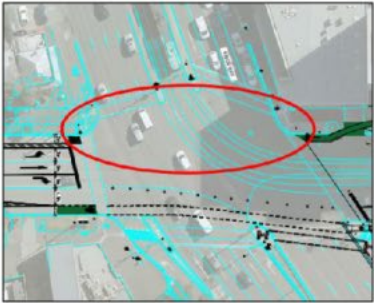
Audit Findings	Level of Risk	Safe System Energy	Recommendations	Responsible Officer	
			P – Primary S – Supporting	ST – Step Towards N – Non-Safe System	Accept Yes/No
<p>a) Intersections</p>					
<p>i. The westbound bicycle lane is marked at the intersection with Kings Way, however there appears to be no line marking for eastbound cyclists. This increases the potential for a collision between cyclists and vehicles.</p>

<p>Occasional Serious HIGH</p>	<p>Above tolerable limits (important)</p>	<p>Consider installing bicycle lane markings for eastbound cyclists across the intersection to guide cyclists and increase awareness of cyclists crossing. (S)</p>		
<p>ii. On westbound lanes just before Palmerston Crescent, the car lane narrows slightly. In the proposal, the bicycle lane will end at this location and cyclists will veer slightly left to reach the footpath on the other side of Palmerston Crescent. Drivers may fail to notice cyclists and give them enough space increasing potential collisions between cyclists and vehicles.</p>

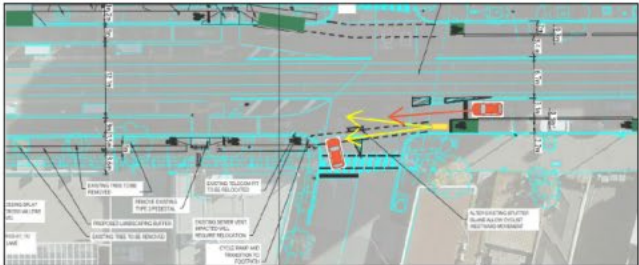
<p>Occasional Serious HIGH</p>	<p>Above tolerable limits (important)</p>	<p>Consider:</p> <ul style="list-style-type: none"> Rerouting the bicycle path through the footpath on approach to this intersection (P) Consider installing green pavement marking of the bicycle lane through the intersection to increase awareness of drivers to cyclists. (S) Painting a sharrow in the lane as it narrows and the bicycle lane ends (S). This may make it more likely that cars pay attention to cyclists.

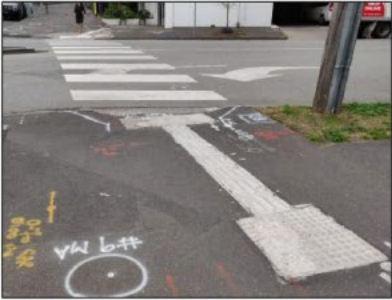
Audit Findings	Level of Risk	Safe System Energy	Recommendations	Responsible Officer	
			P – Primary ST – Step Towards S – Supporting N – Non-Safe System	Accept Yes/No	Comments
<p>c) Line/Pavement Markings</p>					
<p>ix. Several tactile ground surface indicators (TGSIs) were noted as having significant damage which limits their effective use by people with impaired vision.</p>

To Note	-	Consider repairing all damaged TGSIs along the route (S)		
<p>x. One of the bicycle lane crossings (south west) does not appear to have stop line markings at the signalised crossing. Hence, cyclists may be unaware of the pedestrian crossing and fail to stop for the signals. There also appears to be minimal storage space, with cyclists potentially blocking access to Millers Lane.</p>

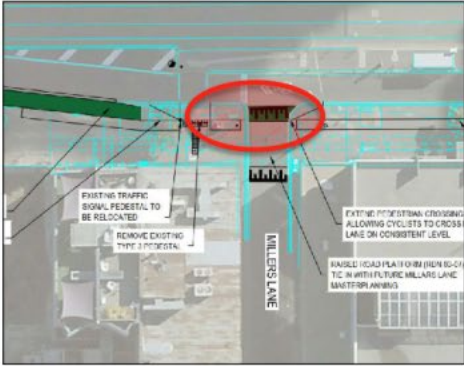
<p>Occasional Minor MEDIUM</p>	<p>Within tolerable limits</p>	<p>Consider:</p> <ul style="list-style-type: none"> Installing a stop line at the signalised crossing (S)

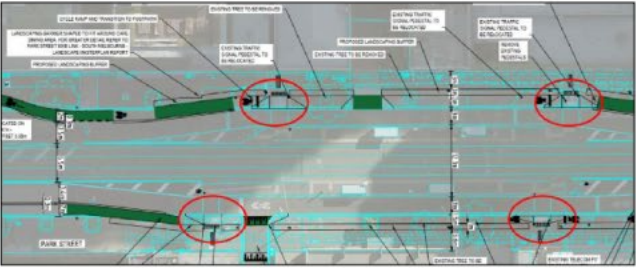
Audit Findings	Level of Risk	Safe System Energy	Recommendations	Responsible Officer	
			P – Primary ST – Step Towards S – Supporting N – Non-Safe System	Accept Yes/No	Comments
<p>xi. Cyclists & pedestrians may be unaware of each other at the signalised crossings to the tram stop increasing the potential for collisions.</p>

<p>Improbable Minor LOW</p>	<p>Within tolerable limits</p>	<p>Consider</p> <ul style="list-style-type: none"> Installing “slow” line marking to warn cyclists of crossing (S) Installing green pavement markings over the crossing points to alert both road users to crossing (S) 		
<p>d) Pavement Quality</p>					
<p>xii. Park Street and the adjacent footpath south of the tram stop has pavement surfacing defects (cracking, potholes, rutting). The uneven surface may destabilise a cyclist.</p>

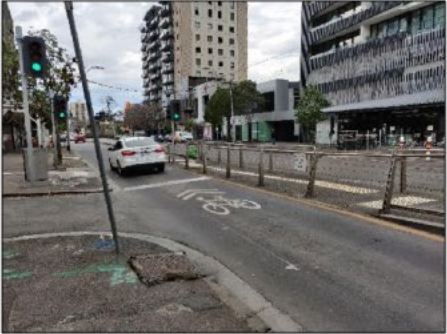
<p>Improbable Minor LOW</p>	<p>Within tolerable limits</p>	<p>Consider reviewing the pavement quality within the project area. Consider rectifying pavement surface defects. (S)</p>

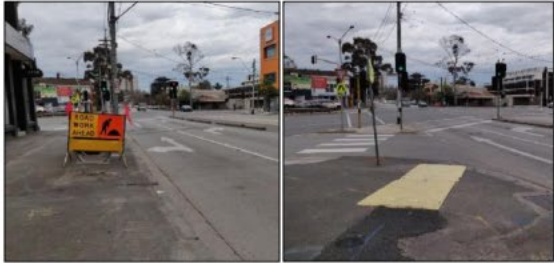
Audit Findings	Level of Risk	Safe System Energy	Recommendations	Responsible Officer	
			P – Primary ST – Step Towards S – Supporting N – Non-Safe System	Accept Yes/No	Comments
<p>xiii. The quality of footpath pavement at the southeast side of Kings Way is poor. This could cause a hazard to cyclists as they ramp up onto the footpath to reach the stopping point at the lights. It is noted that some works are ongoing in the area, but it is unlikely that these works relate to the footpath surface.</p>

<p>Improbable Minor LOW</p>	<p>Within tolerable limits</p>	<p>Consider resurfacing all worn or damaged pavements along the bicycle path (S)</p>

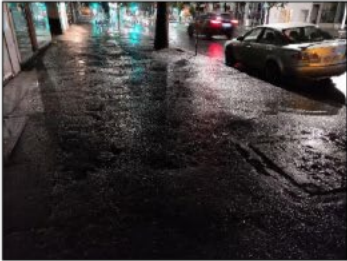
<p>The footpath on the north side of Park Street just to the east of Little Bank Street was also noted to be in poor condition.</p>

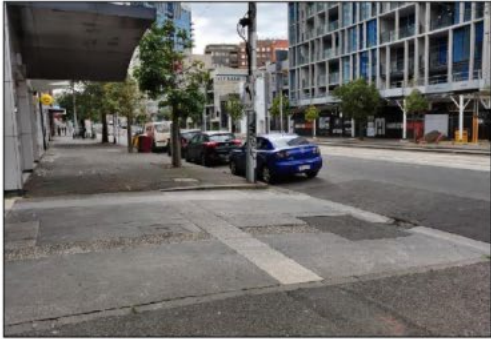
Audit Findings	Level of Risk	Safe System Energy	Recommendations	Responsible Officer	
			P – Primary ST – Step Towards S – Supporting N – Non-Safe System	Accept Yes/No	Comments
<p>xiv. The exit of Little Bank Street has been noted above for its visibility issues. The auditors also note the presence of a kerb along the current footpath and exit of Little Bank Street (as seen below). If unchanged, this would present discomfort and a tripping hazard for cyclists.</p> <p>It is noted that the Final Concept Design Report draft provided by SMEC includes plans to improve the amenity and safety of Little Bank Street.</p>

<p>Improbable Minor LOW</p>	<p>Within tolerable limits</p>	<p>Consider:</p> <ul style="list-style-type: none"> Raising the level of the bicycle path to ensure smooth passage for cyclists along the new alignment (P) Additionally consider raising the footpath, to create a wider pedestrian-cyclist zone that slows vehicle traffic (S). This approach is in the proposal for Millers Lane.
