CONSERVATION MANAGEMENT PLAN

MEMORIAL HALL SOUTH MELBOURNE

PREPARED BY ANDRONAS CONSERVATION ARCHITECTURE
IN ASSOCIATION WITH LANDMARK HERITAGE

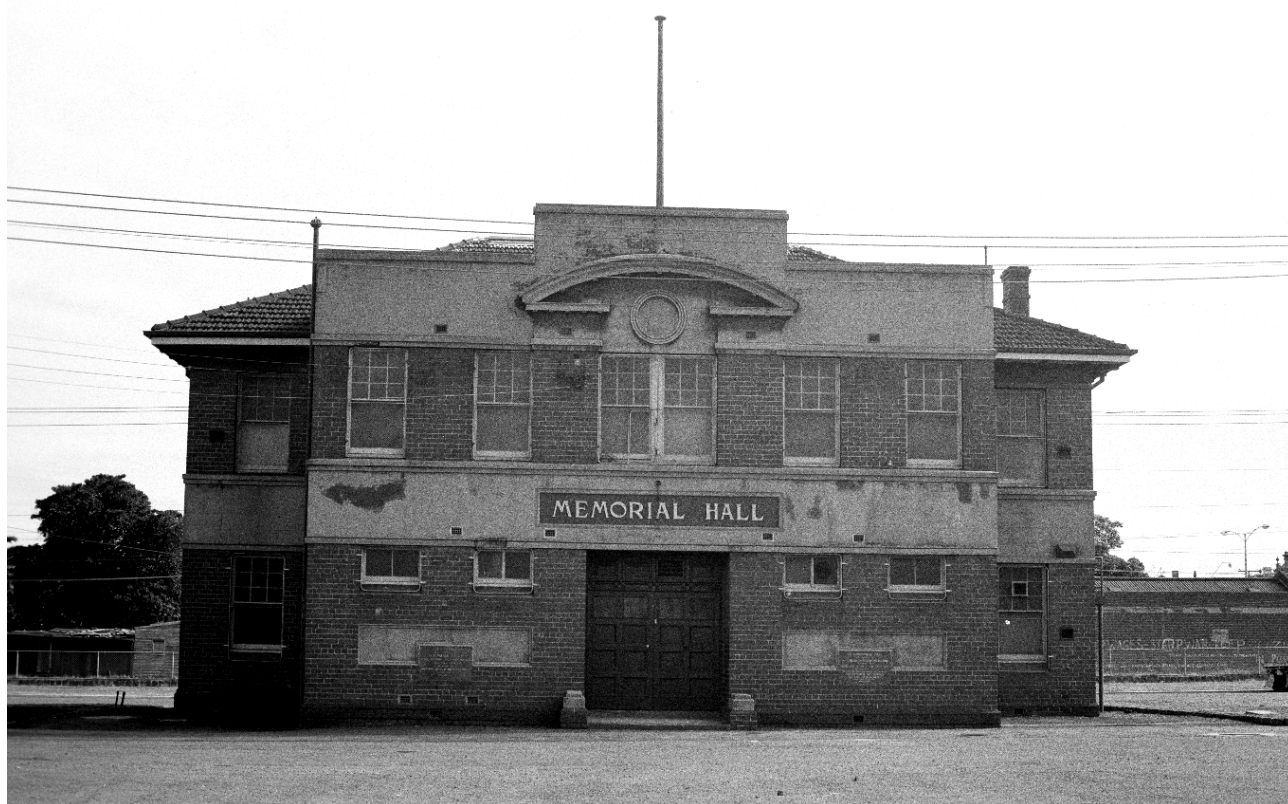
Figure 18, Front façade of the Memorial Hall, c1970-74. Note the peeling paint and render. (State Library of Victoria, Committee for Urban Action Collection)

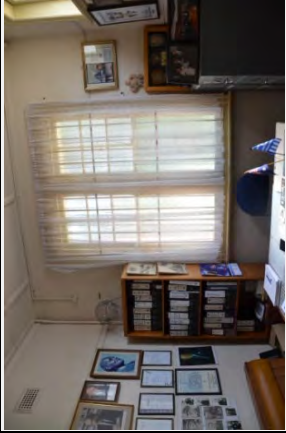
___/___/___
G.01	Ceiling	Evidence of water ingress on ceiling. Possibly from kitchen upstairs, no evidence currently.	Monitor. Ensure plumbing in kitchen above (sink, dishwasher, etc.) is water tight.	Medium

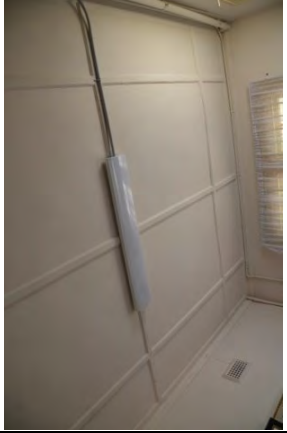
___/___/___
G.01	Floor	Moderate fall in floor from door way to outside corner of room. Evidence of significant deterioration of timber stumps in adjacent room.	Restumping required.	Medium

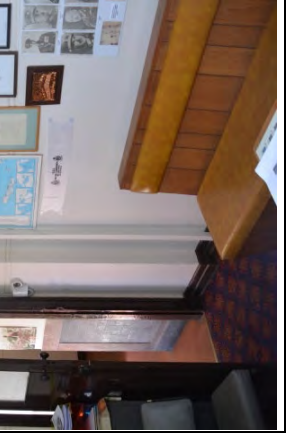
___/___/___
G.01	Window	Non-operable windows. No window winder.	Consider reinstating all windows to match original.	Low

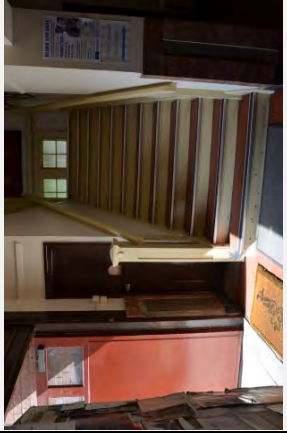
___/___/___
G.02	Wall	Missing alicante marble tile from dado. Additionally, some alicante tiles are drummy and loose in this area.	If alicante tile is still on hand, restore to match original. Loose tiles to be checked and reglued.	Low

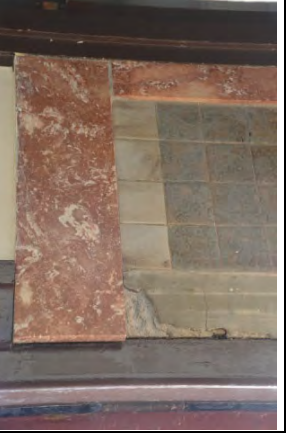
___/___/___
G.02	Floor	Sagging? concrete threshold. Evidence of previous repairs.	Monitor.	Low

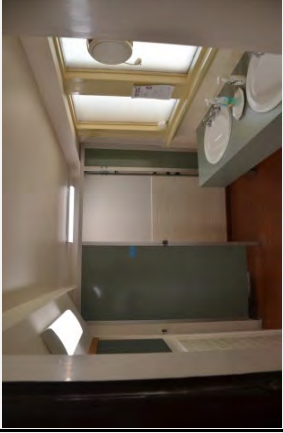
___/___/___
G.04	Compliance	Low head clearance to door.	Review compliance of WC's generally.	High

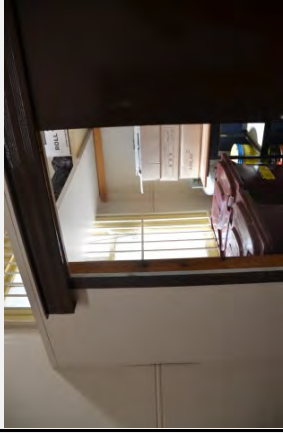
___/___/___
G.05	Wall	Cistern for Male urinals installed through penetration of original masonry wall.	If refurbishment works take place, consider installing cistern within new stud framing in male toilets. Patch repair brickwork and hard plaster wall to match original.	Low

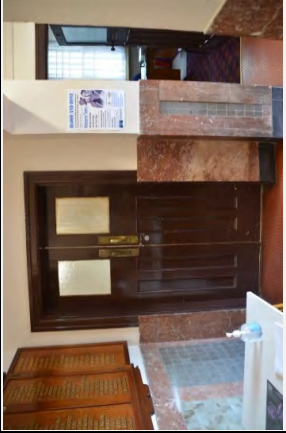
___/___/___
G.07	Wall	Non-original tiles to dado (shown left).	Note.	Low

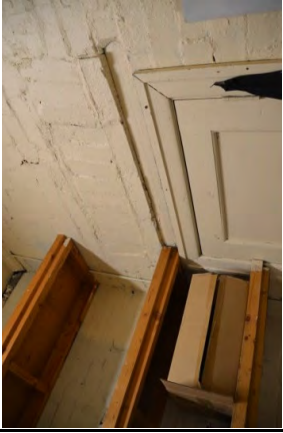
___/___/___
G.10	Ceiling	Missing cornice.	Reinstate cornice to match original.	Low

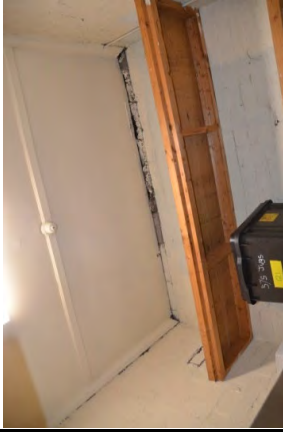
___/___/___
G.10	Floor	Minor undulation in floor. Sound condition.	Monitor. If other subfloor works take place, inspect and restump if required.	Low

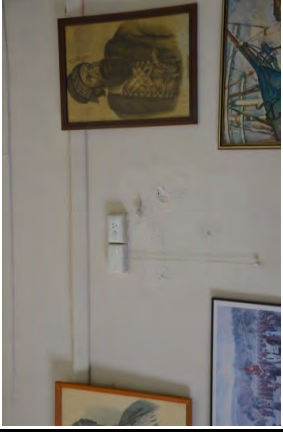
___/___/___
1.04	Telecommunication	Telecommunications services in inconvenient location. Is it still required?	Remove redundant services.	Low

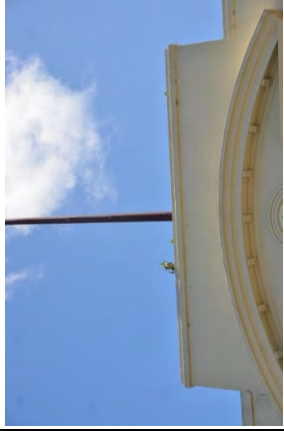
___/___/___
East Elevation	Wall	Minor cracking to front façade is evident around larger apertures (doors and windows). Possibly due to differential movement of the building over time.	Monitor cracking. Update: Defect generally inspected by structural engineer. Refer to report prepared by Mark Hodkinson dated 18th June 2021 - 3.5 External Brickwork Walls	High

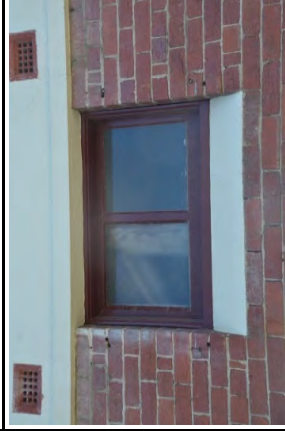
___/___/___
East Elevation	Wall	Significant loss of mortar around windows. Possibly due to falling damp from box gutter behind parapet. Note larger/open perpendes.	Inspect box gutter for leaks and repair if required. Repoint brickwork once water ingress has been addressed.	High

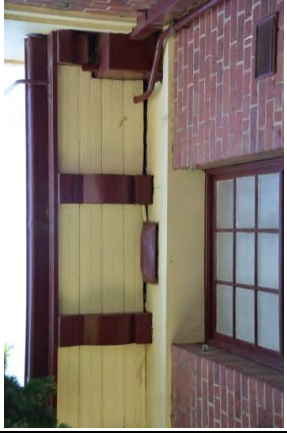
___/___/___
East Elevation	Wall	Concrete lintels cracking. This is possibly due to expansion and contraction of concrete lintels.	Monitor. Consult Structural Engineer if cracking becomes more significant. Update: Defect generally inspected by structural engineer. Refer to report prepared by Mark Hodkinson dated 18th June 2021 - 3.5 External Brickwork Walls.	Low

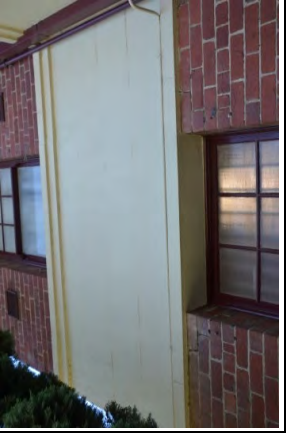
___/___/___
East Elevation	Wall	Inadequate subfloor ventilation. This will be contributing to moisture/damp issues in the timber subfloor.	Provide additional subfloor vents to improve subfloor ventilation.	High

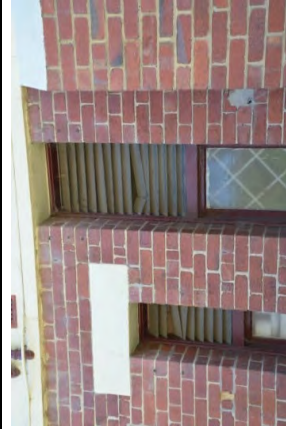
___/___/___
South Elevation	Wall	Gap between opening and vent.	Seal between opening and vent. Ensure all penetrations in masonry wall are properly sealed.	Low

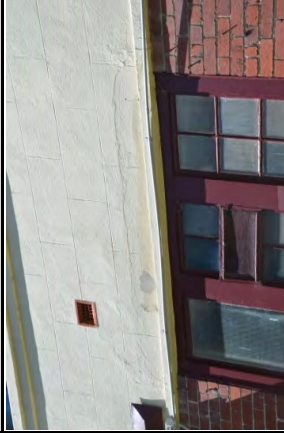
___/___/___
West Elevation	Ceiling	Corbel and soffit appears detached from wall. Indicating significant spreading of truss.	Further investigation of the roof structure required. Consult with Structural Engineer. Structural Engineer to determine if this is a problem or not. Update: Defect generally inspected by structural engineer. Refer to report prepared by Mark Hodkinson dated 18th June 2021 - 3.6 <i>Western Façade Corbels</i> .	High

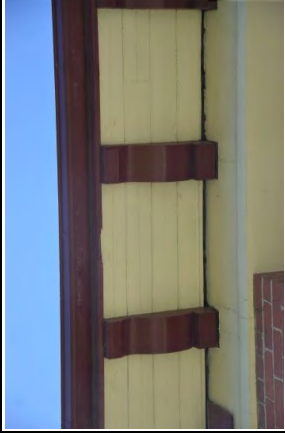
___/___/___
West Elevation	Roof Plumbing	Oxidisation to underside of gutter indicates water collecting in gutter & corroding guttering.	Adjust eaves gutter to ensure adequate fall to outlets. Renew all guttering and other roof plumbing.	High

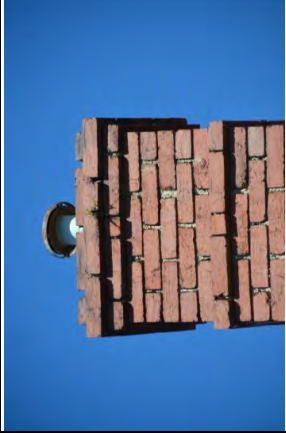
___/___/___
North Elevation	Wall	<p>Vents missing straps.</p>	<p>Repair straps.</p>	Low

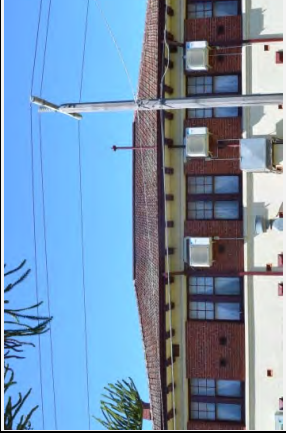
___/___/___
Roof	Roof	Hip appears to be bowing slightly. Possibly related to spreading trusses.	Further investigation of the roof structure required. Consult with Structural Engineer. Structural Engineer to determine if this is a problem or not. Update: Roof structure inspected by structural engineer. Refer to report prepared by Mark Hodgkinson dated 18th June 2021 - 3.1 Roof Structure	High

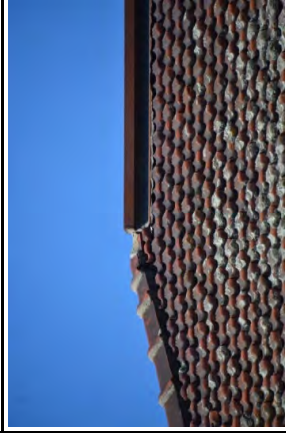
___/___/___
Roof	Roof	Tiles have a moderate amount of lichen which will be releasing organic acids, this accelerates corrosion of roof gutters.	Ongoing issue. Monitor guttering for corrosion. As it is suspected that current guttering will require renewing due to corrosion.	Low
