Tree maintenance on Canterbury Road and Ferrars Street

Version 1.0, 07 June 2024

City of Port Phillip

Tree removals

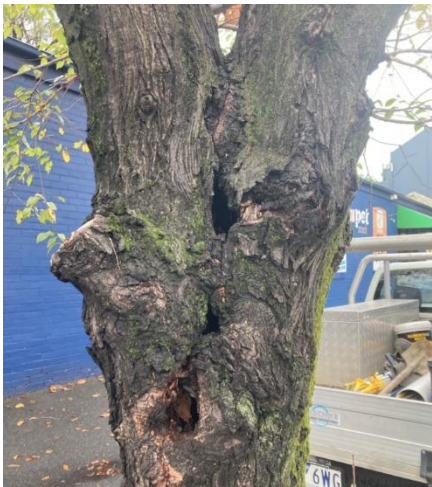
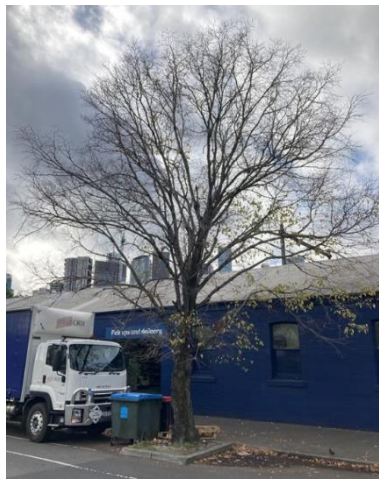
Tree location: 213 FERRARS ST

Historical damage and poor adaptive growth have compromised the structural integrity of this tree, specifically at the point where the trunk divides into two stems, see image below left. This tree will never develop a sound structure.

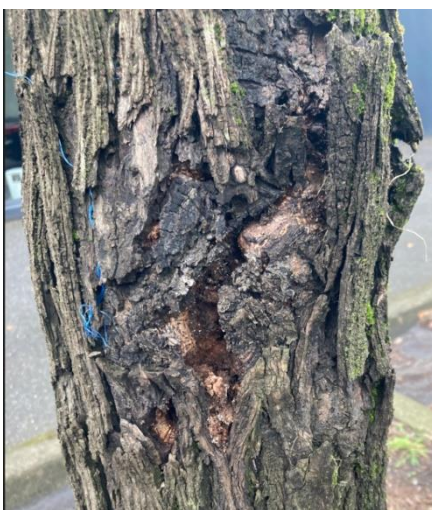
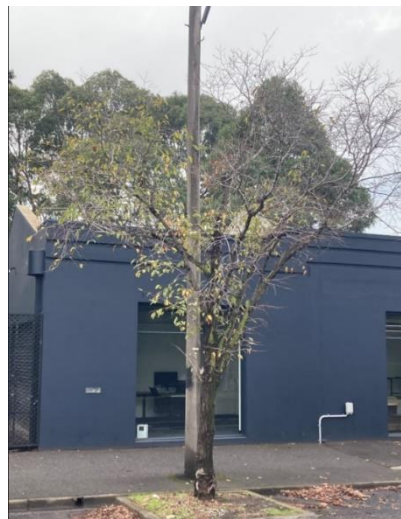
Tree location: 329 FERRARS ST

Historical damage has created a wound on the base of the trunk that has compromised the long term structural stability of the tree, see image below left.

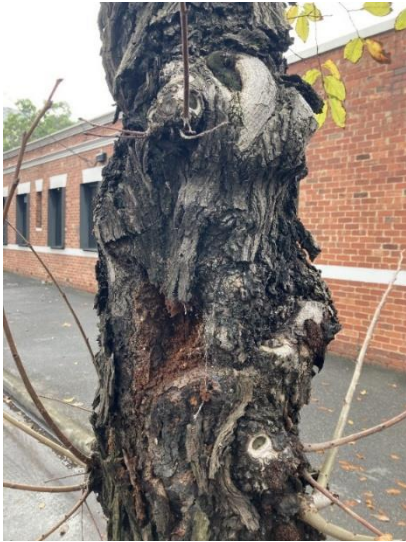
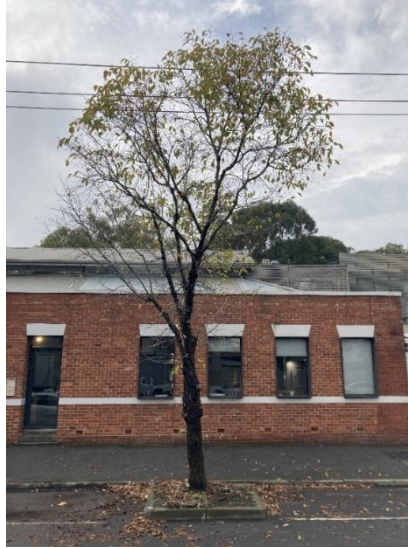
Tree location: 335 FERRARS ST

Historical damage has created a wound on the base of the trunk that has compromised the long term structural stability of the tree, see image below left.

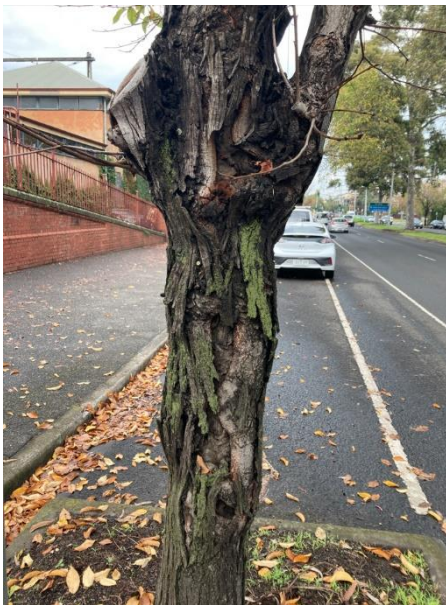
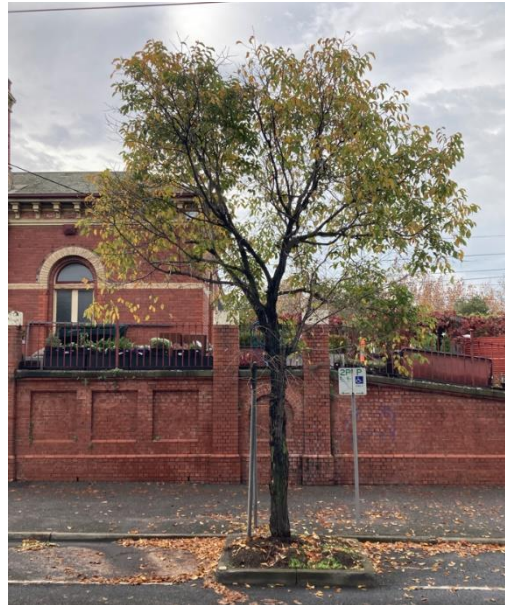
Tree location: 361 FERRARS ST

Historical damage has created a wound on the base of the trunk that has compromised the long term structural stability of the tree, see image below left.

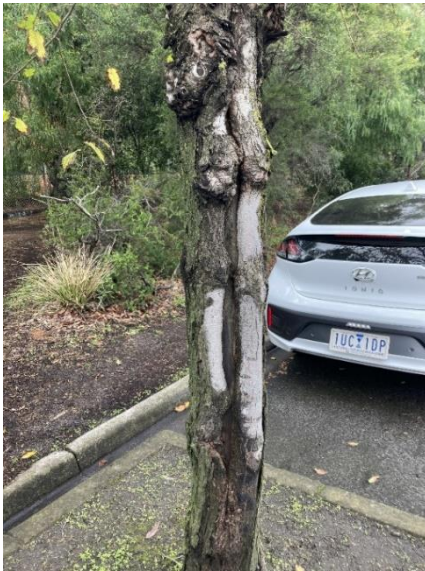
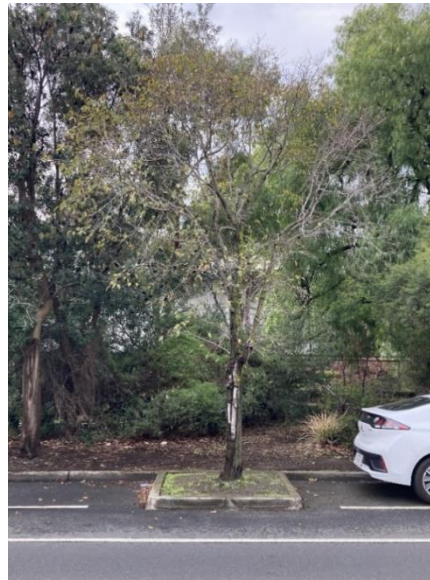
Tree location: opp. 27 CANTERBURY RD

Historical damage has created a wound along most of the trunk that has compromised the long term structural stability of the tree, see image below left.

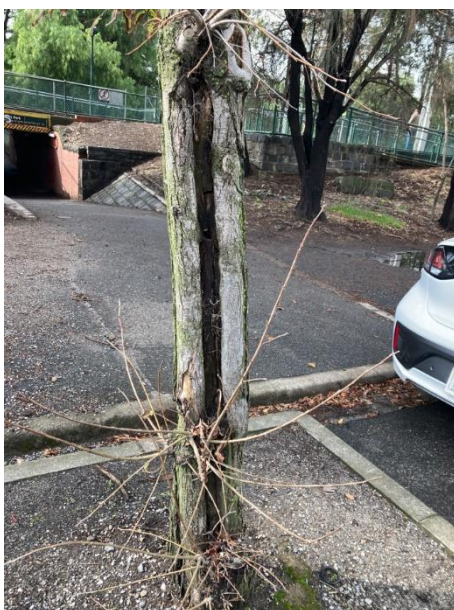
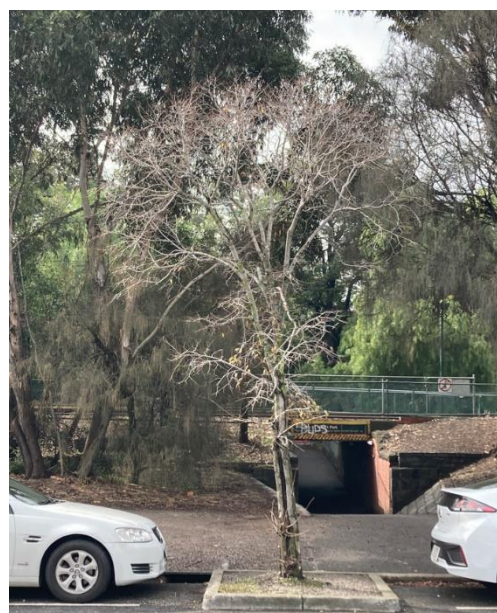
Tree location: opp 40 CANTERBURY RD

Historical damage has created a wound along most of the trunk that has compromised the long term structural stability of the tree, see image below left. Additionally the root system has failed, likely due to vehicle strike.

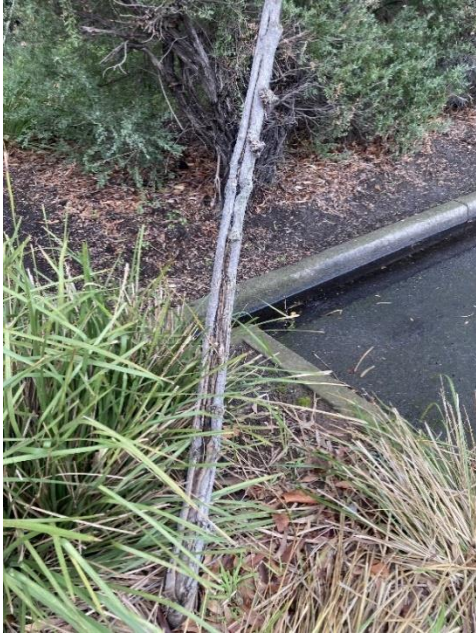
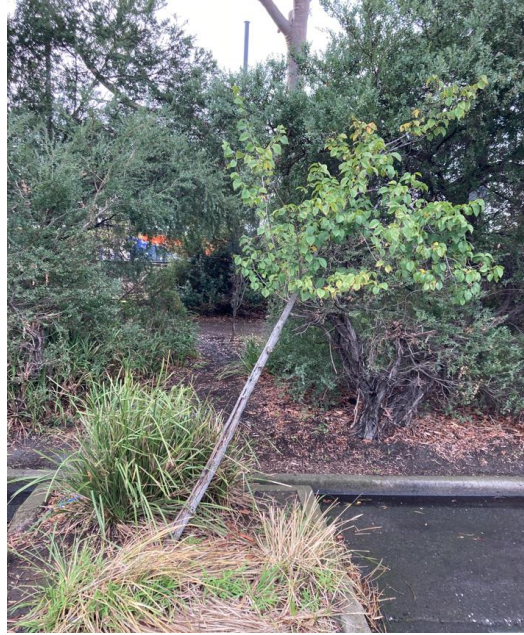
Tree location: opp 61 CANTERBURY RD

Historical damage has created a wound along most of the trunk that has compromised the long term structural stability of the tree, see image below left. Additionally the root system has failed, likely due to vehilce strike.

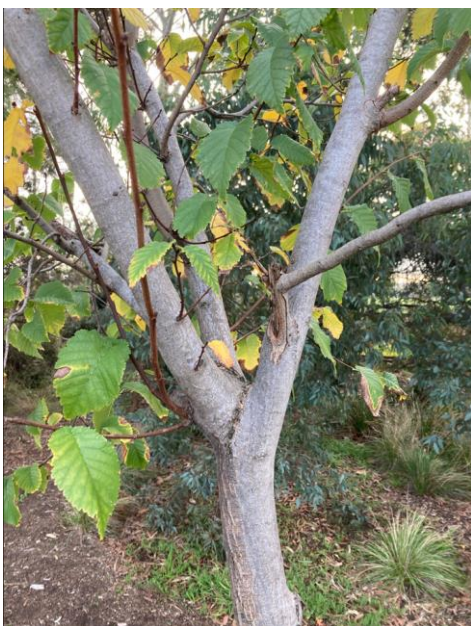
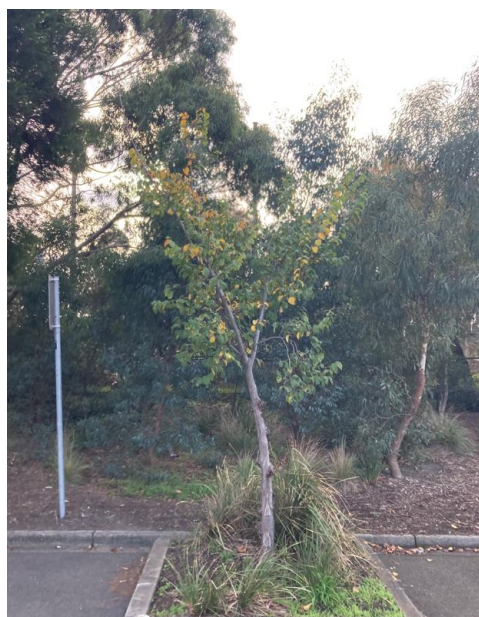
Tree location: opp 61 CANTERBURY RD

Poor formative pruning has failed to establish dominant central leader.

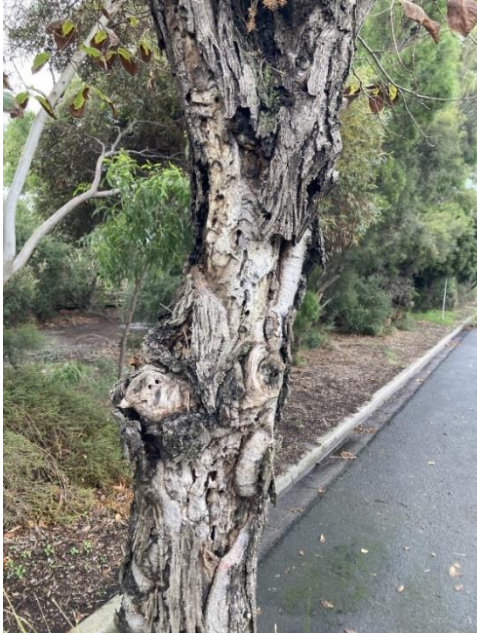
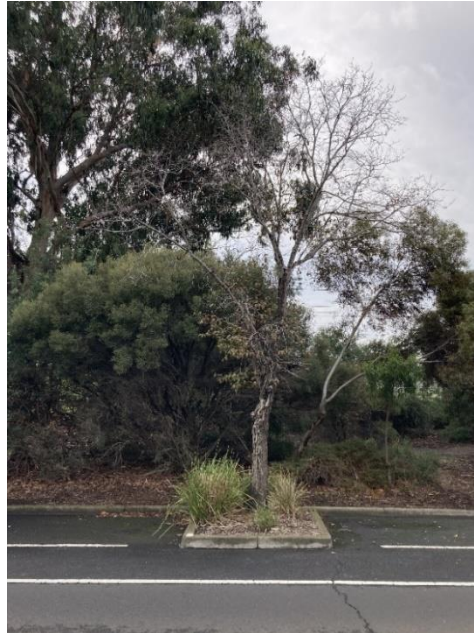
Tree location: opp 69 CANTERBURY RD

Wood eating beetles have compromised the vascular system of this tree, leading to severe canopy dieback and compromise of the trunk's structural integrity.

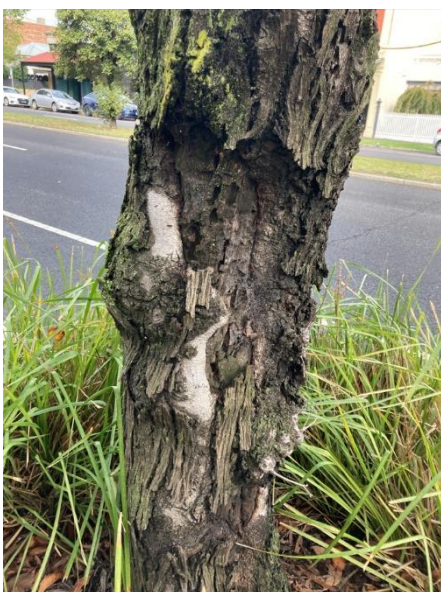
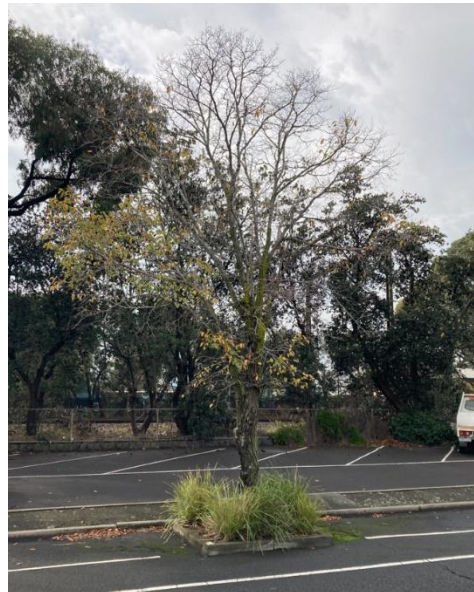
Tree location: opp 79 CANTERBURY RD

Wood eating beetles have compromised the vascular system of this tree, leading to severe canopy dieback and compromise of the trunk's structural integrity.

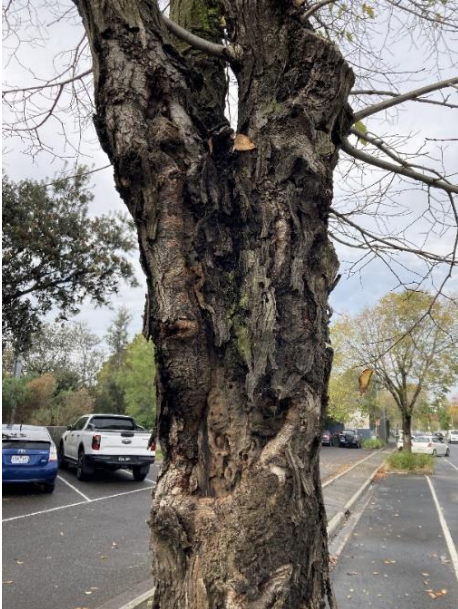
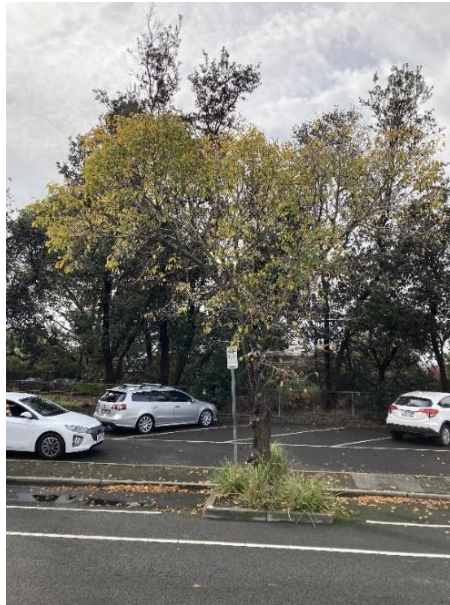
Tree location: opp 88 CANTERBURY RD

Wood eating beetles have compromised the vascular system of this tree, leading to canopy dieback and compromise of the trunk's structural integrity.

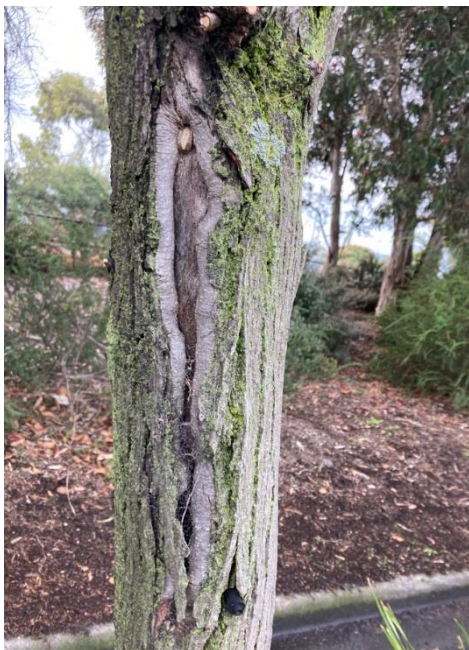
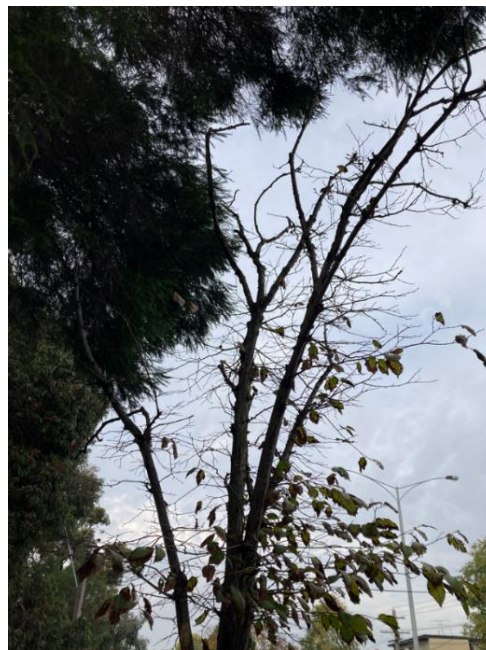
Tree location: opp 140 CANTERBURY RD

This tree has been overshadowed by adjacent trees, causing poor growth and canopy decline. A wound on the trunk will have contributed to the canopy decline.

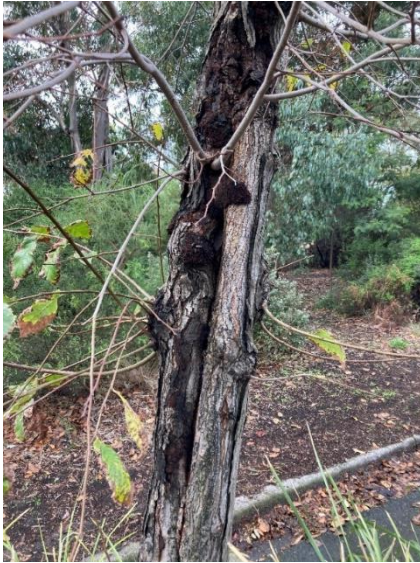
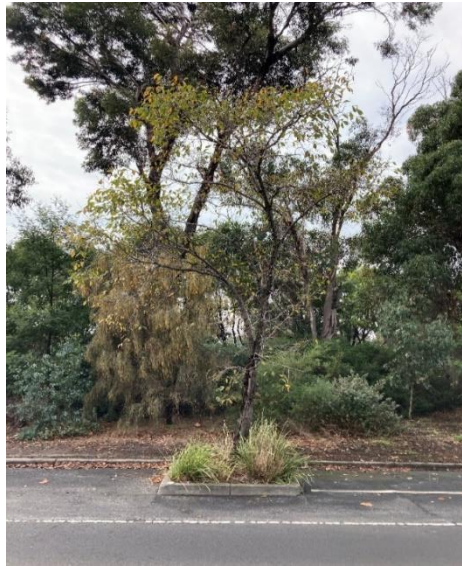
Tree location: opp 143 CANTERBURY RD

Wood eating beetles have compromised the vascular system of this tree, leading to severe canopy dieback and compromise of the trunk's structural integrity.

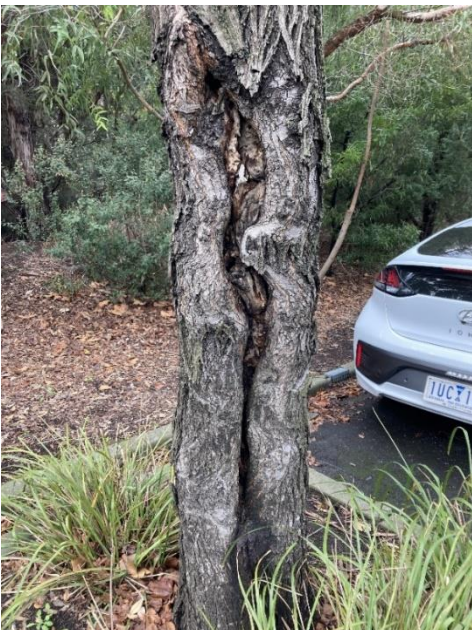
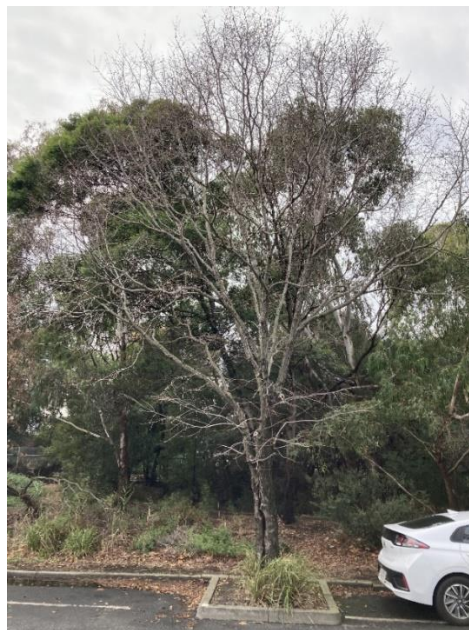
Tree location: opp 175 CANTERBURY RD

Historical damage has created a wound along most of the trunk that has compromised the long term structural stability of the tree, see image below left. Additionally the canopy has declined, likely caused by the loss of vascular tissue.

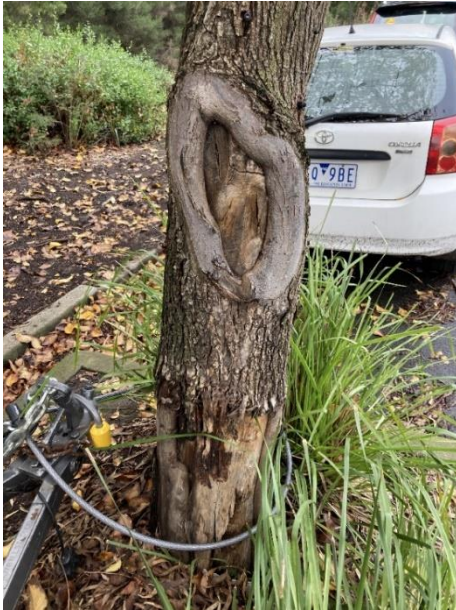
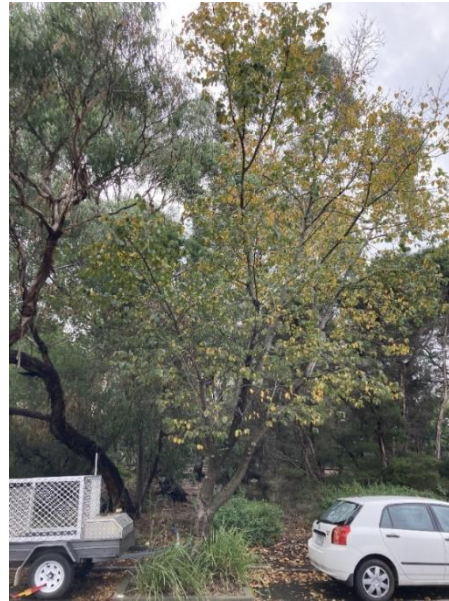
Tree location: opp 179 CANTERBURY RD

Historical damage, and poor pruning practices, to the base of the tree have compromised the long term structural stability of this tree.

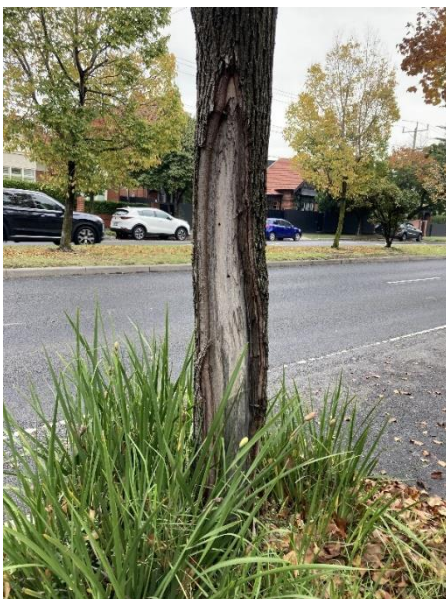
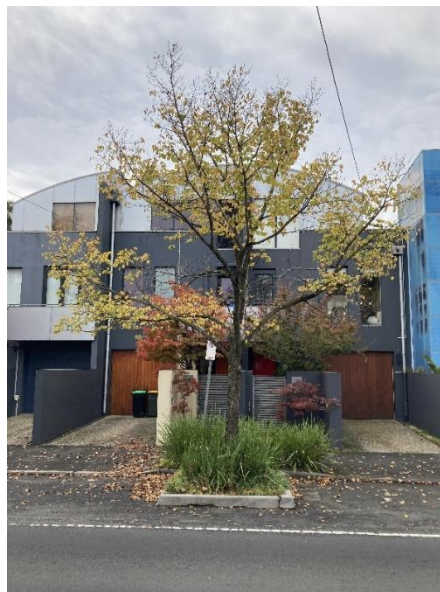
Tree location: 269 CANTERBURY RD

Historical damage to the base of the tree have compromised the vascular system and long term structural stability of this tree.

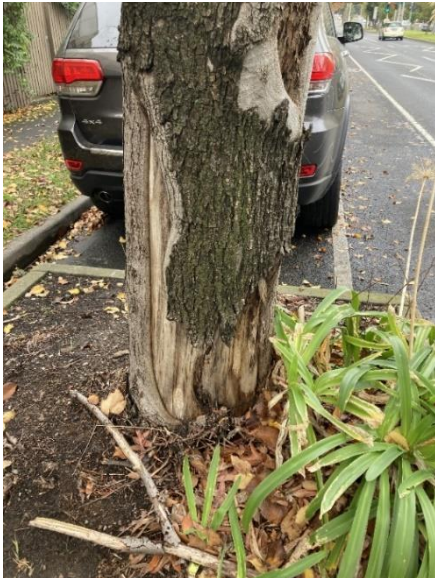
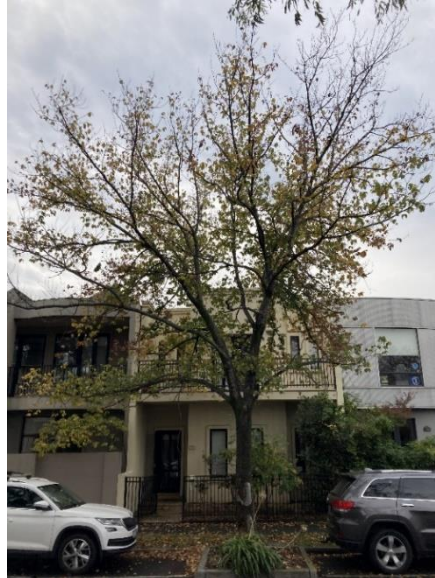
Tree location: 318 CANTERBURY RD

Historical damage, and poor pruning practices, to the base of the tree have compromised the long term structural stability of this tree. The low wound will have caused degradation of the structural root system.

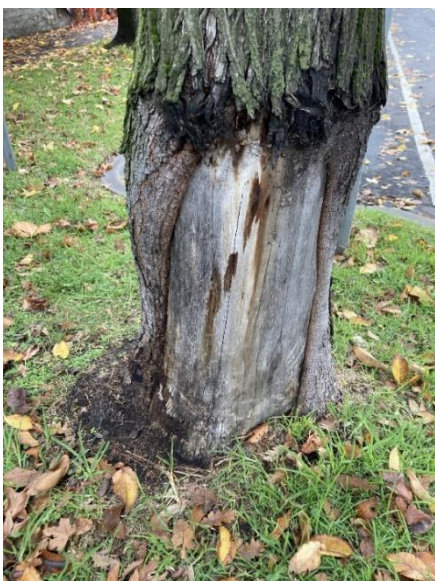
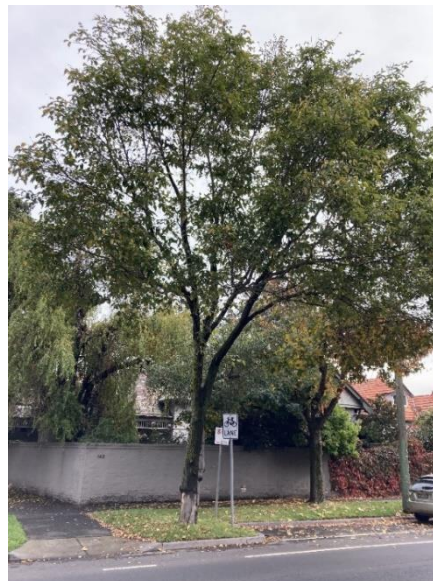
Tree location: 142 CANTERBURY RD

Historical damage to the base of the tree have compromised the structural stability of this tree. The low wound will have caused degradation of the structural root system.

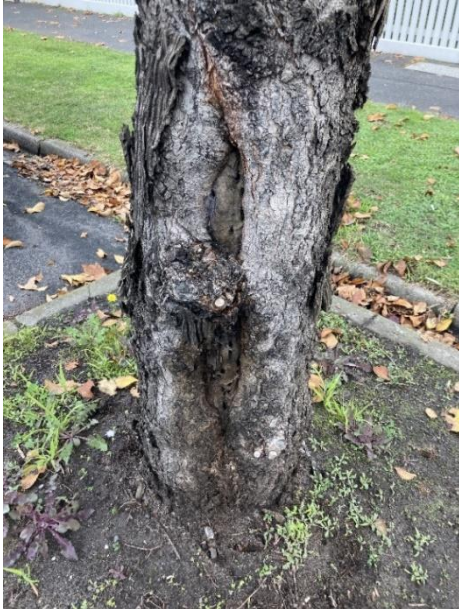
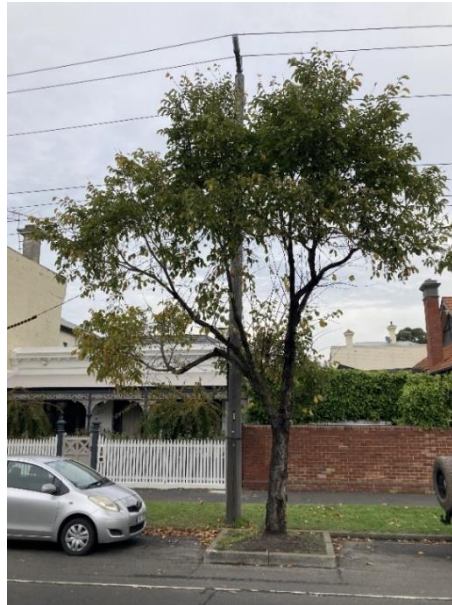
Tree location: 79 CANTERBURY RD

Historical damage to the base of the tree has compromised the long term structural stability of the tree.

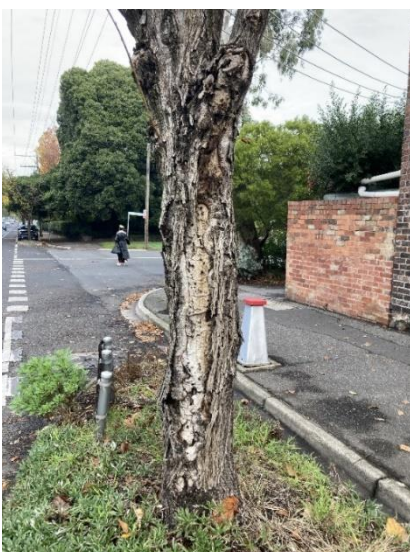
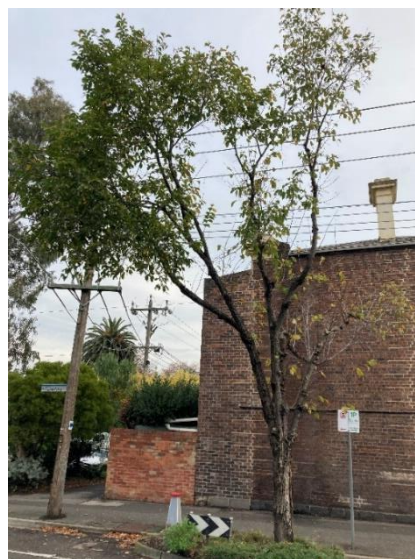
Tree location: adj 2 ST VINCENT PLACE NORTH on FERRARS ST

Wood eating beetles have compromised the vascular system of this tree, leading to severe canopy dieback and compromise of the trunk's structural integrity.

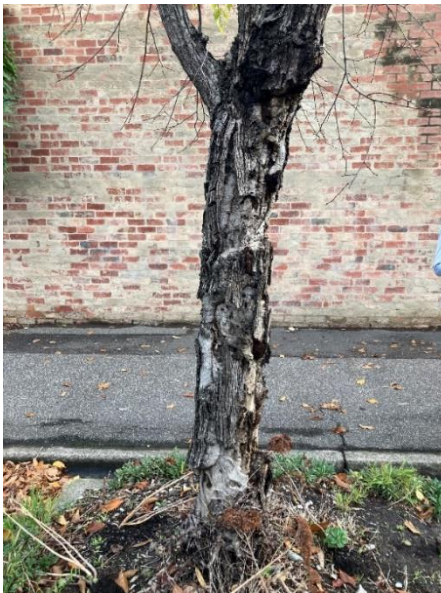
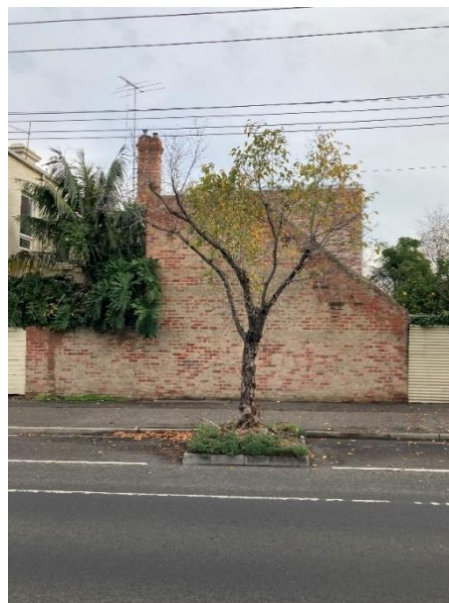
Tree location: adj 2 ST VINCENT PLACE NORTH on FERRARS ST

Wood eating beetles have compromised the vascular system of this tree, leading to severe canopy dieback and compromise of the trunk's structural integrity.

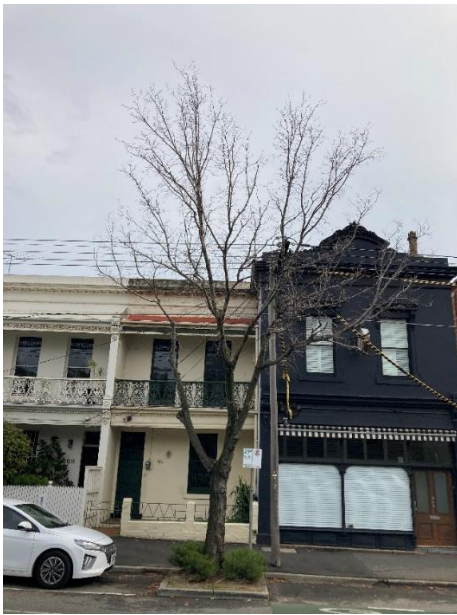
Tree location: 258 FERRARS ST

This tree is dead, there is no live vascular tissue.

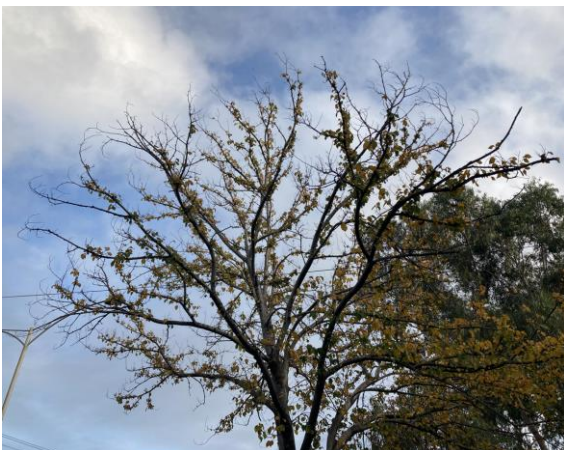
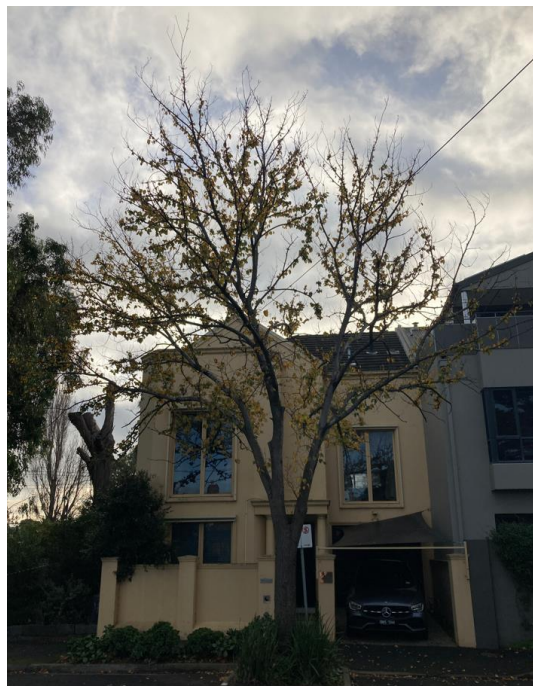
Tree Location: 262 CANTERBURY RD

This tree exhibits tip dieback through the whole crown.

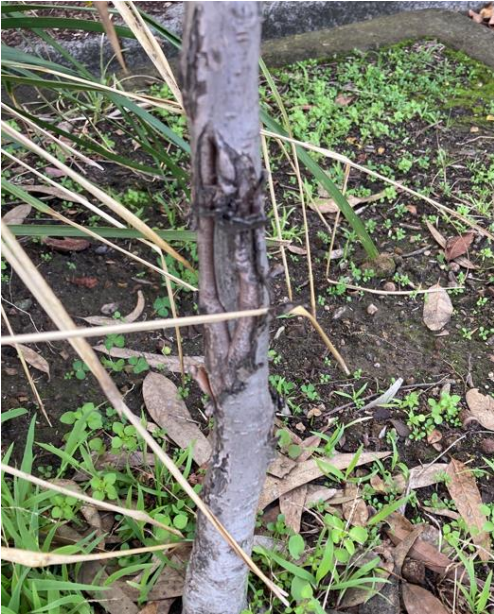
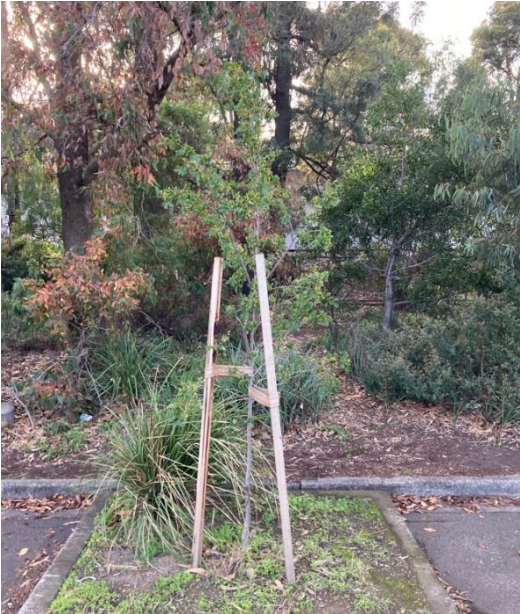
Tree Location: opp 22 CANTERBURY RD

Poorly performing juvenile tree, species not in theme with boulevard palette.

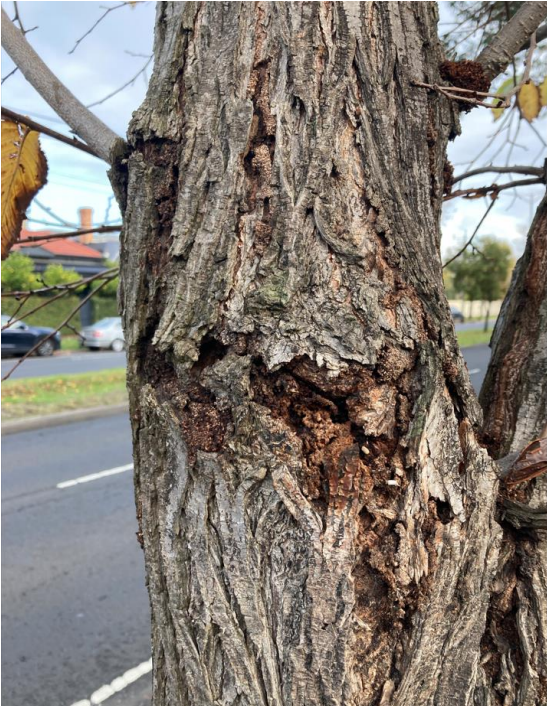
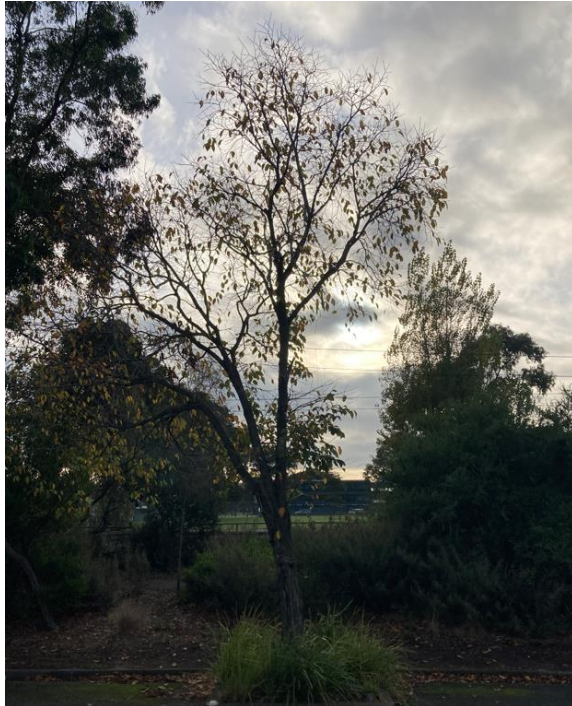
Tree Location: opp 134 CANTERBURY RD

Wood eating beetles have compromised the vascular system of this tree, leading to severe canopy dieback and compromise of the trunk's structural integrity.
