# **Greenwood Consulting** <sup>P/L</sup>

## **1 - 7 Waterfront Place Port Melbourne**

## **Tree Protection Management Plan**

**Friday, 14 February 2025**

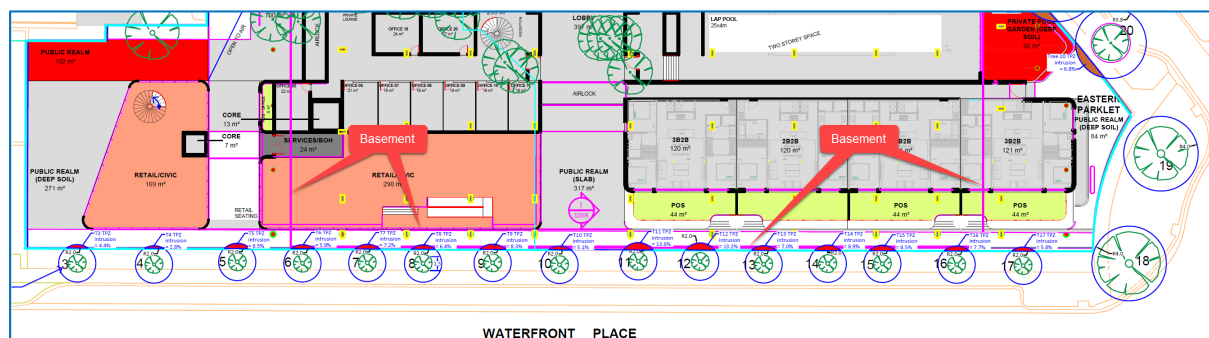
Figure 1 Basement TPZ intrusion for Trees 3 - 20

It is assumed that site works will, for Trees 3, 4 & 5, excise the TPZ up to the property boundary.

The TPZ intrusion for these trees is as set out below.

ID	%	ID	%	ID	%	ID	%	ID	%
3	4.4%	6	5.9%	9	8.3%	12	13.2%	15	8.5%
4	2.8%	7	7.2%	10	5.1%	13	7.0%	16	7.7%
5	8.5%	8	6.4%	11	13.6%	14	8.9%	17	5.8%

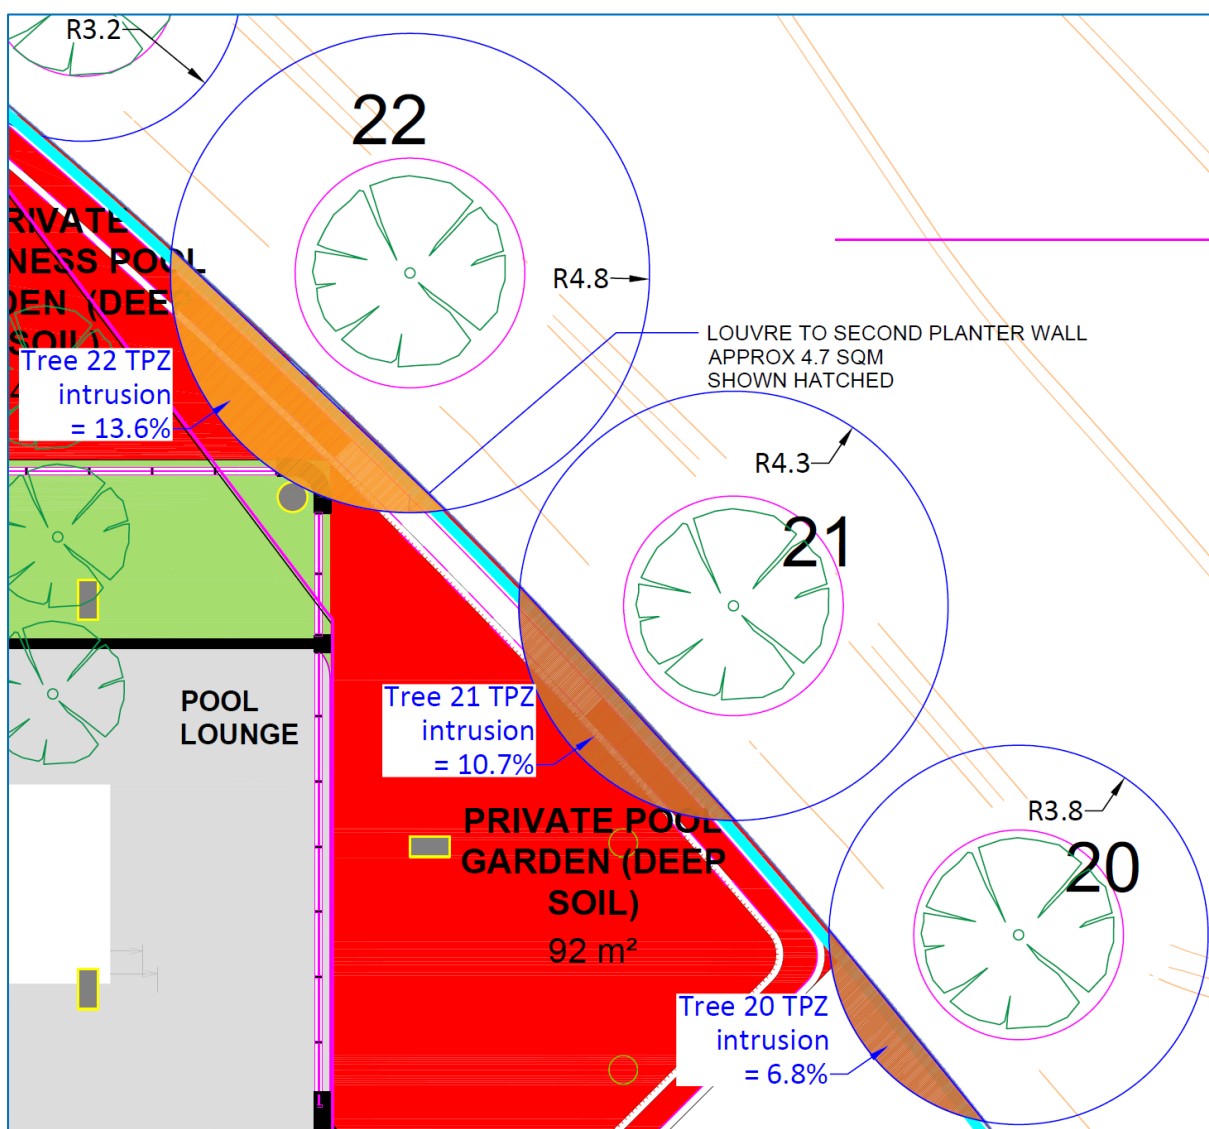
Figure 3 TPZ intrusion for Trees 20, 21 & 22

This impact could be ameliorated by the improvement of the growing conditions for this tree (mulch and irrigation) or by preserving the soil volume for this tree within the site.

If these recommendations cannot be achieved, then it is likely that this tree will be vulnerable to drought and nutrient stress.

2. Either the growing conditions for this tree must be improved or the soil volume within the site must be preserved.
  - a. If the soil volume is to be preserved, then:
    - i. The soil volume within the TPZ for this tree, within the subject site and outside the proposed building footprint must be maintained as is.
      1. Excavation or soil disturbance within the area specified above must be avoided.
      2. This specification must be annotated on all of the project plans as appropriate.
  - b. If the growing conditions for this tree are to be improved, then:
    - i. The entirety of the TPZ within the road reserve and that it outside the paved areas must be mulched to a depth of 10cm.
    - ii. Fully automated drip irrigation must be installed within the above area.
    - iii. The mulch and irrigation must be maintained for a minimum of 5 years.

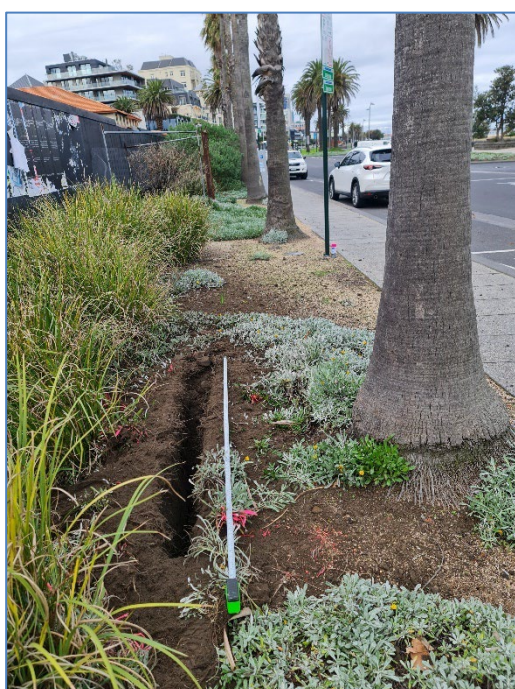
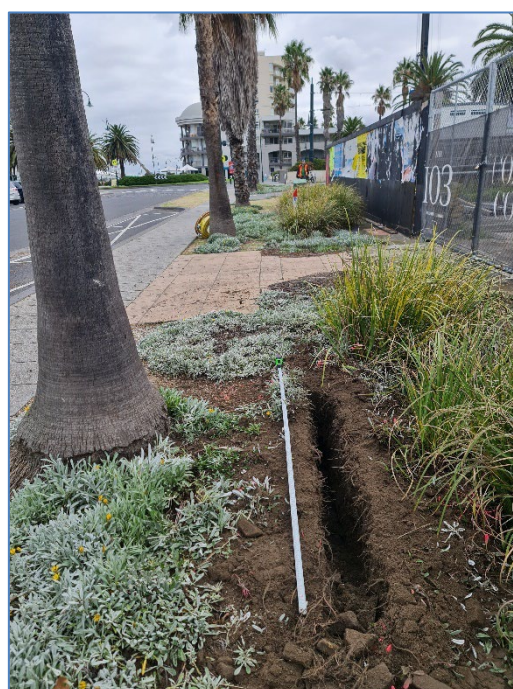
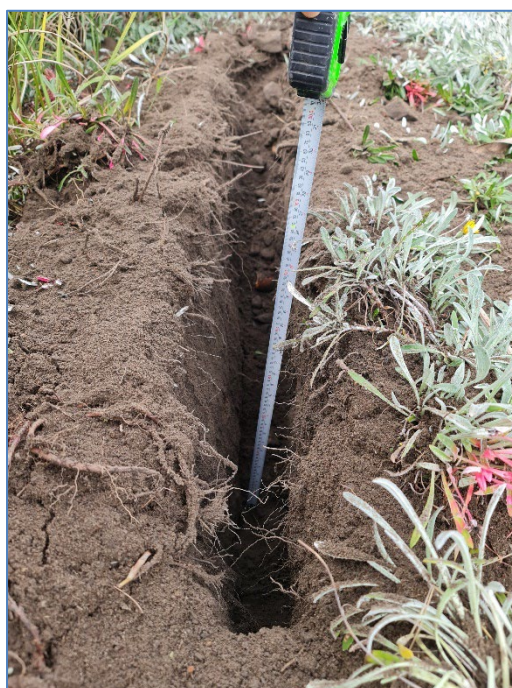
### 15.1. Tree 5

Minor fibrous root mass was observed in each of the trenches. As stated above, palm trees can readily replace damaged or severed tree roots. The extent of root mass encountered is not expected to impact on tree health and longevity.
