Kerferd Rd, Montague St,
Herbert St - Intersection,
Albert Park

Road Safety Audit

Audit Stage: Existing Conditions

Report for City of Port Phillip

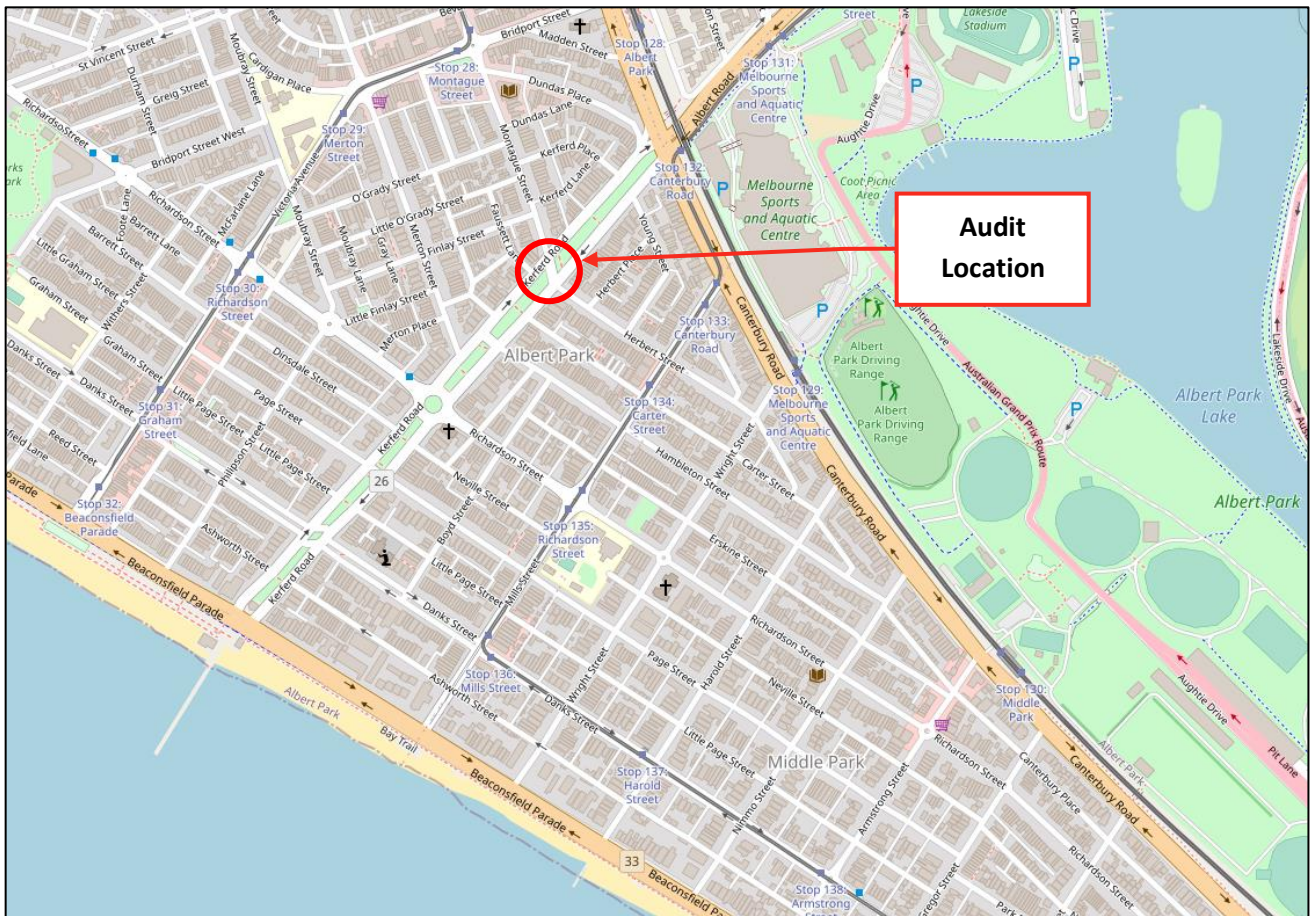
Figure 1: Map of audit location (source: OpenStreetMap)

The audit location is the intersection of Kerferd Road, Montague Street and Herbert Street in Albert Park. Herbert Street has a two-way, six lane divided cross-section, inclusive of on-street parking on either side of the roadway and additional on-street bicycle lanes. Herbert Street road users are subject to a 60km/h speed limit.

Herbert Street and Montague Street are minor roads and intersect with Kerferd Road as a staggered T-intersection, with Montague Street skewed. A diagonal break in Kerferd Roads' wide centre median enables motorists to move directly between Herbert Street and Montague Street. Approaches from either minor road have a Give-Way condition with an additional Give-Way condition within the median break.

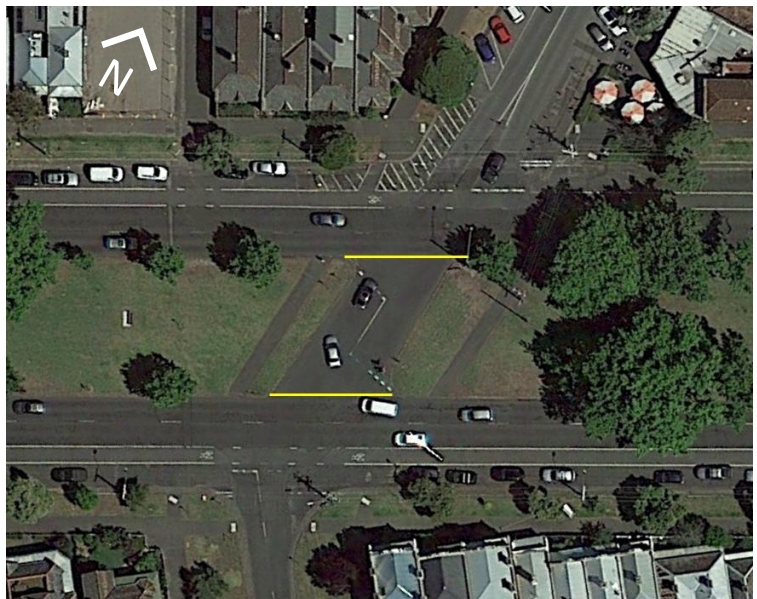
This would eliminate many of the conflict points at this intersection. It is predicted that traffic distribution will mean vehicles move to safer intersections and routes. The Auditors also consider the amount of permeability across Kerferd Road to be excessive for passenger vehicles with four crossing points within ~500m in this section. There are low risk u-turn opportunities within close proximity to this intersection providing ample local access.

The design could consider measures to retain cyclist permeability across the intersection. This could be achieved via low cost treatments or a more permanent infrastructure.

1. Closing the median break.

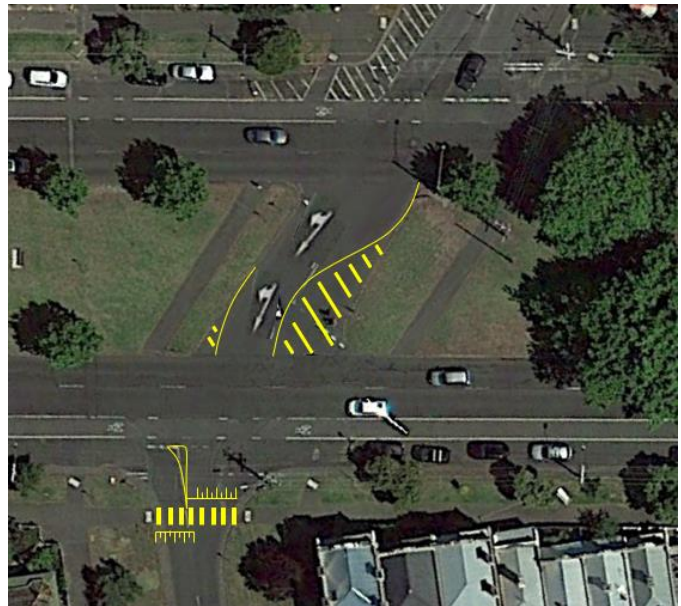
If there are concerns about the traffic impact on Ferrars Street/Canterbury Road intersection, a partial closure would reduce the risk by squaring the crossing and simplifying the crossing point. It should be noted that this will not be as effective in risk reduction as the full closure.

This could be achieved via low cost treatments or a more permanent infrastructure.

2. Partial Median Closure

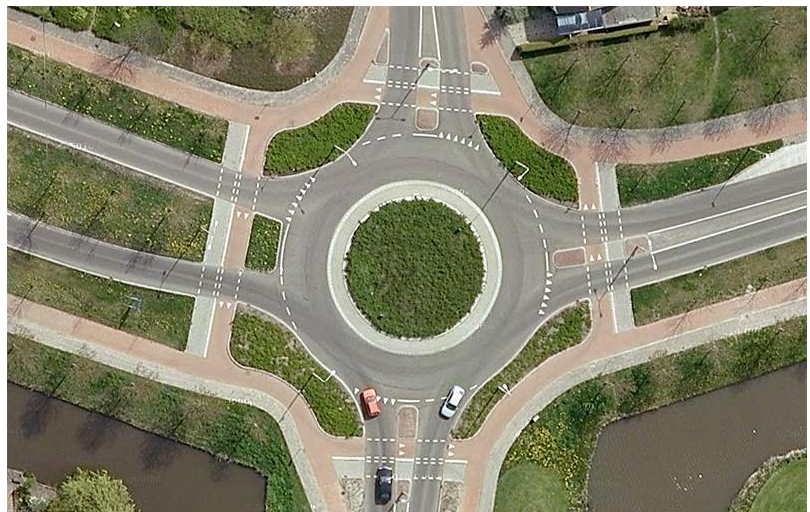
(the picture to the right is a Dutch style protected roundabout. Similar examples can be seen on Moray Street, South Melbourne. Design work would be required to cater for the intersection stagger between side roads)

7. Converting the intersection to a protected roundabout ie. with appropriate pedestrian and cyclist facilities.

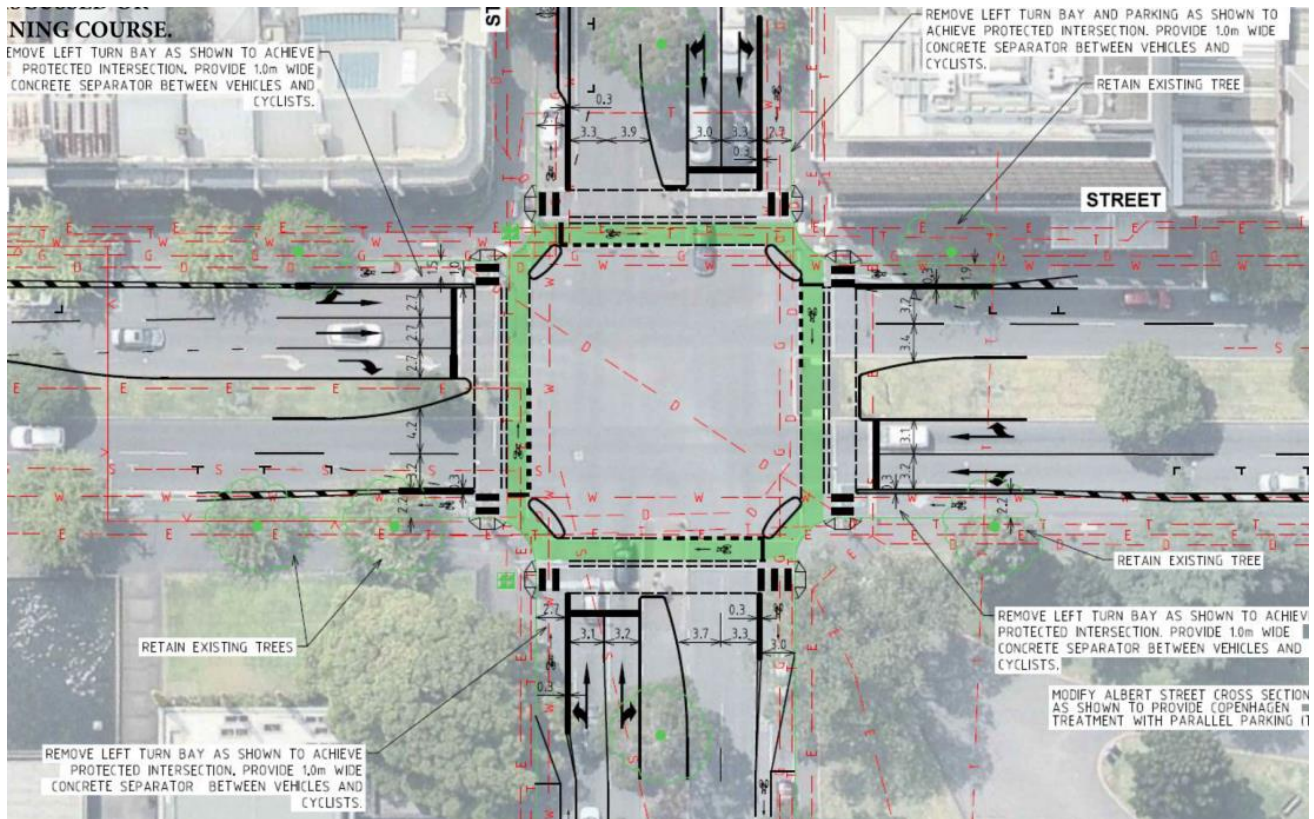
8. Converting the passive controlled intersection to a **protected signalled intersection** (similar to Albert Street/Lansdowne Street, East Melbourne (design snip below)).

It should be noted that both these options (#7 and #8) are high cost and would not be as effective in reducing risk as the intersection closure. Further detailed work would be required to determine the most appropriate treatment between a roundabout or traffic signals, and how the treatment best caters for pedestrians and cyclists.

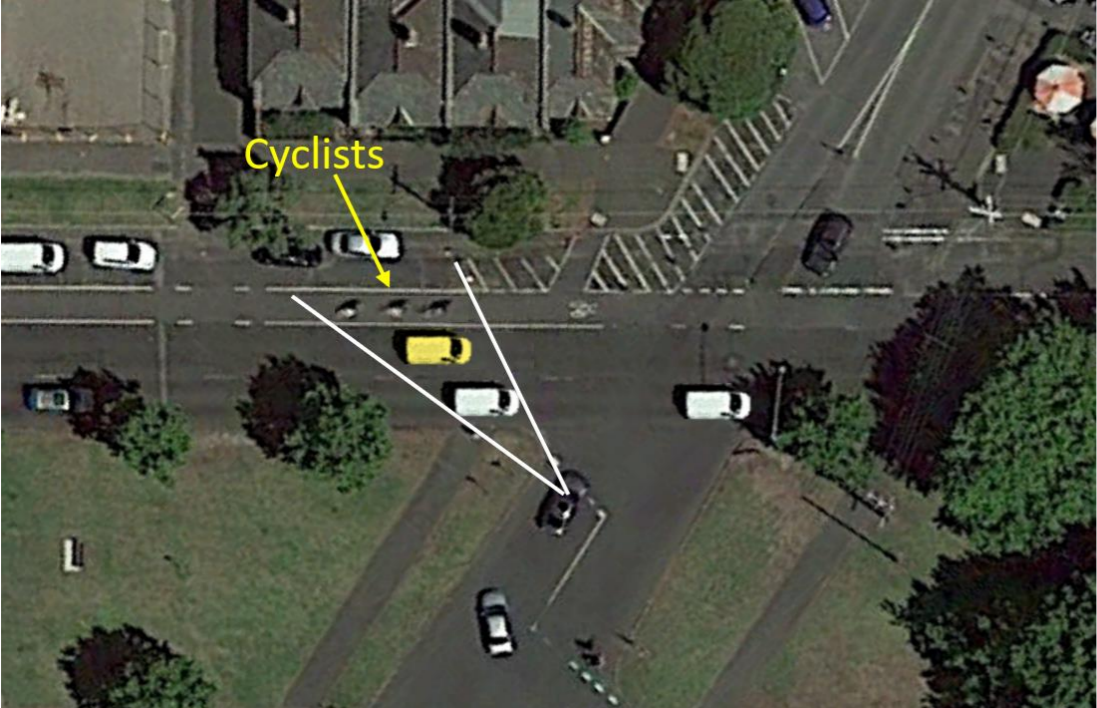
4.1 Sight Lines for Vehicles Exiting Median					
<p>1. There are a number of issues hampering sight lines for vehicles exiting the median into the side roads. These include the dynamic visual obstruction possibility, the angle and the trees. These are described in more detail below:</p> <p>Dynamic Visual Obstruction (masking) Because Kerferd Road is two lanes, there is potential for a dynamic visual obstruction (masking) type issue. The sketch below shows that the yellow van, and the three cyclists would be hidden by the white van for the vehicle exiting the median. If vehicles were banked back from the signalised intersection, or if the masking vehicle was further back on Kerferd Road, the vehicle exiting the median may take a hard acceleration and collide with the yellow car, or the cyclist.</p>

<p>An additional issue related to the dynamic visual obstruction associated with the dual lanes is the high cognitive load on a driver exiting the median. The driver is required to be alert to two traffic lanes, one cyclist lane and pedestrians crossing the side road.</p>	<p>Occasional Serious High</p>	<p>Exceeds tolerable levels (important)</p>	<p>Consider the options presented on page 9 and 10 above, with the preferred option from the Auditors being:</p> <ul style="list-style-type: none"> Close the median break (P)

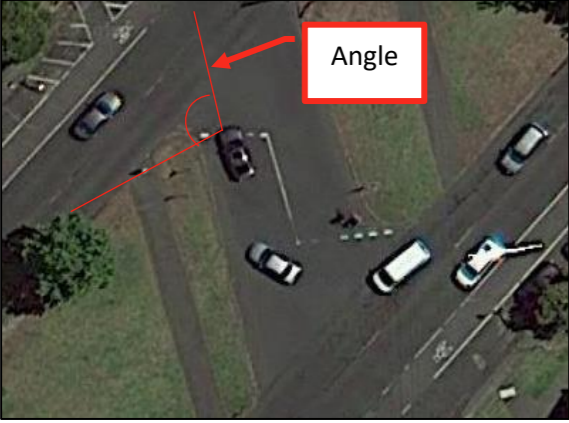
Audit Findings	Level of Risk	Safe System Energy	Recommendations P – Primary ST – Step Towards S – Supporting N – Non-Safe System	Responsible Officer	
				Accept Yes/No	Comments
<p>Angle Within the median break, traffic lanes intersect with Kerferd Road on a skewed angle (greater than 90 degrees) with a Give-Way condition. Angles greater than 90 degrees can be difficult for some motorists to turn their heads far enough to observe through traffic.</p>

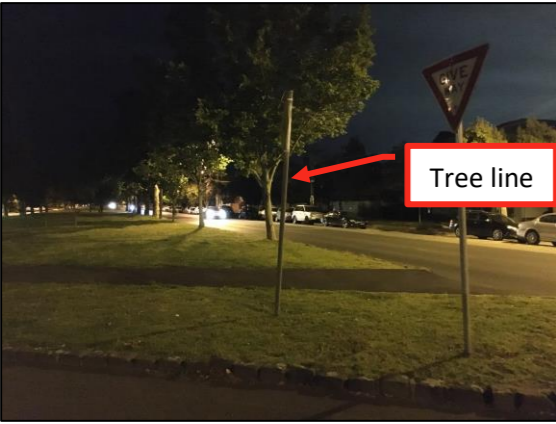
<p>A potential front seat passenger may impede a motorist's sight line as they are forced to observe traffic from behind their shoulder, in line with said passenger.</p> <p>Trees An established tree line is also present in close proximity to the roadway impeding sightlines to smaller road users such as motorcyclists and cyclists.</p> <p>A motorist may fail to observe a through vehicle, these issues compound to increase the likelihood of failure to Give-Way crashes.</p>

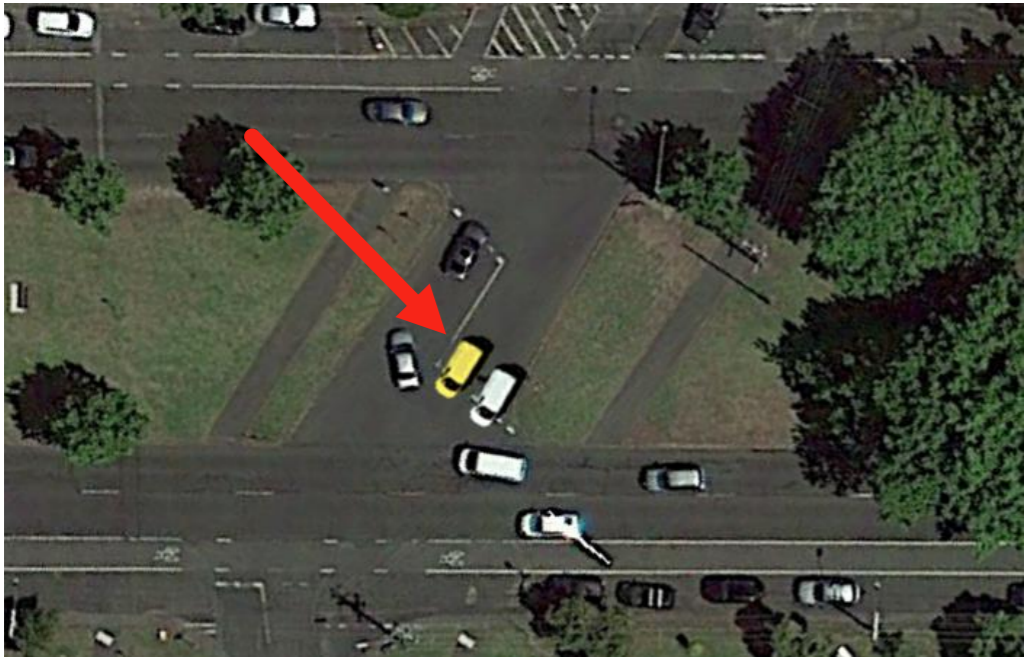
Audit Findings	Level of Risk	Safe System Energy	Recommendations P – Primary ST – Step Towards S – Supporting N – Non-Safe System	Responsible Officer	
				Accept Yes/No	Comments
<p>4.2 Median Opening Width</p> <p>1. There are very wide lanes in the median opening. The skewed angle of the opening means these may be required for the swept path of larger vehicles. Unfortunately this causes two issues; a. There is the possibility of two vehicles storing side-by-side while one waits to turn right and the other waits to travel straight (see mock up below with the yellow and white vans). This causes a dynamic visual obstruction (masking) issue. This may result in the crashes as identified in finding #1. b. The wide lanes encourage higher speeds for vehicles making a dash through the intersection.</p>

<p>Improbable Serious Medium</p>	<p>Exceeds tolerable levels (important)</p>	<p>Consider the options presented on page 9 and 10 above, with the preferred option from the Auditors being:</p> <ul style="list-style-type: none"> • Close the median break (P)

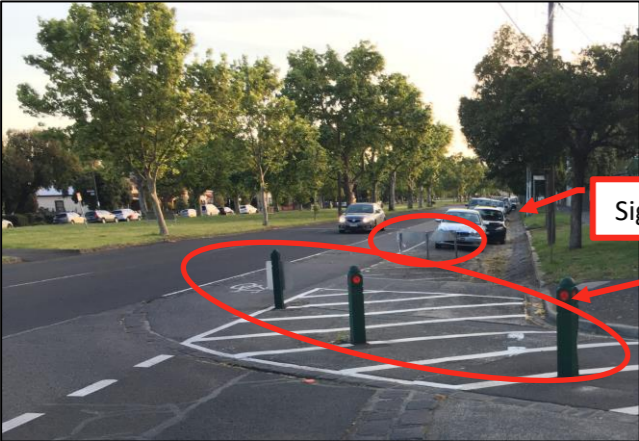
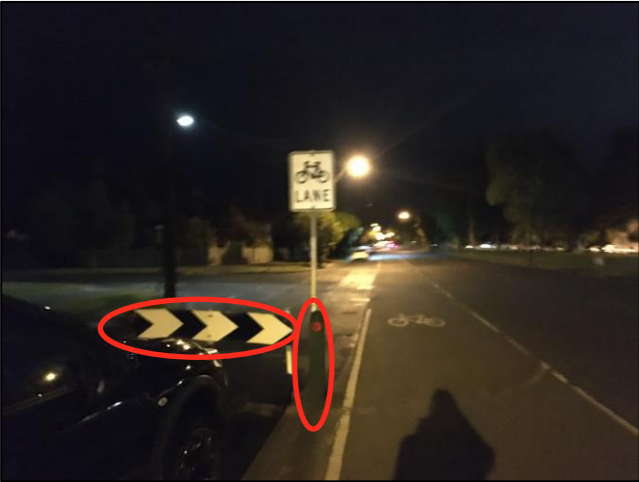
Audit Findings	Level of Risk	Safe System Energy	Recommendations P – Primary ST – Step Towards S – Supporting N – Non-Safe System	Responsible Officer	
				Accept Yes/No	Comments
<p>4.3 Strike Hazards in Roadway</p> <p>1. Where Montague Street intersects Kerferd Road, and to the northeast of Herbert Street, wooden bollards and signage have been installed in front of the kerb. It is assumed that these treatments in conjunction with pavement markings have been installed to a pseudo kerb-outstand thus reducing the speed of left turning vehicles and providing better sight lines for exiting vehicles. While the Auditors support the principles and compliment the low-cost innovative treatment, the bollards and signs in these locations are close to the cyclist running lane and could pose a strike hazard to a cyclist, motorcyclist or a vehicle.</p> <div style="display: flex; flex-direction: column; align-items: flex-start;">

</div>	<p>Occasional Minor Medium</p>	<p>Within tolerable levels</p>	<p>Consider measures that provide a safe road environment to all road users, such measures could include:</p> <ul style="list-style-type: none"> Removing bollards and signage, installing kerb extensions, reinstalling compliant bollards and signage as required (S). <p>Additional raised thresholds could be considered for pedestrian safety as per the recommendations below.</p>

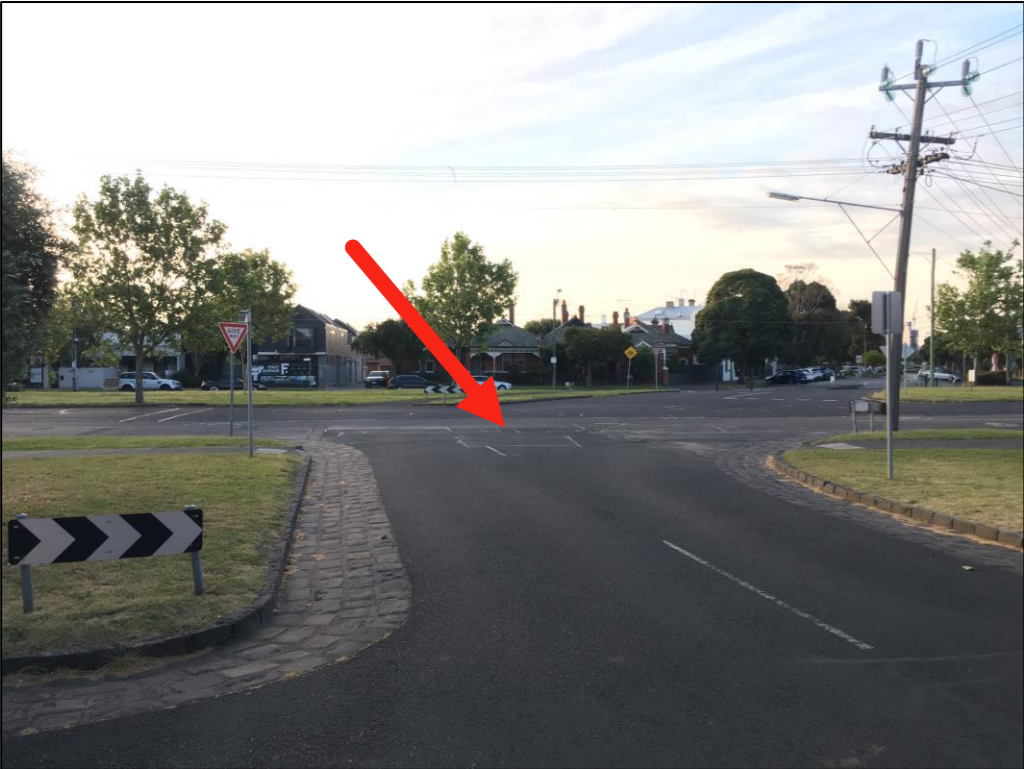
Audit Findings	Level of Risk	Safe System Energy	Recommendations P – Primary ST – Step Towards S – Supporting N – Non-Safe System	Responsible Officer	
				Accept Yes/No	Comments
<p>4.4 Unexpected Bicycles</p> <p>1. Kerferd Road has dedicated bicycle lanes which provides cyclists road width. However, due to the complexity of the intersection and the number of lanes, motorists that approach the intersection from the minor roads may not detect a through cyclist. This increases the likelihood of a collision between a cyclist and a motorist.</p>

<p>Occasional Serious High</p>	<p>Exceeds tolerable levels (important)</p>	<p>Consider measures to slow vehicles on the approach to Kerferd Road and measures to highlight the potential presence of cyclists. This may include:</p> <ul style="list-style-type: none"> • Raised threshold treatments (S) • Installing a green pavement treatment within the bicycle lanes on the approach and through the intersection (S)

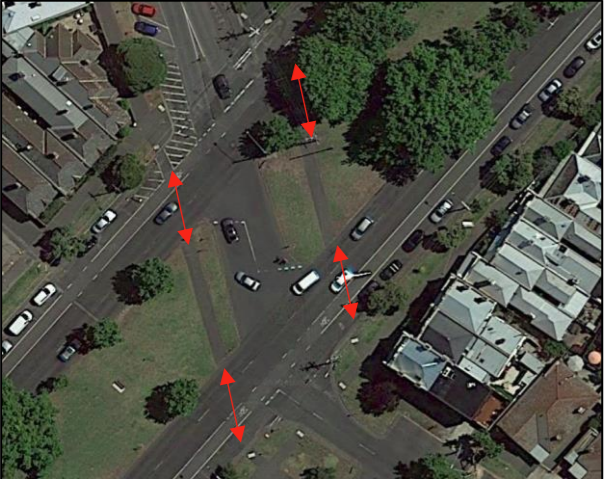
4.5 Pedestrians					
<p>1. Kerferd Road pedestrian crossing points do not align perpendicular to the carriageway. This results in pedestrians crossing the roadway at a diagonal angle. A pedestrian crossing a roadway on a diagonal angle increases the time they are exposed to through traffic. This increases the likelihood of a collision between a pedestrian and a motorist.</p>

<p>Improbable Serious Medium</p>	<p>Exceeds tolerable levels (important)</p>	<p>Consider:</p> <ul style="list-style-type: none"> Installing pedestrian priority crossing points (P) Realigning kerb ramps so the crossing points are perpendicular to the roadway (S) <p><i>It is noted the current diagonal crossing points are likely to suit pedestrian desire lines and any realignment works should take this into consideration.</i></p>		
<p>2. Motorists wishing to exit the median, and drive onto the minor roads are required to give-way to motorists in the two through lanes and cyclists in the bicycle lane. This may result in a motorist exiting the median through a small break in the traffic flow and accelerating quickly (shown as the yellow vehicle in the image below). A pedestrian wishing to cross the minor road may not expect the yellow vehicle to accelerate through a small break and may walk out into the roadway. This increases the likelihood of a crash between a pedestrian and a motorist.</p>

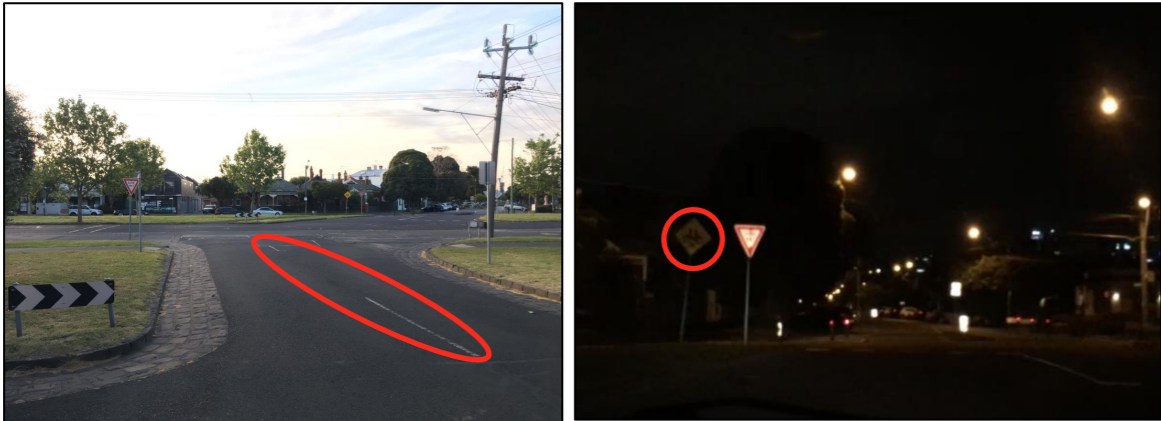
Audit Findings	Level of Risk	Safe System Energy	Recommendations P – Primary ST – Step Towards S – Supporting N – Non-Safe System	Responsible Officer	
				Accept Yes/No	Comments
<p>3. Some of the signage and line marking are faded on the approach and through the intersection (see images below for examples). This reduces the clarity of the intersection which is already complicated. This in turn adds to the cognitive load on a driver which may result in them colliding with another vehicle or a pedestrian, cyclist or motorcyclist.</p>

<p>Improbable Serious Medium</p>	<p>Exceeds tolerable levels (important)</p>	<p>Consider the options presented on page 9 and 10 above, with the preferred option from the Auditors being:</p> <ul style="list-style-type: none"> • Closing the median break (P) • In the interim of any major works, consider updating the signage and line marking (S)
