Elwood Foreshore – Preliminary Aboriginal Cultural Heritage Assessment

The City of Port Phillip has engaged Eco Logical Australia (ELA) to undertake a preliminary Aboriginal cultural heritage assessment of an area of coastal foreshore in Elwood, Victoria. This assessment is intended to assist with the future master planning of the area.

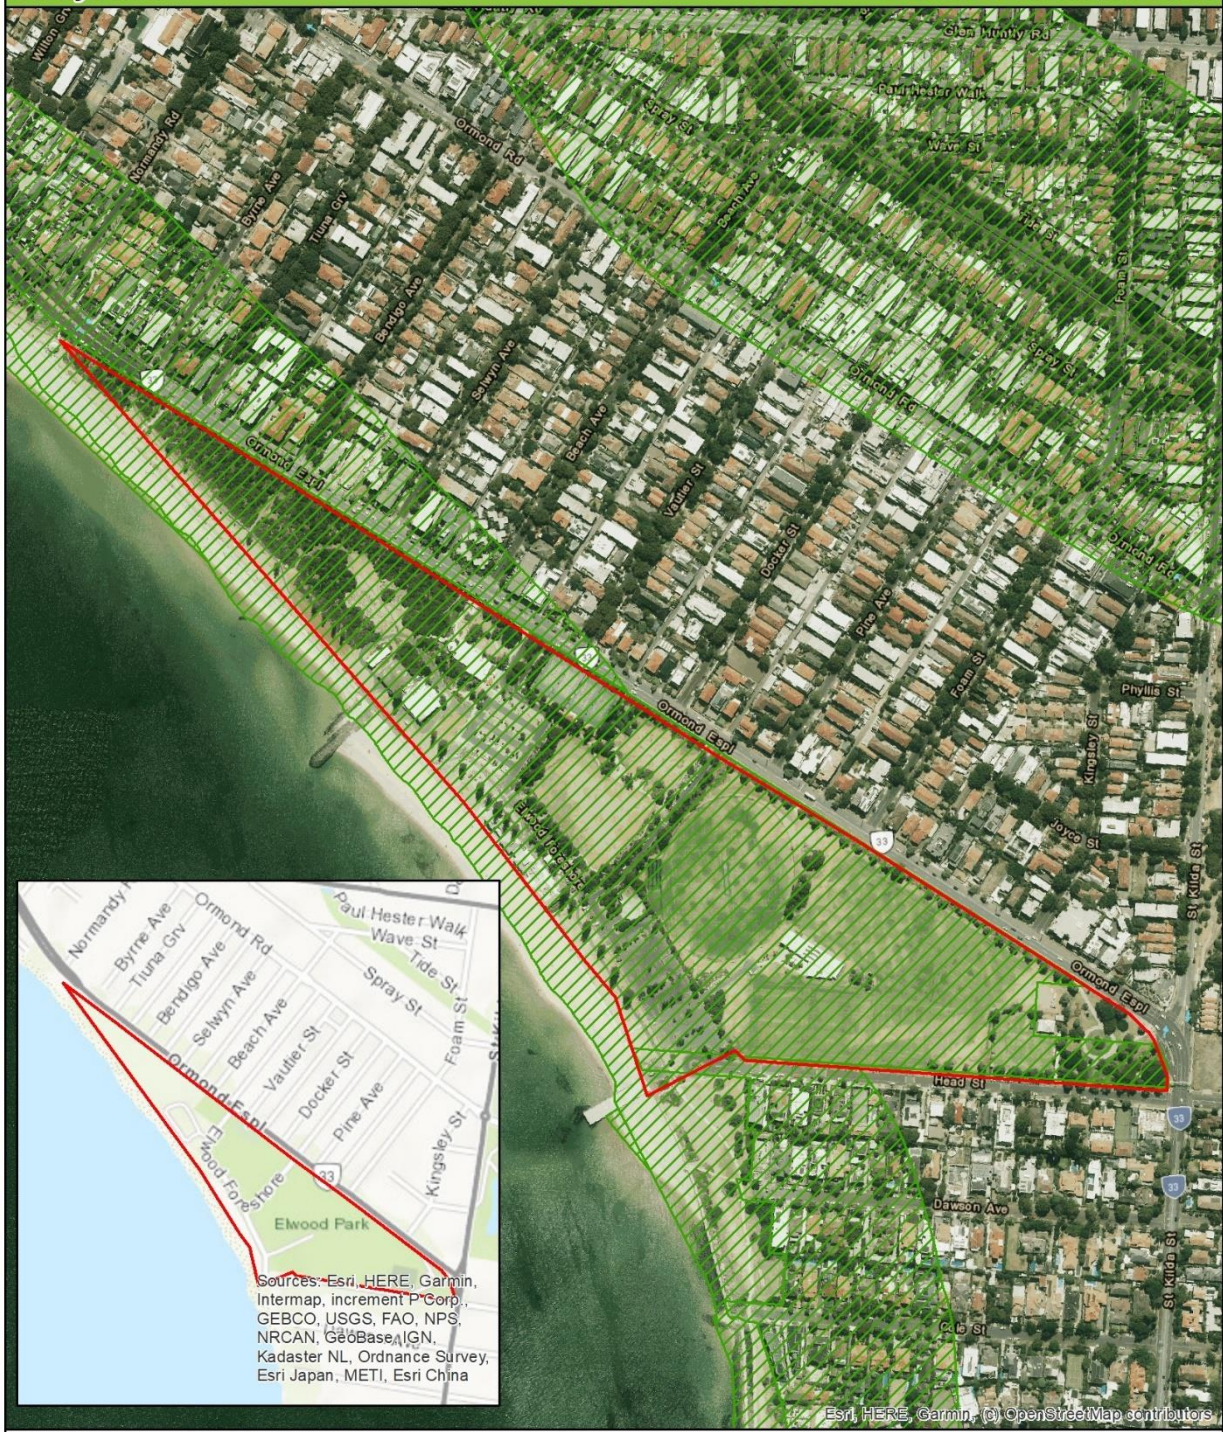
Figure 1: Map of the study area

The study area for the assessment has been defined as a single polygon, approximately 16 ha in area and bounded by the Port Phillip Bay foreshore to the west, Ormond Esplanade to the north, and Head Street in the south (Figure 1).

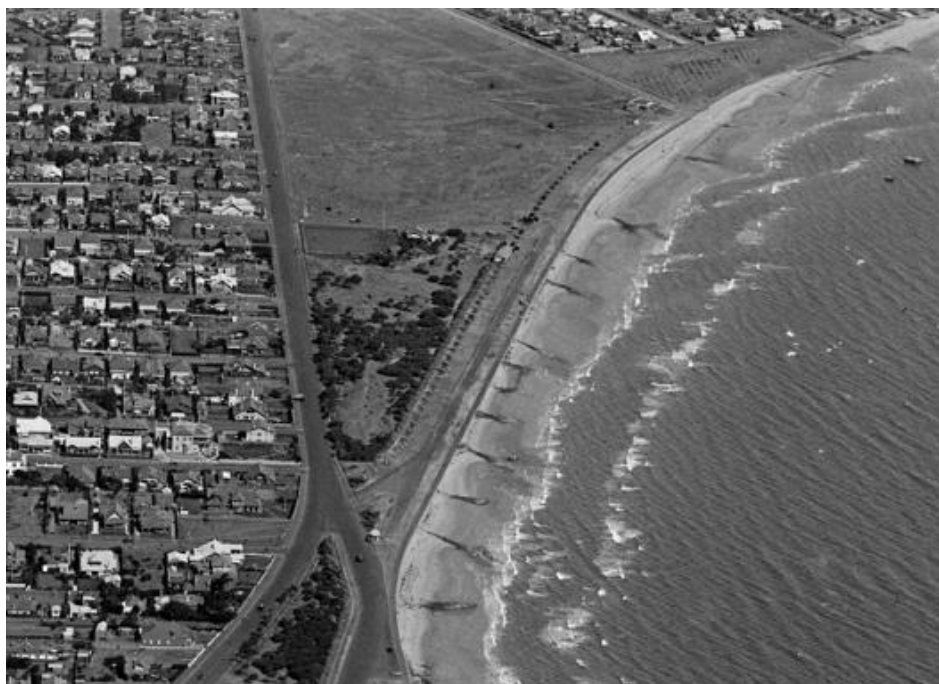
Figure 2: 1925 aerial image of study area, facing eastward (Pratt 1925 via Trove)

Historical aerial photography is available for the study area dating from the 1920s. Imagery from 1925 and 1929 (Figure 2 and Figure 3 respectively), shows the eastern half of the study area cleared of vegetation to Head Street, in keeping with its use as a public reserve, and is largely undeveloped. The original Elwood Life Saving Club is present within the study area at the beach end of Head Street, and there also appears to be a residence facing Ormond Esplanade at its eastern extent. Pine trees have been planted along the foreshore and the promenade is visible extending along the beachfront. In the 1925 photograph, only a shed is present on foreshore, aside from the life saving club, with additional structures appearing in the 1929 image. A recreational ground, possibly the bowls club, is visible abutting Ormond Esplanade and extending into the study area. Vegetation has been partially cleared within the north-western portion of the study area.

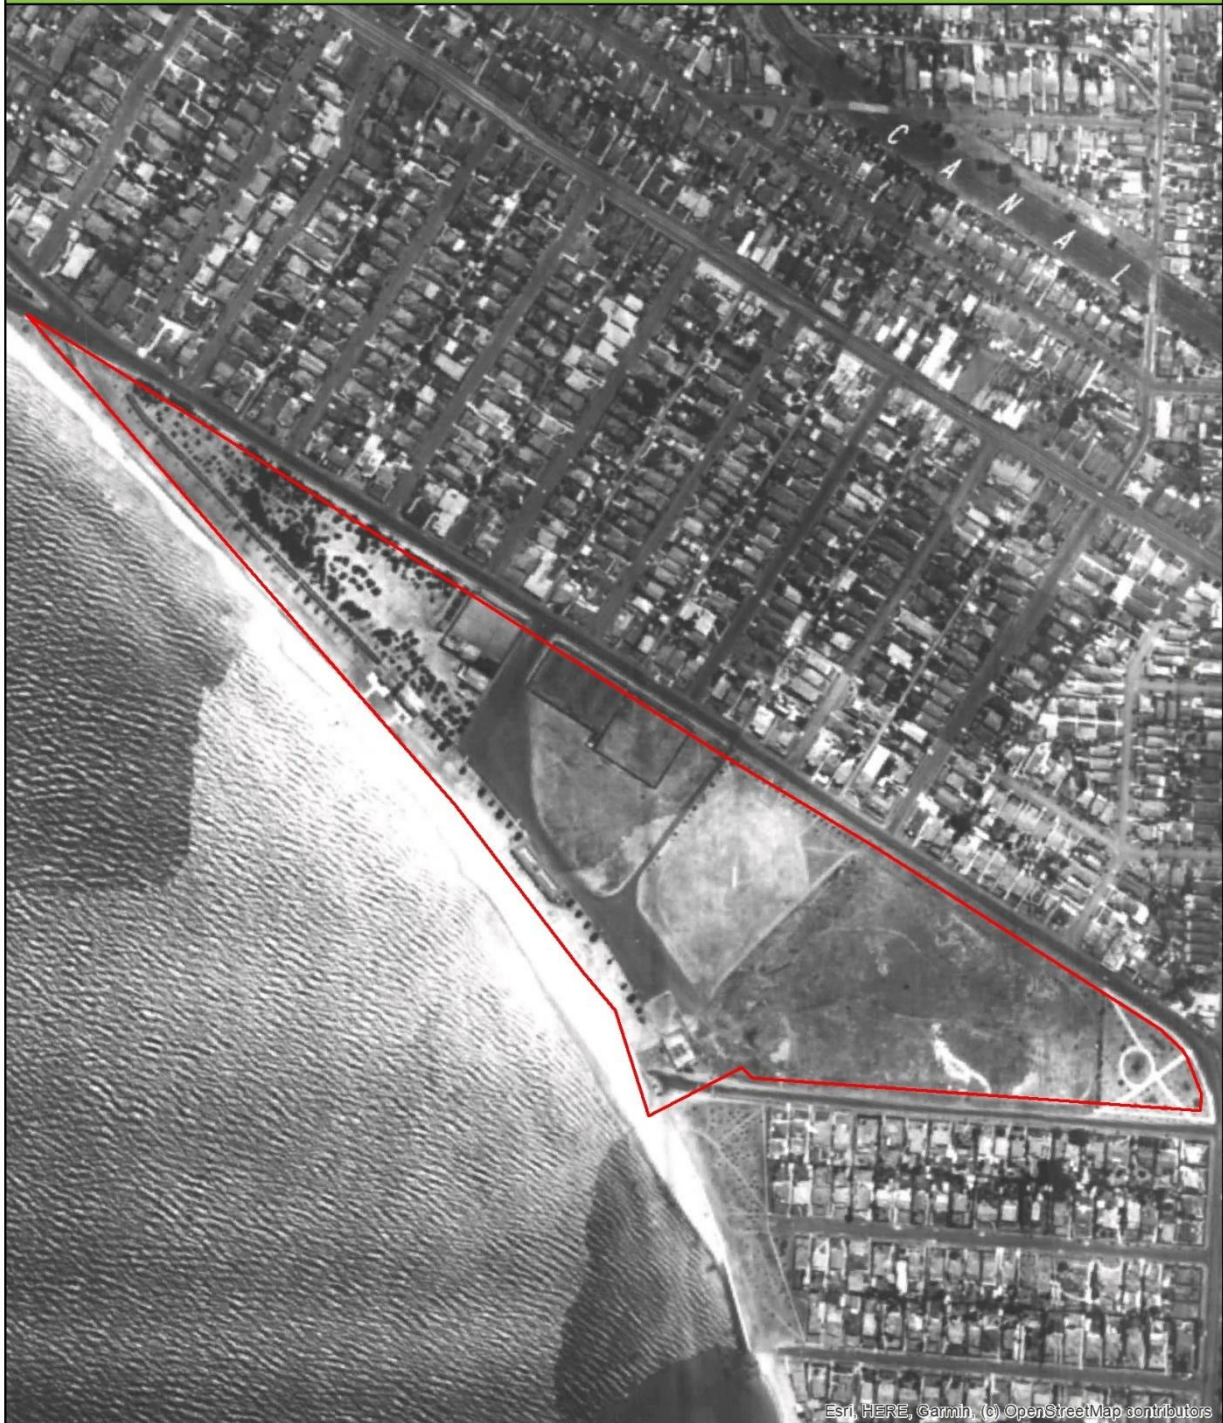
Figure 4: 1945 aerial image of study area (Adastra Airways)

Aerial imagery dating to 1945 (Figure 4) shows the addition of two more recreational grounds (one possibly a tennis court) along Ormond Esplanade to the east of the bowls club. More buildings have been constructed along the foreshore and further vegetation clearance has occurred within the north-western area. The Wattie Watson Oval has been developed, although no stands are present, and the Head Street Reserve in the south-east corner of the study area has been landscaped.

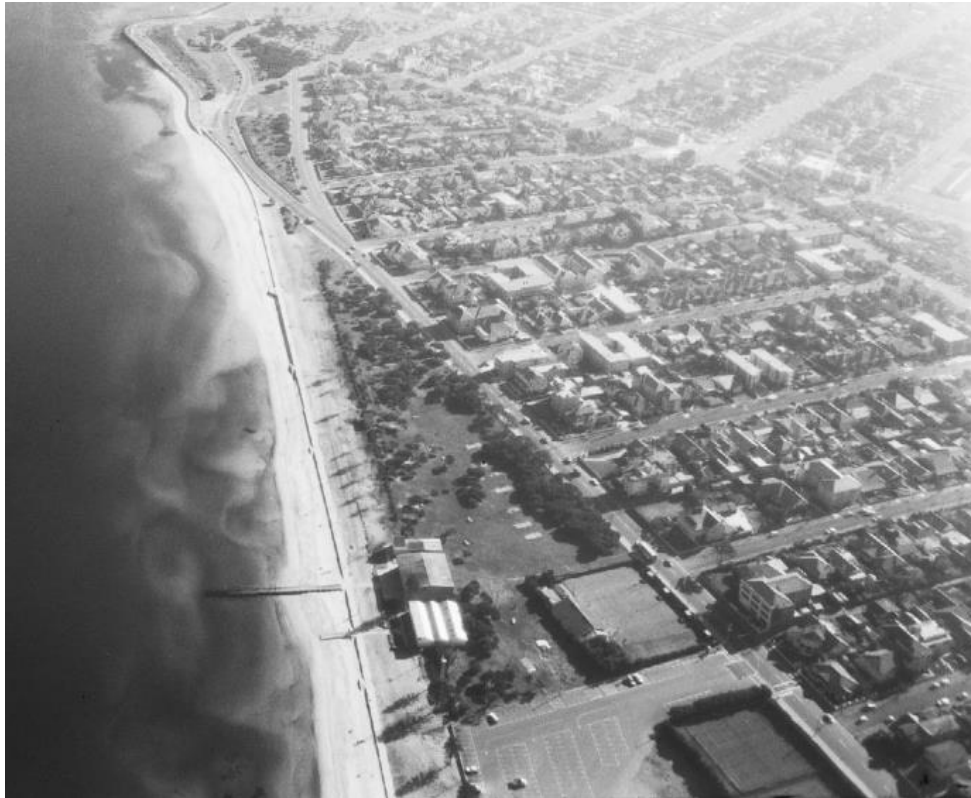
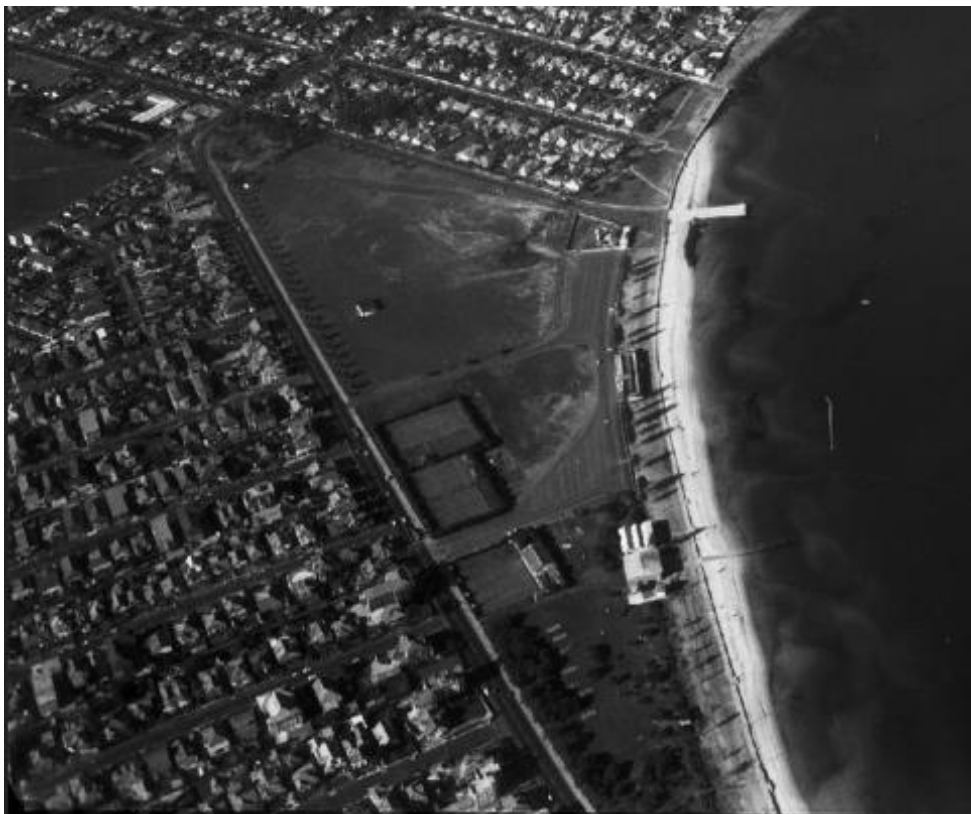
Subsequent land development occurred during the mid-late 20th century, as shown in imagery from 1968 (Figure 5 and Figure 6). The central and southern carparks have been constructed by this time, and there is a small hut on the oval. Vegetation to the north-west is sparse and appears heavily reduced compared to coverage evident in 1945. These features are also evident on an aerial photograph from 1970 (Figure 7). The 1970 aerial also shows the present-day croquet club, adjacent to the Head Street reserve, having been constructed.

Figure 5: 1968 aerial image of study area facing west (Payens 1968a)

Figure 6: 1968 aerial image of study area facing north-east (Payens 1968a)

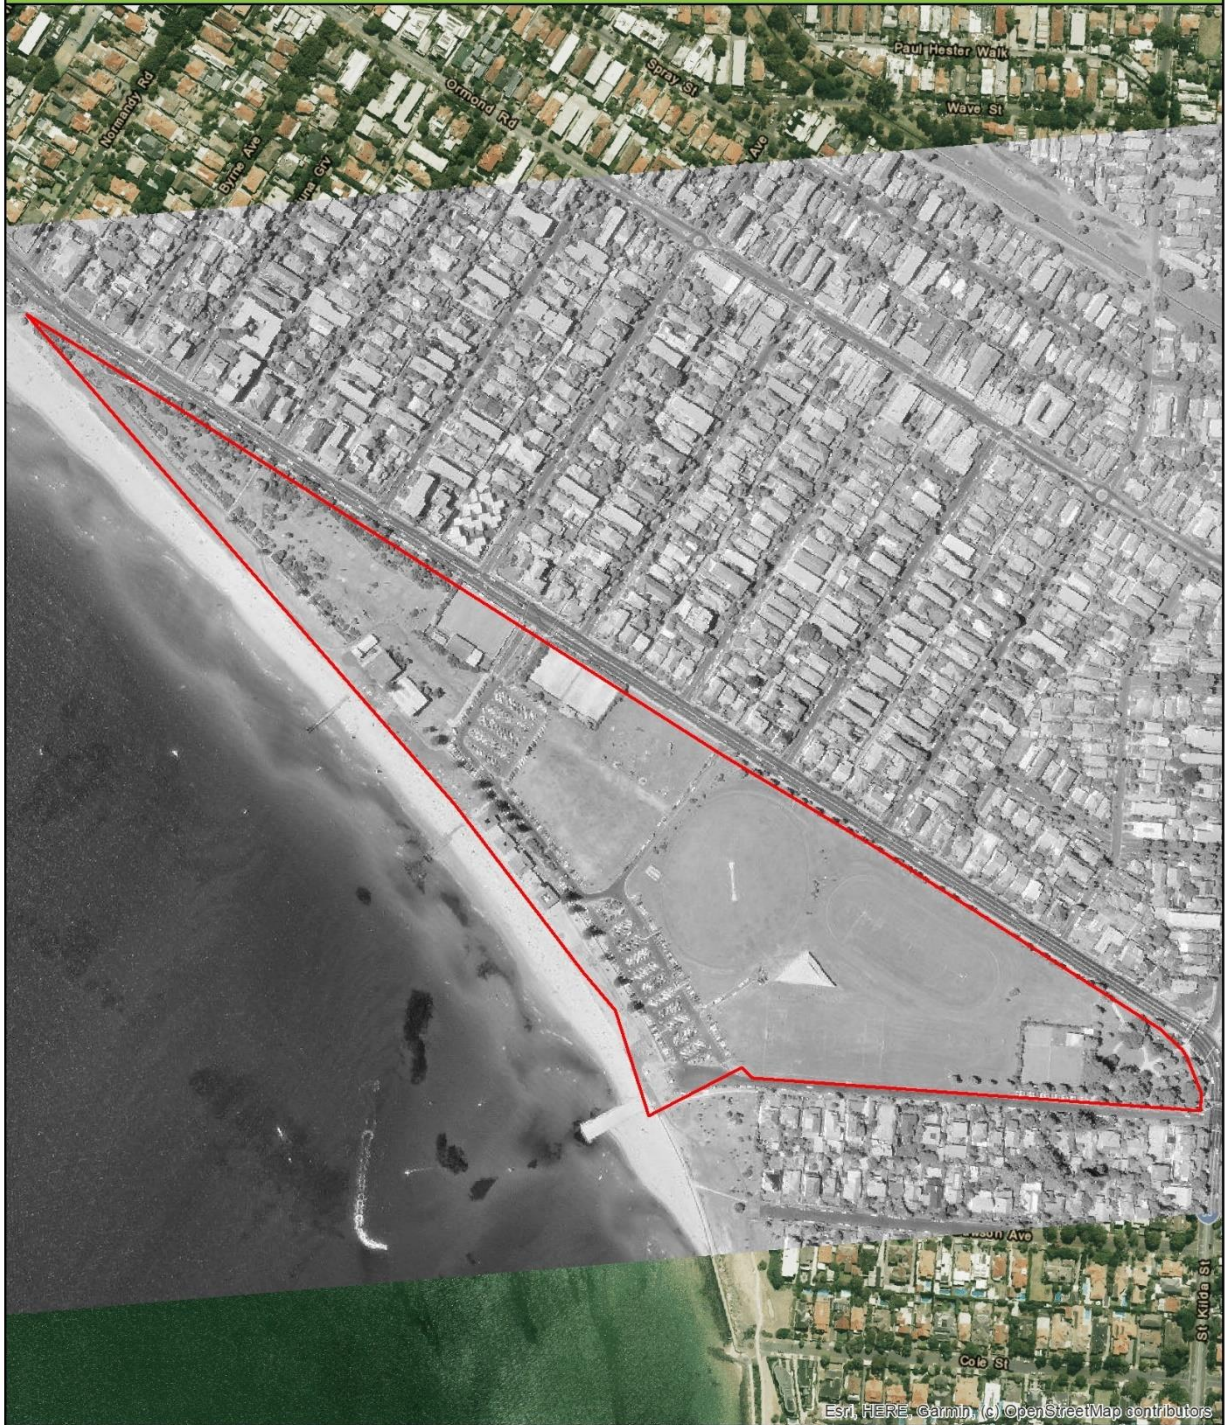
Figure 8: 1987 aerial image of study area (via Landata 2020)

By 1987 (Figure 8), car parking in the central and eastern sections of the study area had become more formalised, and the Wattie Watson oval and adjacent playing fields have been heavily landscaped. A sporting facility has been constructed in the middle of the playing fields and there are cricket nets adjacent to the oval. The new Life Saving Club and Bathers building has been built by this time and the

study area has undergone widespread landscaping, especially along the foreshore and through the car parks. Vegetation coverage within the north western area is generally unchanged since 1970.

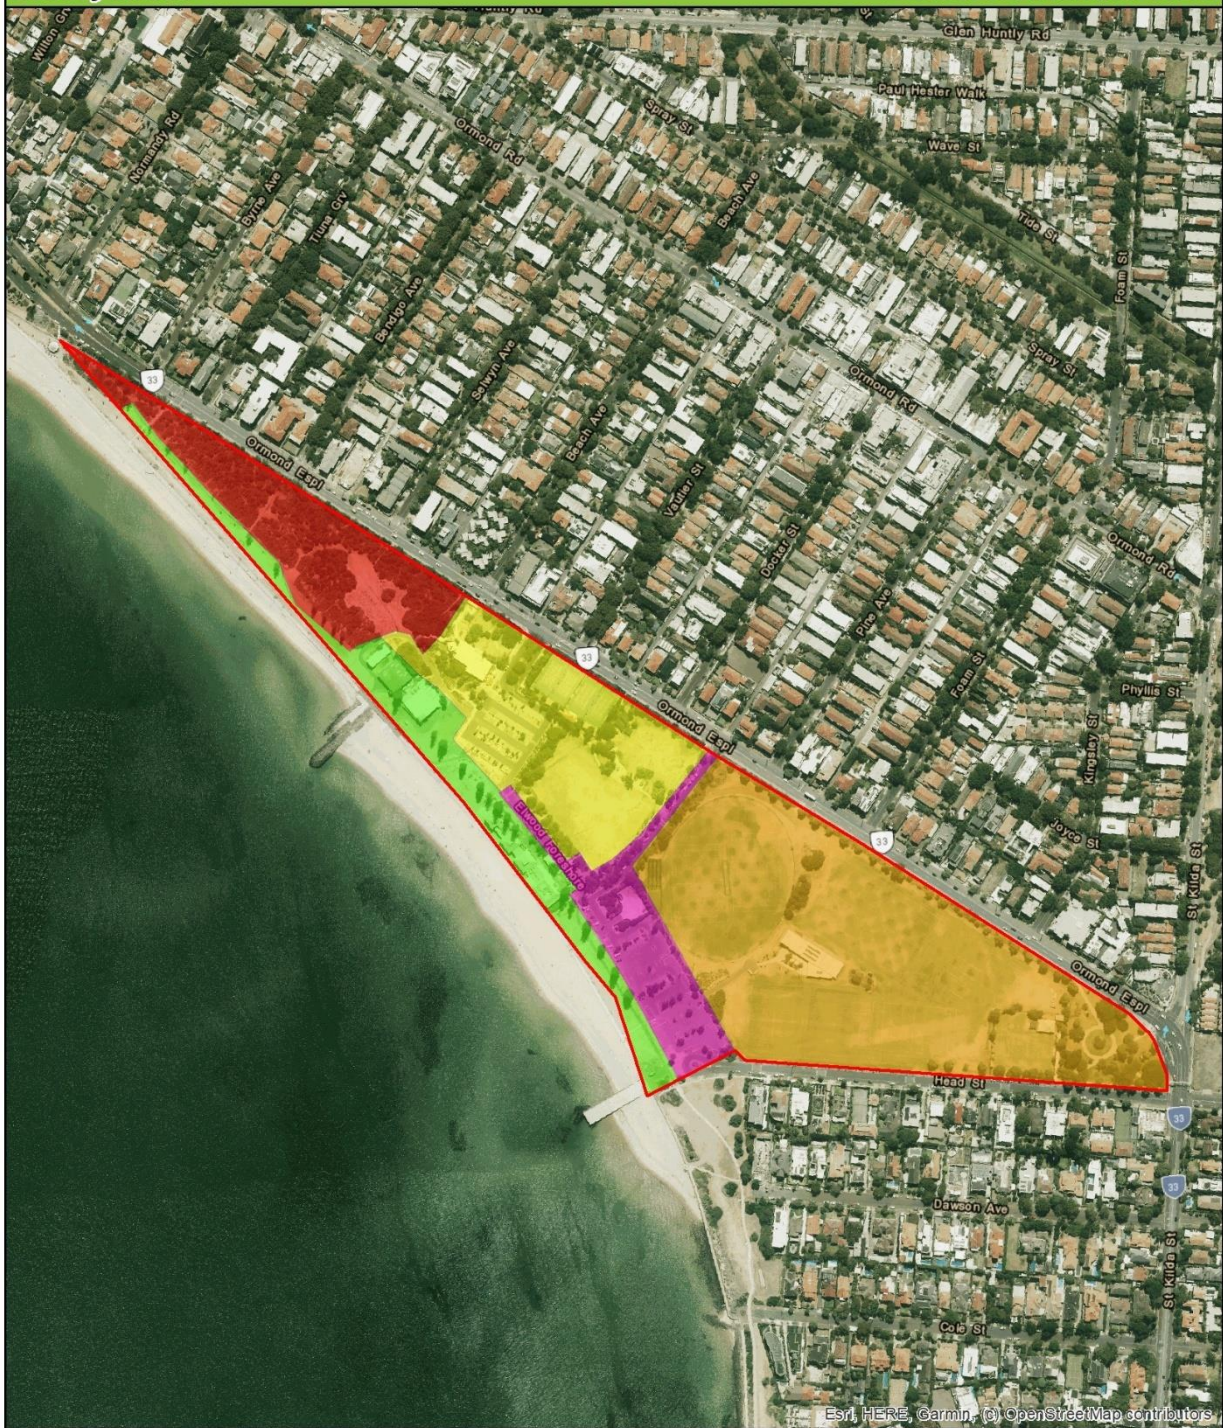
Figure 9: Survey areas described above

A site inspection was undertaken on 23 April 2020 by ELA Heritage Advisors Daniel Claggett and Caroline Hawker. A second inspection to include the playing fields to the south was undertaken by Caroline Hawker on 28 May 2020. The inspection was conducted by means of a pedestrian walkover with the purpose of assessing the study area and recording evidence of land development and heritage constraints. The inspection included the entirety of the study area, from Head Street in the south-east to the north western boundary of the study area adjacent Ormond Esplanade. The study area was assessed as five separate survey areas (southern, carpark, foreshore, central and northern areas), defined based on the visible ground surface impacts to these areas. A map of the study area is found in Figure 9.

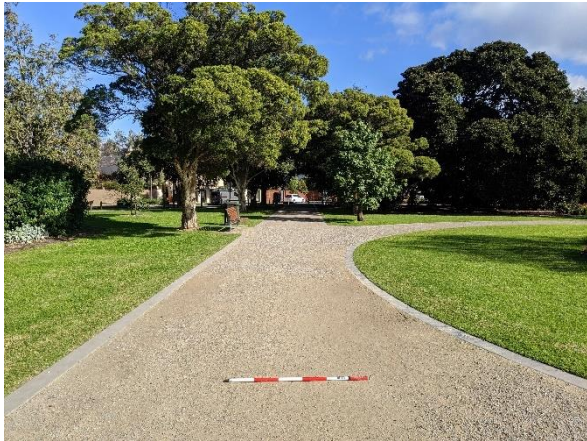
The site inspection identified numerous impacts to the ground surface across the extent of the study area. The southern section of the study area contains heavily landscaped sporting fields, sporting club facilities, cricket nets, gardens and a croquet club (Figure 10 to Figure 15). Numerous pit covers for utilities were noted, including an extensive recycled water and sprinkler system across the playing fields and the Head Street Reserve. The edges of the playing fields have mounded revegetated garden beds, and a stormwater drain has been converted into a small wetland area.

Figure 10: Formal paths, garden beds and landscaping within Head Street Reserve, facing south-west_28/05/20

The findings of the assessment demonstrates that the intersecting area of cultural heritage sensitivity across the southern portion of the study area has been impacted by machinery across its entirety. This area is covered by heavily landscaped playing fields, sporting facilities, cricket nets, the Head Street Reserve and the Elwood croquet club. Mechanical impacts to this area have included the levelling of the playing fields, landscaping, building and road construction, drainage culverts and the installation of extensive subsurface utilities and a sprinkler system. The assessment therefore determined that the southern portion of the study area has been subjected to impacts constituting significant ground disturbance as per Regulation 5 of the Regulations.

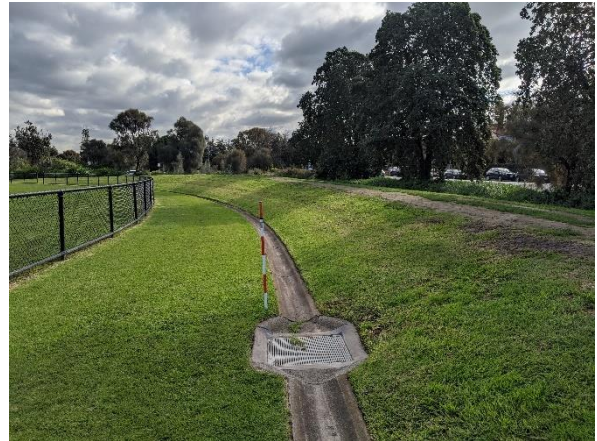
Figure 11: Landscaping and drainage around Wattie Watson Oval, facing north-west_28/05/20

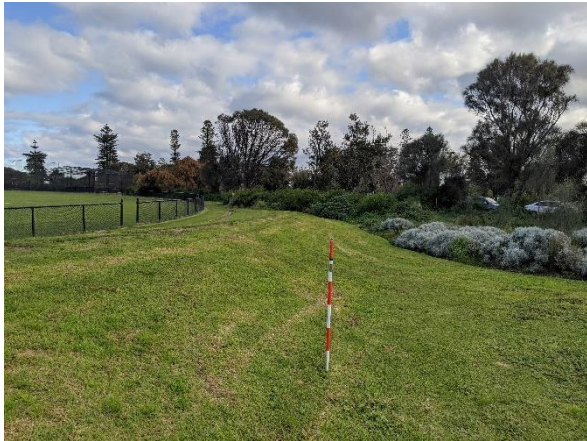
Figure 12: Landscaping and garden beds at Wattie Watson Oval, facing west_28/05/20

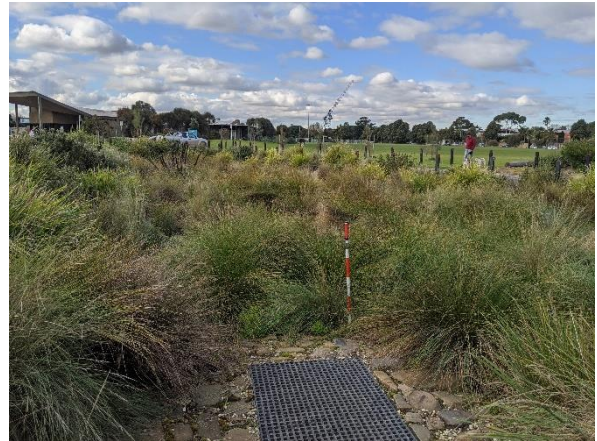
Figure 13: Landscaped drainage, with sporting facilities in background, facing north-east_28/05/20

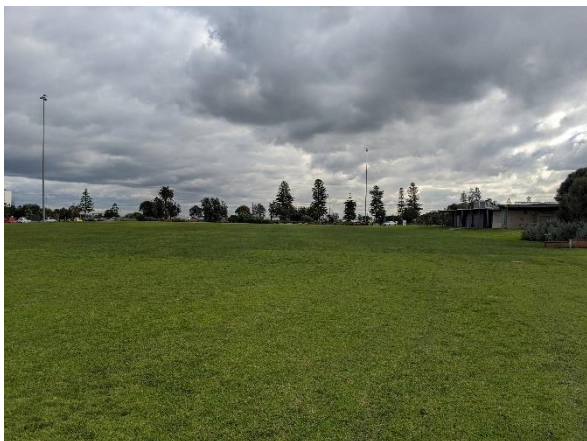
Figure 14: Playing fields and club facilities, facing west_28/05/20

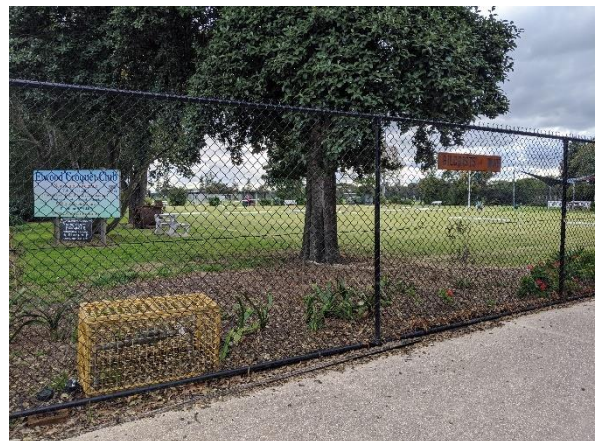
Figure 15: Croquet club, facing west_28/05/20

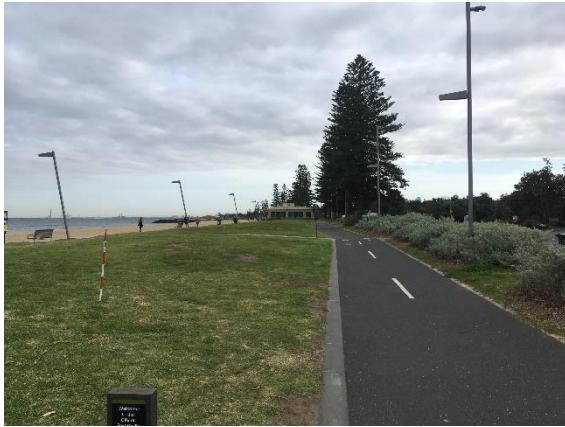
The entirety of the foreshore portion of the study area, located directly adjacent Elwood beach presented evidence of significant landscaping and grading in order to create walking tracks (Figure 16), green spaces and the construction of recreational and community facilities, such as the Elwood Life Saving Club (Figure 17) and Sailing Club. In addition, numerous underground utilities and services area listed in this area, as seen in multiple areas by the presence of pit covers and utility boxes (Figure 18). This indicates a robust process of excavation along their respective alignments.

Figure 16: General view of the Elwood foreshore area, showing landscaping and the construction of walking paths and lamp posts, facing north_23/04/20

The findings of the assessments demonstrate that the intersecting area of cultural heritage sensitivity across the foreshore has been modified and disturbed by machinery. Mechanical impacts include the construction of walkways and freestanding buildings, including the extant sailing club and other structures and also substantial landscaping works. The assessment determined that the foreshore portion of the study area has been subjected to impacts constituting significant ground disturbance as per Regulation 5 of the Regulations.

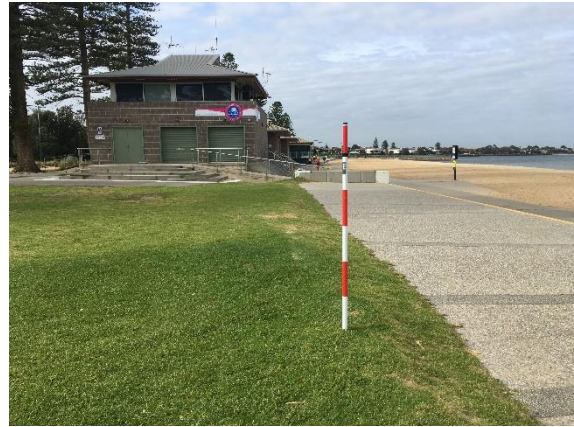
Figure 17: Elwood lifesaving club, located adjacent Elwood beach, facing south_23/04/20

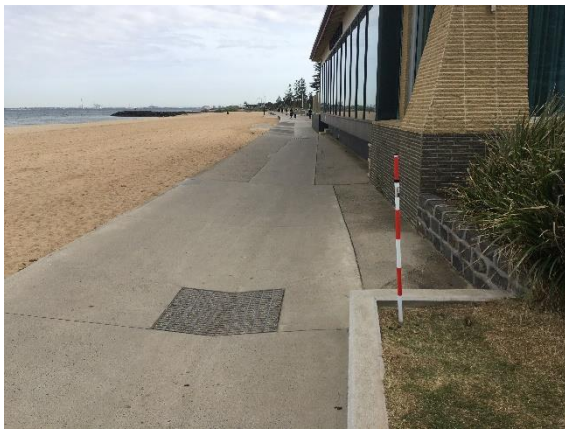
Figure 18: Walking path located directly adjacent Elwood beach, with a pit cover for underground stormwater infrastructure visible, facing north_23/04/20

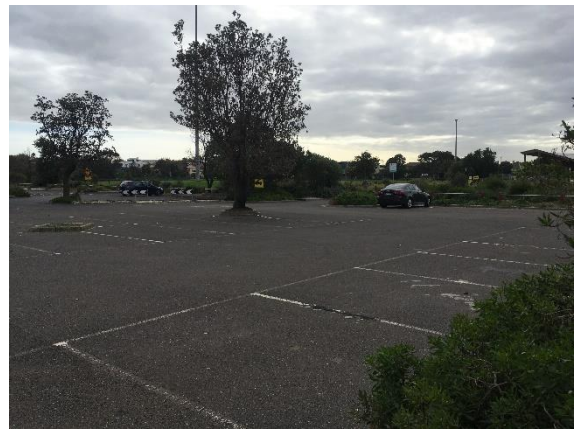
The carpark portion of the study area has been disturbed through the construction of this area (Figure 19). Other disturbances to ground surfaces include mounded and built-up garden beds (Figure 20) and the construction of a loading area with low retaining walls (Figure 21).

Figure 19: Large asphalt carpark, facing southeast_23/04/20

The findings of the assessments demonstrate that the intersecting area of cultural heritage sensitivity across the car park portion of the study area has been impacted by machinery across its entirety. This area is covered almost in its entirety by a constructed carpark. Ground preparation associated with the construction of the carpark includes grading and levelling followed by the introduction of foundational deposits, gravels and asphalt/ bitumen capping. Further mechanical impacts include the construction of buildings and a concrete loading area, as well as walking paths, landscaping, drainage culverts and the installation of subsurface utilities. Based on the development history and coverage of existing structures, it is evident that the car park portion of the study area has been impacted by works constituting significant ground disturbance as per Regulation 5 of the Regulations.

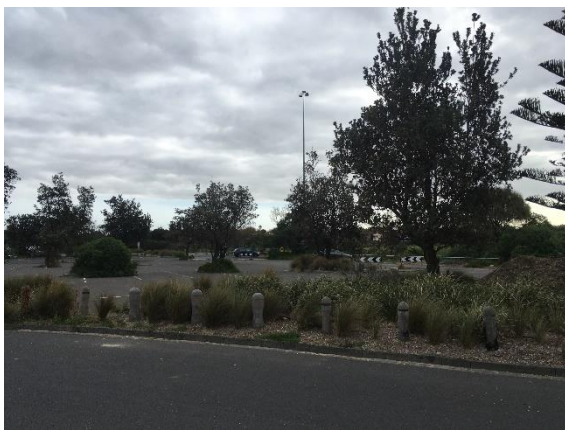
Figure 20: Garden bed with planted vegetation within the car park portion of the study area, facing northeast_23/04/20

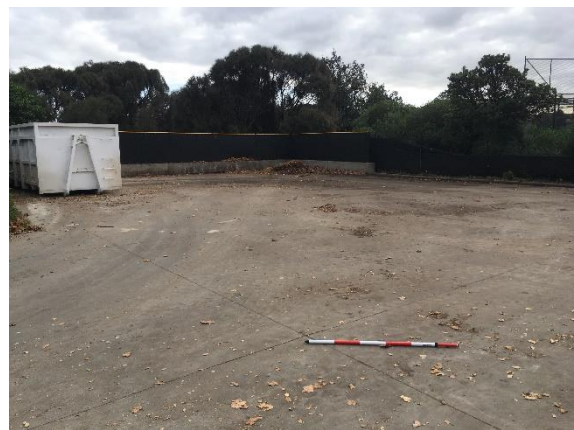
Figure 21: Loading area containing low retaining walls within the car park portion of the study area, facing northeast_23/04/20

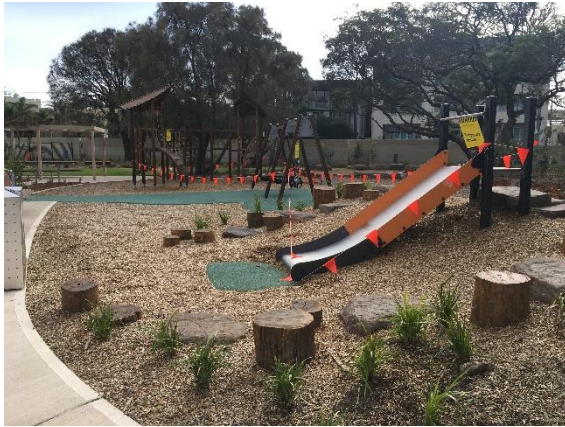
Figure 22: Playground within the central portion of the study area, located adjacent the kindergarten, facing northeast_23/04/20

The central portion of the study area consists of recreational facilities such as a playground and tennis courts (Figure 22) as well as open green spaces (Figure 23) and a kindergarten (Figure 24). All of these areas have impacted on the ground surface through landscape grading, the construction of underground services such as sprinkler systems (Figure 25) and the construction of the kindergarten and tennis courts themselves. Also located in this area is a second carpark (Figure 26) and landscaped garden beds containing planted native and exotic vegetation.

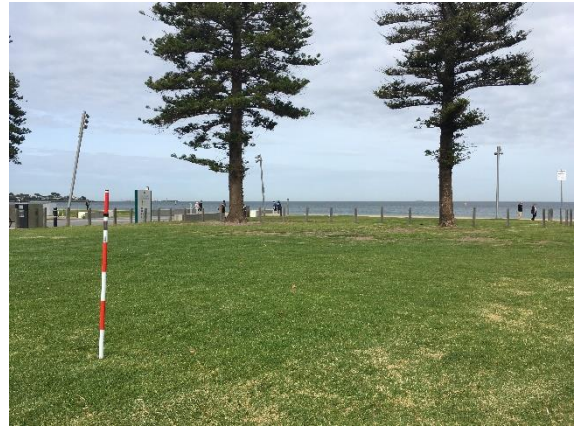
Figure 23: Looking towards Elwood Beach from an open green space in the foreshore portion of the study area, facing southwest_23/04/20

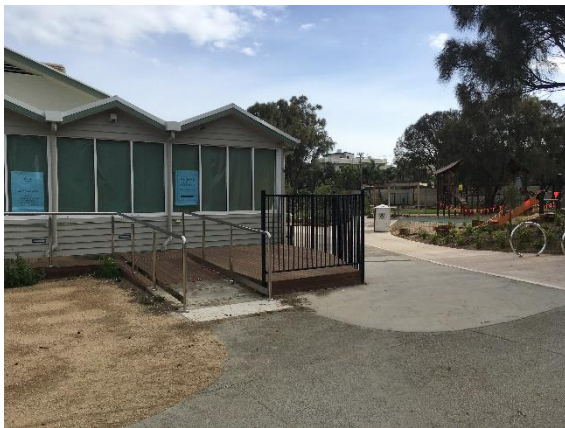
Figure 24: Kindergarten within the central portion of the study area, with additional disturbances from land grading and the construction of paved areas, facing northeast_23/04/20

The findings of the assessments demonstrate that the intersecting area of cultural heritage sensitivity across the central portion of the study area has been disturbed by machinery across its entirety. Mechanical impacts across this area include carpark and building construction, as well as the development of a tennis court. Open areas are heavily landscaped, and an extensive sprinkler system has been installed under the lawn. Playground, walking paths and BBQ facilities have been installed, and extensive subsurface utilities were indicated by Dial Before You Dig listings. This area was also previously disturbed by the construction of the former bowls club and sporting fields. The assessment determined that the central portion of the study area has been subjected to impacts constituting significant ground disturbance as per Regulation 5 of the Regulations.

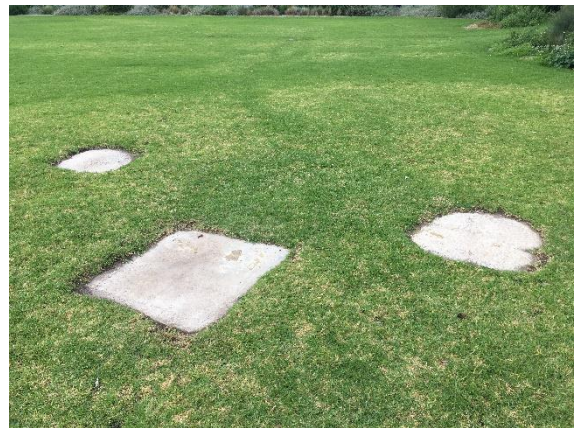
Figure 25: An example of the multiple underground services that run through the green spaces within the central portion of the study area_23/04/20

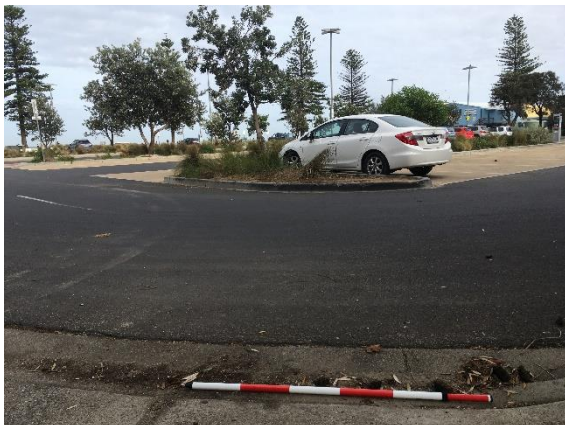
Figure 26: Carpark located in the central portion of the study area, facing northwest_23/04/20

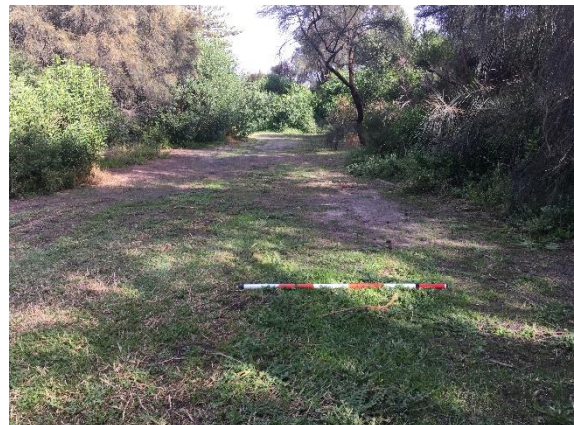
Figure 27: Open area within vegetated northern portion of the study area, facing north_23/04/20

The northern section of the study area consists of moderately dense regrowth and remnant coastal scrub and tree vegetation, with portions of this area having been cleared for open green spaces (Figure 27) and walking paths (Figure 28). Ground disturbance within this area is less significant than in the remainder of the study area, with the most notable impacts seen through landscaping and mounding of introduced and existing soils (Figure 29). In addition, localised ground disturbance through the installation of underground services is evident along limited alignments within portions of this area (Figure 30). A small portion of remnant sand dune within a more heavily vegetated portion of this area was identified, with sand and shell material mixed with introduced soils (Figure 31).

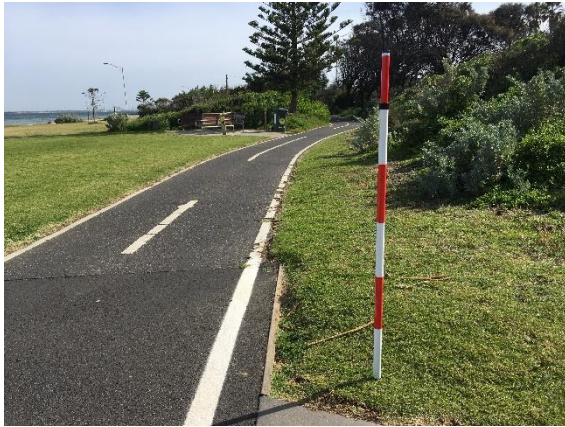
Figure 28: Walking trail located between the immediate Elwood foreshore and the vegetated section of the study area, facing north_23/04/20

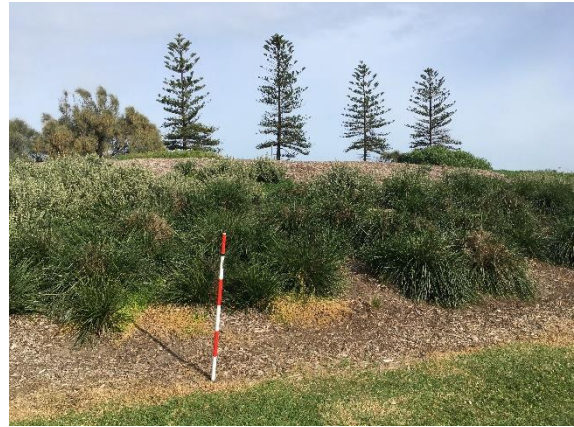
Figure 29: Large, mounded garden bed containing planted vegetation in the study areas north, facing west_23/04/20

The findings of the assessments demonstrate that the northern portion of the study area does not display evidence of significant ground disturbance across its entirety. Mechanical impacts to this area

are limited to landscaping along the immediate foreshore, and to facilitate mounding and revegetation efforts. Localised impacts include additional walking paths and subsurface utility installation. Aerial imagery indicates that although this area has been modified, vegetation was never entirely cleared, and therefore evidence of comprehensive development is absent. The northern portion of the study area is therefore considered to retain areas of cultural heritage sensitivity as per Regulations 30 and 31 of the Regulations.

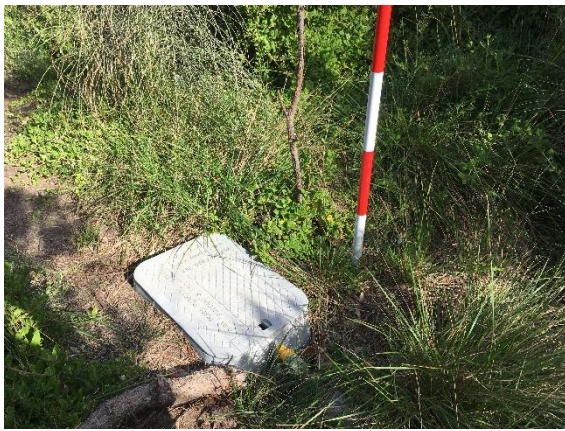
Figure 30: Example of an underground service in the northern portion of the study area_23/04/20

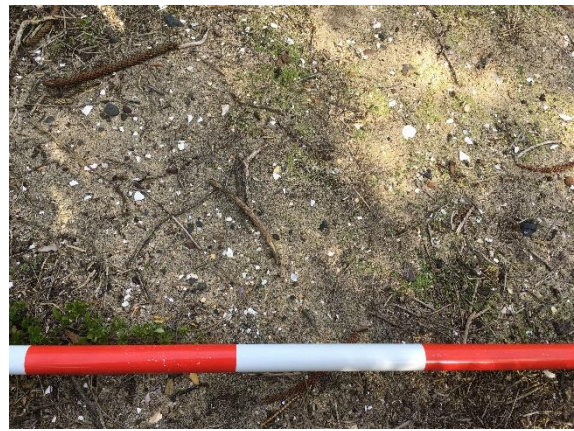
Figure 31: Remnant sand dune and shell material mixed with introduced soil identified in the northern portion of the study area_23/04/20

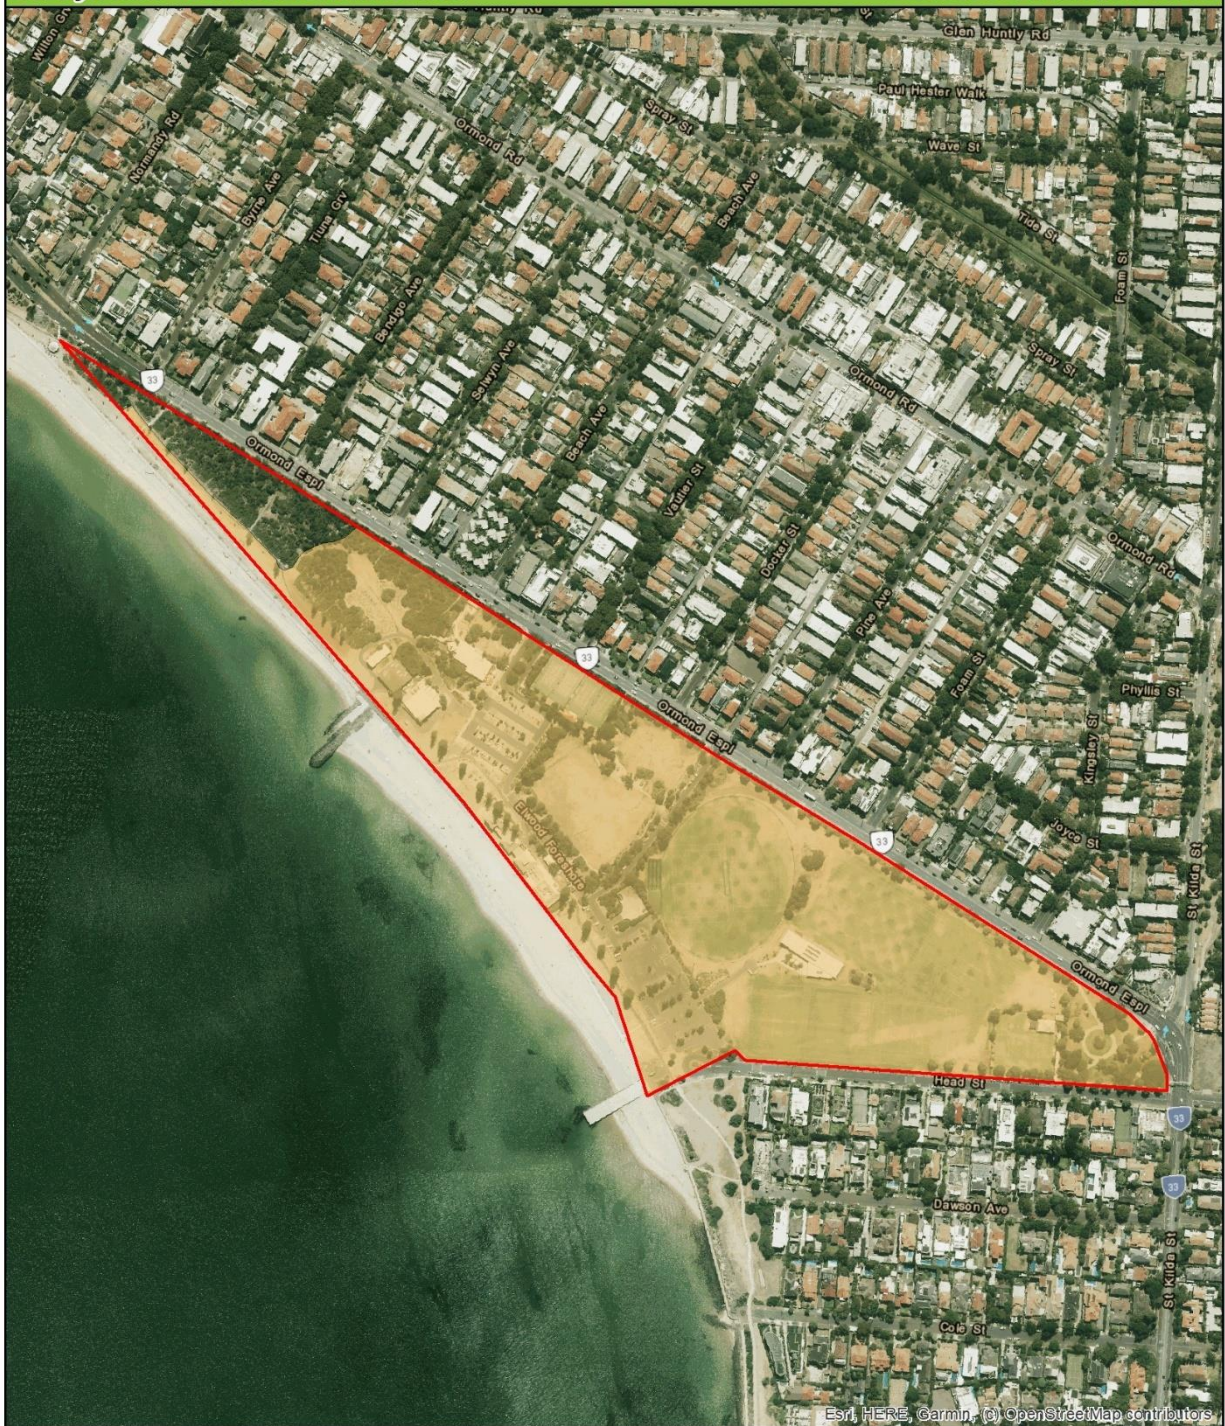
Figure 32: Areas of Significant Ground Disturbance within Study Area

The assessment of the study area details numerous developments that constitute significant ground disturbance as described in Regulation 5 of the *Aboriginal Heritage Regulations 2018* (Vic). However, these impacts do not account for the entirety of the study area and therefore the study area should be regarded as retaining an extant area of cultural heritage sensitivity in the northern portion in accordance with reg 34 (2) of the *Aboriginal Heritage Regulations 2018* (Vic). Areas that have been subject to significant ground disturbance are mapped in Figure 32.

Areas which have been subject to significant ground disturbance, and therefore do not retain an area of cultural heritage sensitivity, are mapped in Figure 32. A mandatory cultural heritage management plan would not be required for developments confined wholly to these areas.

Further assessment would be recommended if development were planned to occur in the northern section of the study area, since an area of cultural heritage sensitivity should be considered to be present in this area.
