## INDOOR AMBIENT AIR VAPOUR INVESTIGATION AT FORMER SOUTH MELBOURNE GASWORKS

ENVIRONMENTAL EARTH SCIENCES VIC  
REPORT TO CITY OF PORT PHILLIP  
NOVEMBER 2012  
VERSION 2

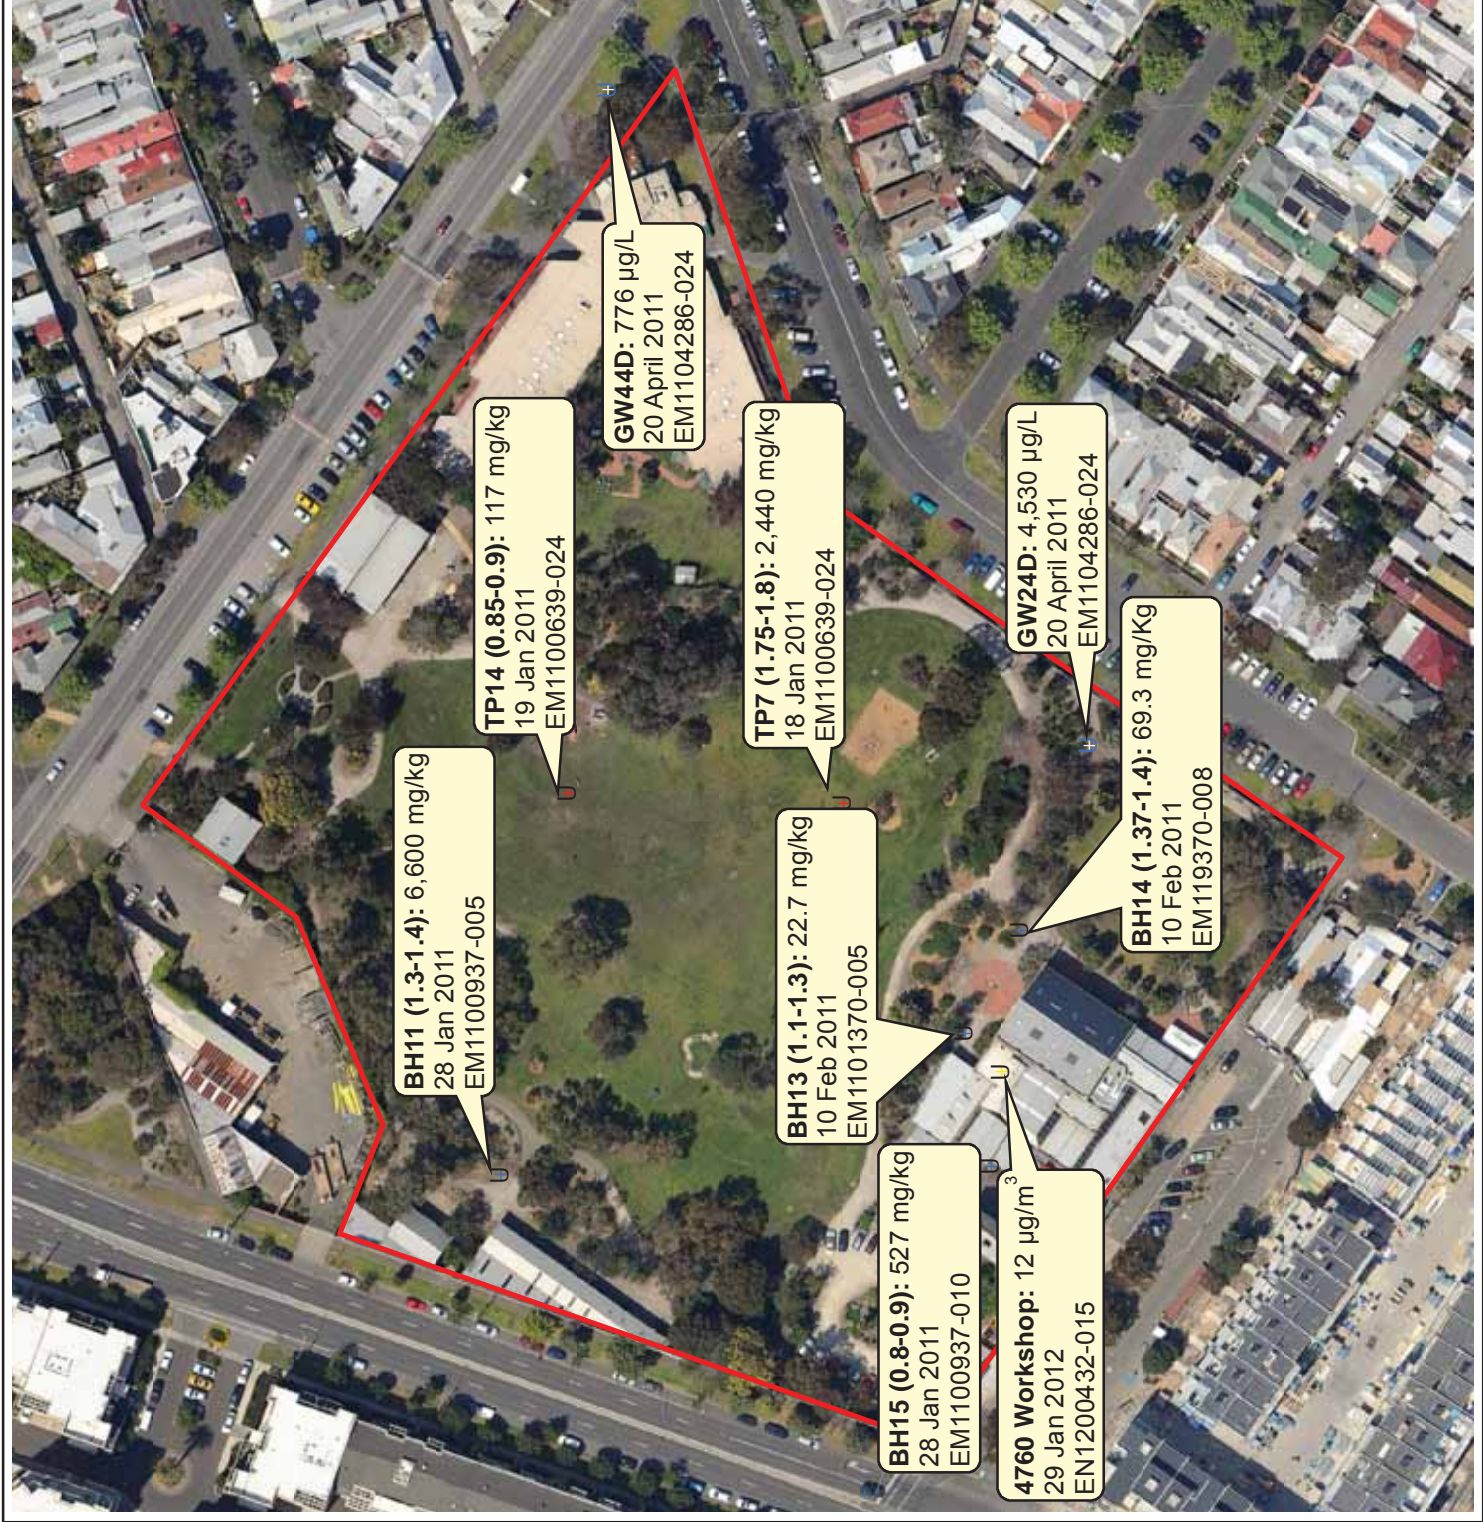
- Site Boundary
- U Vapour Sample Locations
- U Groundwater Bore Locations
- U Test Pit Locations
- U Borehole Locations
