CONSERVATION MANAGEMENT PLAN

MEMORIAL HALL SOUTH MELBOURNE

PREPARED BY ANDRONAS CONSERVATION ARCHITECTURE
IN ASSOCIATION WITH LANDMARK HERITAGE

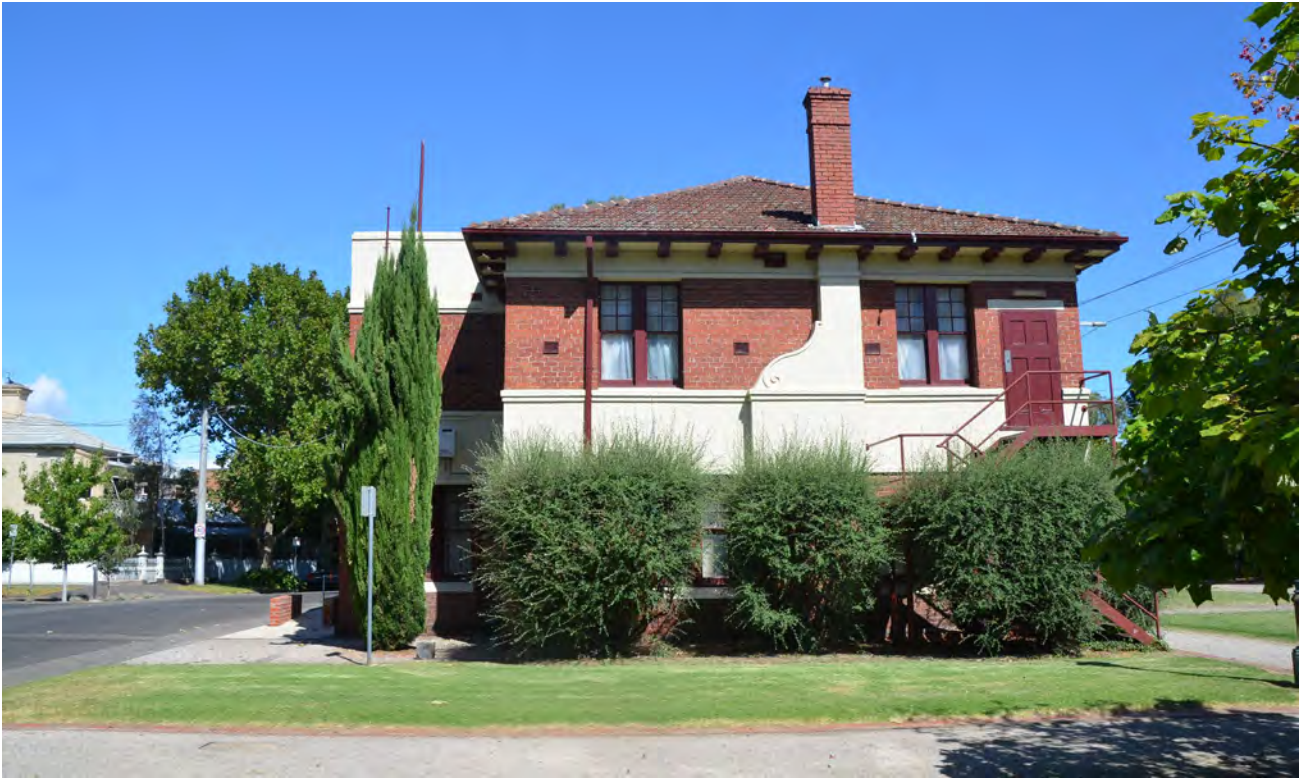
Figure 3. North elevation, exterior – note original scroll detailing to the external chimney breast and modern metal egress stair.

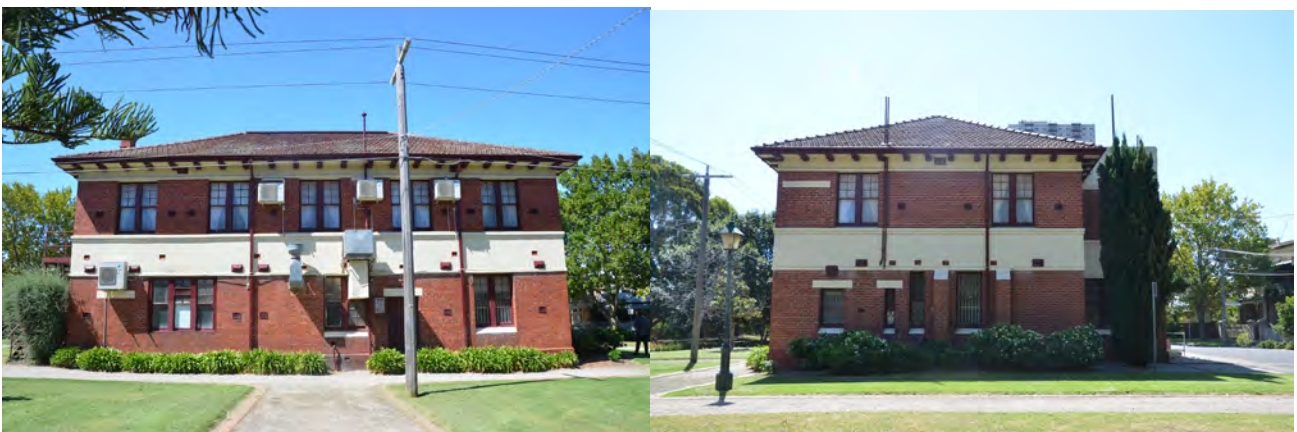
The rear (west) elevation has undergone the most significant degree of change, with the closing up of original openings and particularly with the installation of building plant (condensers, extractor fans, etc.).

Figure 4. West elevation (left) & south elevation (right); note significant building plant on west elevation.

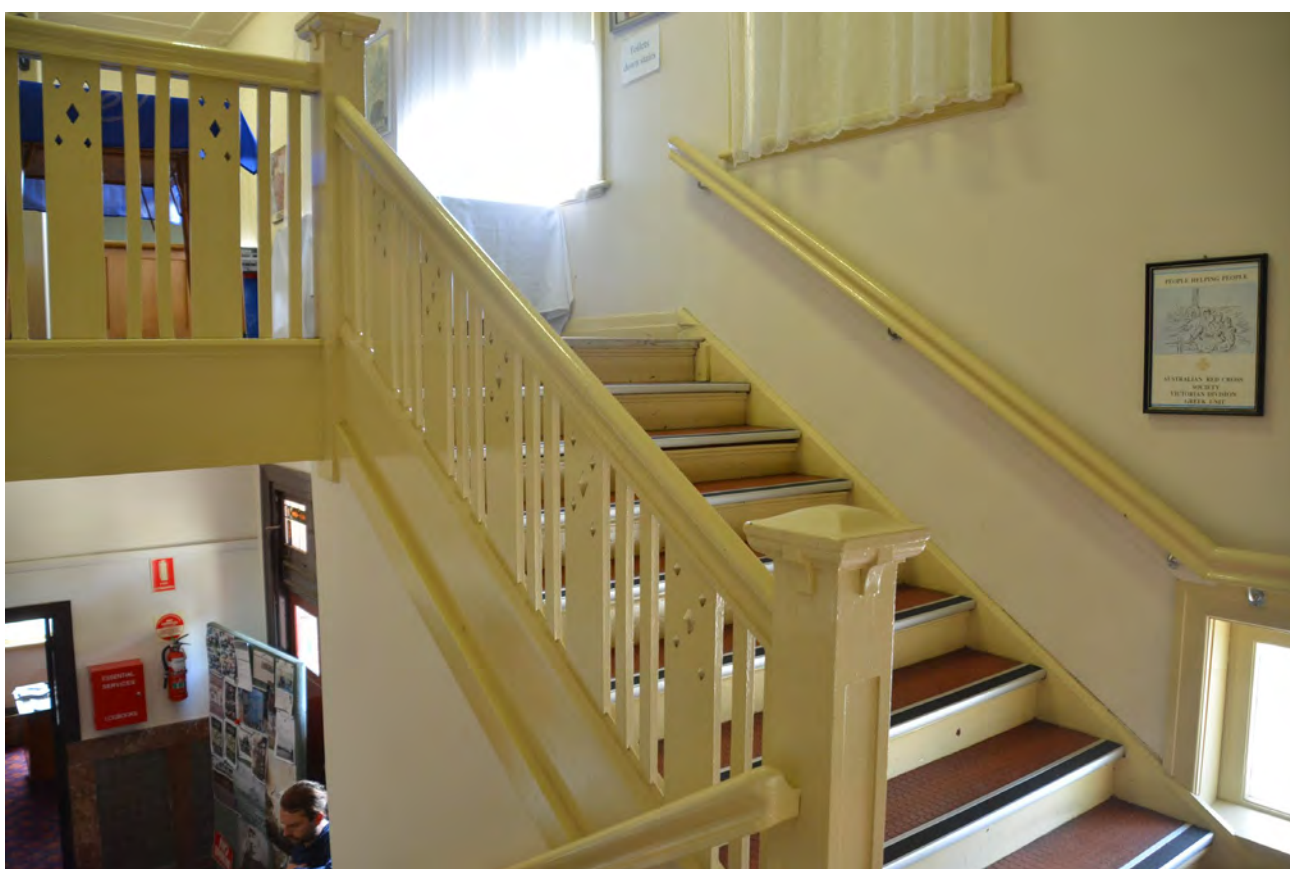
Figure 7. Staircase, interior – highly intact, although over painting diminishes their appearance

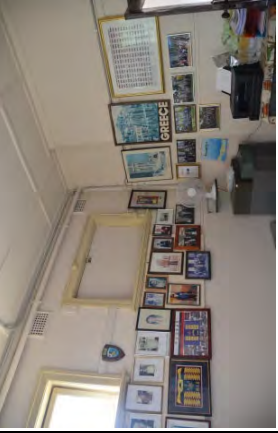
___/___/___
G.01	Window	Non-operable windows. No window winder.	Consider reinstating all windows to match original.	Low

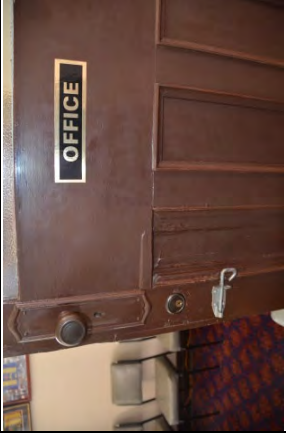
Location Code	Element	Description/Defect Notes	Action	Priority	Image Reference	Revision Date
G.01	Door	Reinforced door appears to be damaged. Possible broken in to previously and repaired.	Redo poor repairs to timber door and jamb to match original. Review door hardware.	Low

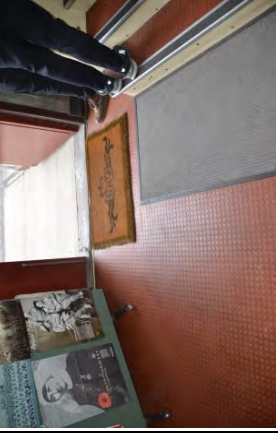
___/___/___
G.02	Floor	Sagging? concrete threshold. Evidence of previous repairs.	Monitor.	Low

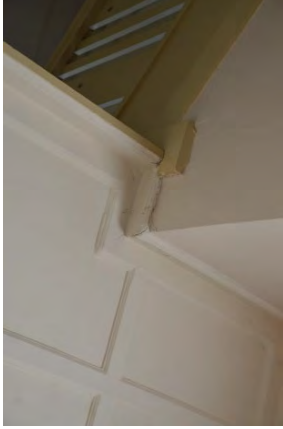
Location Code	Element	Description/Defect Notes	Action	Priority	Image Reference	Revision Date
G.02	Ceiling	Movement in landing of stairs above. Evidence of movement of header beam.	Monitor.	Low

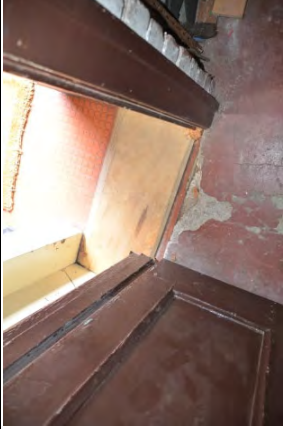
___/___/___
G.03	General Description	Storage Ceiling - Fibrous plaster, soffit of stairs above. Walls - Painted brickwork. Floor - concrete. Door - Timber w/ cement sheet inserts			 	___/___/___
G.03	Floor	Cracking to concrete slab.	Monitor movement. Patch repair to eliminate tripping hazard.	Low

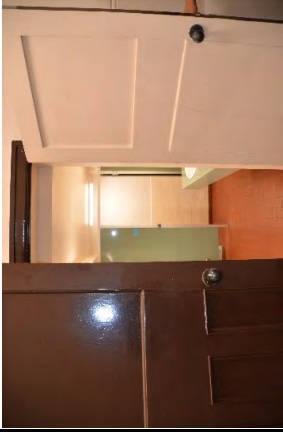
___/___/___
G.04	Compliance	Low head clearance to door.	Review compliance of WC's generally.	High

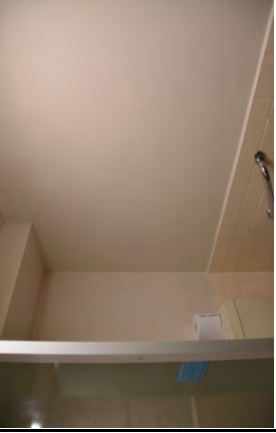
___/___/___
G.04	Wall	Diagonal cracking. Previously patched repaired.	Monitor.	Low

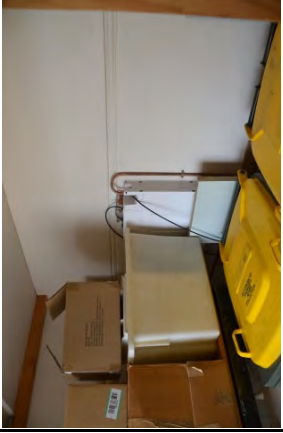
___/___/___
G.05	Wall	Cistern for Male urinals installed through penetration of original masonry wall.	If refurbishment works take place, consider installing cistern within new stud framing in male toilets. Patch repair brickwork and hard plaster wall to match original.	Low

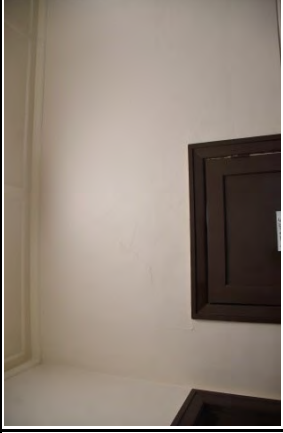
G.06	Wall	Drummy hard plaster above door.	Monitor.	Low

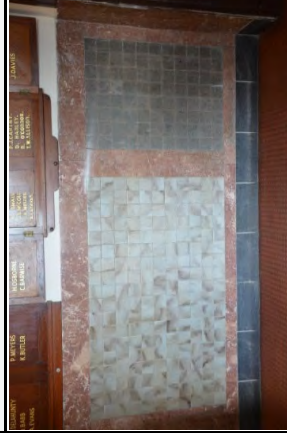
___/___/___
G.07	Wall	Non-original tiles to dado (shown left).	Note.	Low

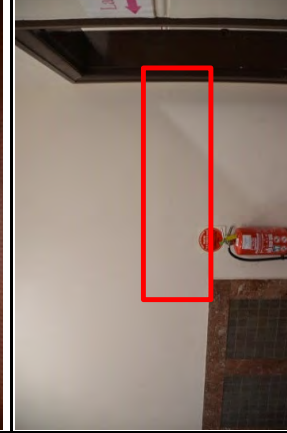
___/___/___
G.07	Wall	Original plaster dado detail has been patched over.	Reinstate plaster dado detail.	Low

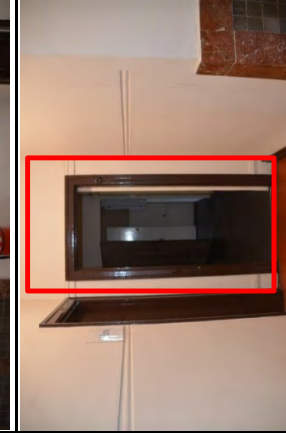
___/___/___
G.07	Wall	Non-original infill stud wall with plywood lining. Non-original door frame/ door.	Note.	Low

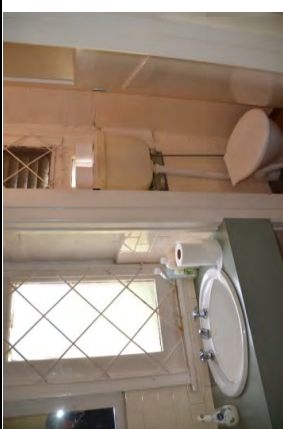
___/___/___
G.08/G.09	Compliance	Pan cubicles undersized. Non-compliant.	Review Males Toilets in general.	Medium

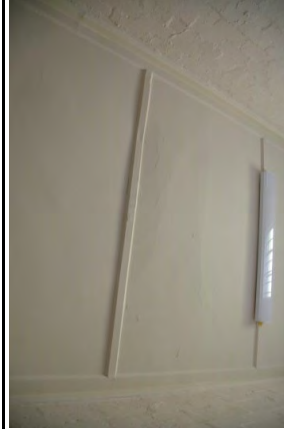
G.08/G.09	Ceiling	Sagging fibrous plaster ceiling.	Repair sagging fibrous plaster ceiling as required. Ensure stability of all plaster ceiling panels and straps.	Medium

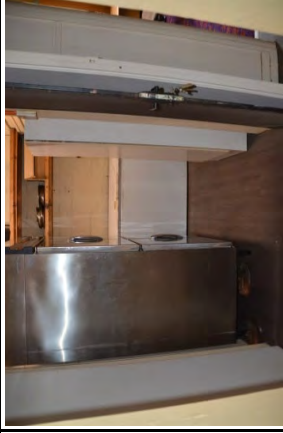
___/___/___
G.10	Floor	Minor undulation in floor. Sound condition.	Monitor. If other subfloor works take place, inspect and restump if required.	Low

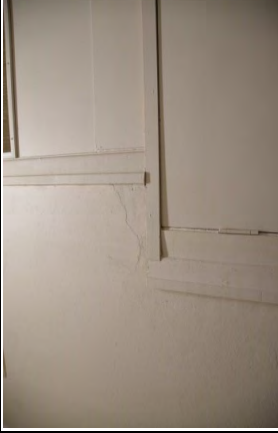
Location Code	Element	Description/Defect Notes	Action	Priority	Image Reference	Revision Date
G.11	Door	Opening has been widened at a later date. Untidy appearance.	Consider reinstating doorway to match original. Timber frame and architrave to match original.	Low

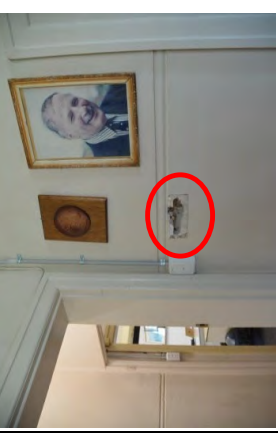
___/___/___
G.12	Wall	Opening in wall. Possibly location of previous light switch.	Patch repair. Paint to match.	Low

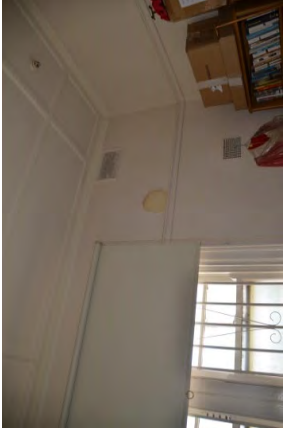
Location Code	Element	Description/Defect Notes	Action	Priority	Image Reference	Revision Date
G.12	Wall	Paint flaking. Possibly related to water ingress from leaking downpipe on exterior wall.	Check downpipe for leaks and seal if required. Monitor wall. Patch repair after water ingress is resolved (Low priority).	High

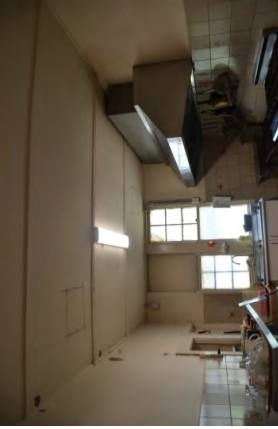
___/___/___
G.14	Ceiling	Canite ceiling is in poor condition and is not a suitable material for a commercial kitchen ceiling. Assume original fibrous plaster ceiling above.	Remove canite ceiling. Make good original fibrous plaster ceiling above.	Medium

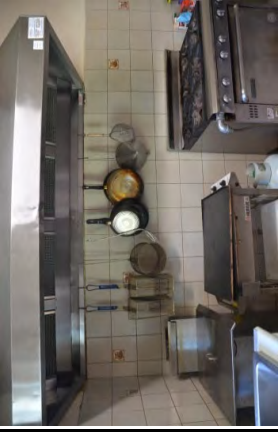
Location Code	Element	Description/Defect Notes	Action	Priority	Image Reference	Revision Date
G.14	Compliance	Stove not entirely under range hood is non-compliant.	Engage a licenced contractor to ensure all cooking facilities are compliant and stove is under rangehood. Health Surveyor to be asked to inspect.	Medium

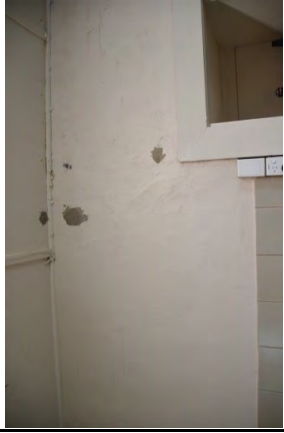
___/___/___
G.14	Wall	Minor cracking to south wall above door way. Evidence of previously patch repaired.	Monitor.	Low

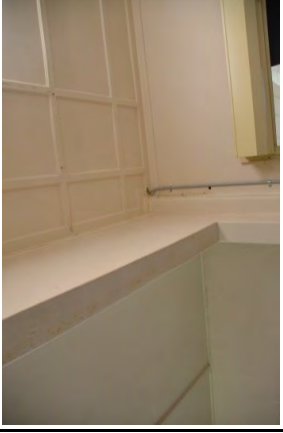
___/___/___
G.15	Wall	Drummy hard plaster north wall.	Monitor.

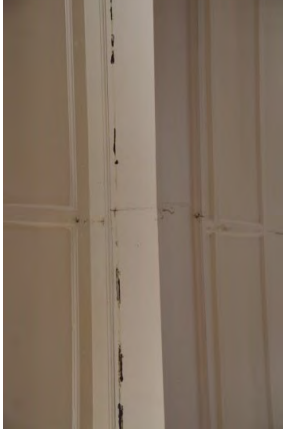
___/___/___
G.16	Ceiling	Cracking noted in timber which encases steel beam. Inspected by structural engineer. Refer to report prepared by Mark Hodgkinson dated 18th June 2021: <i>The cracking in the ground floor ceiling identified by Andronas' report appears to be cracking from the floor level and is actually where a pre-existing surface mounted conduit has been removed.</i>	Patch and paint to match existing ceiling.	Low

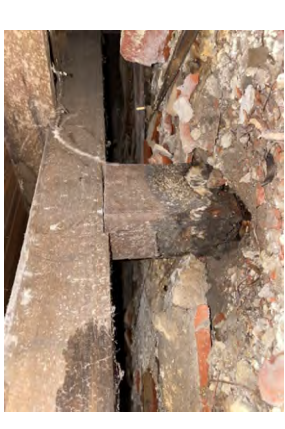
Item	Description of works	Priority	Applicable conservation policy
3	<p>Timber subfloor works</p> <p>The timber floor is showing significant signs of deflection in room G.16 (Old Billiard Room/Meeting Room) and a moderate fall to the doorway in G.01 (Old Secretary's Office). Inspection of the timber subfloor indicates significant decay of timber stumps.</p> <p>Action: An entire reconstruction of the timber subfloor to ground level should be considered. This should be done in tandem with resolving subfloor ventilation issues to prevent future damp issues from occurring. Provide sufficient openable areas to subfloor vents and ensure that all vents remain free of debris (refer also to item 8, remove planting).</p>	High 0-1 yrs	
4	<p>Roof and roof plumbing works</p> <p>The roof and roof plumbing defects noted in the condition survey and structural engineer's inspection should be actioned to prevent water ingress occurring.</p> <p>Action: Works include the following:</p> <ul style="list-style-type: none"> - Remediate missing mortar pointing from hip capping joints. (high priority) - Replace missing terracotta tiles. (high priority) - Inspect box gutters and downpipes for leaks and repair as required. (high priority) - Adjust eaves gutter to provide adequate fall to outlet/downpipe. (high priority) - Provide flashings at intersection between ridge and hip (medium priority). - Treat or make good all downpipes for corrosion and repaint (low priority). 	High 0-1 yrs	<p><i>Building 6.4.1 - Maintain the Memorial Hall to ensure that it is retained in a structurally stable and safe condition with appropriate detailing and traditional materials, workmanship and authentic detailing respecting the original fabric.</i></p> <p><i>Building 6.4.3 - Treat the interior of the Memorial Hall with due respect for the significant elements and intact spaces and preserve them, including wall linings, cornices, moulded dado line, despite the lack of Internal Alteration Controls in the planning scheme</i></p>

___/___/___
G.16	Structural	Significant deterioration of timber stump near inspection opening. Assume similar deterioration to all timber stumps.	Restumping required.	High

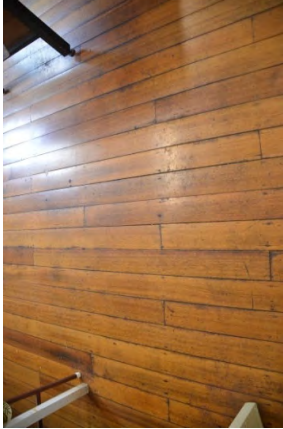
G.16	Floor	Timber floorboards showing signs of cupping. Corrosion staining evident from nails. Gaps opening up between floorboards.	As restumping is required, the timber floor will need to be removed, treated and relayed. Floor to be refixed with galvanised nails. Where gaps remain, caulk to seal.	Low

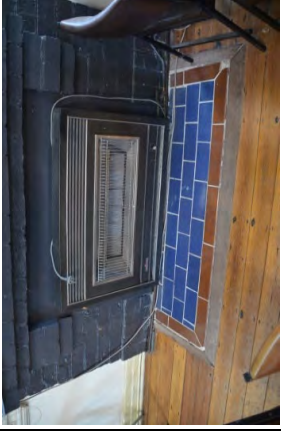
Location Code	Element	Description/Defect Notes	Action	Priority	Image Reference	Revision Date
G.16	Compliance	Due to recent A/C upgrades, the gas heater should be removed as it is probably non-compliant.	Remove gas heater and reinstate fire place. Chimney could be blocked to prevent drafts (decommissioned).	High

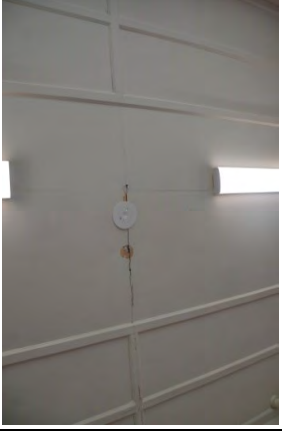
___/___/___
G.16	Ceiling	Cracking to ceiling. Inspected by structural engineer. Refer to report prepared by Mark Hodgkinson dated 18th June 2021: <i>The cracking in the ground floor ceiling identified by Andronas' report appears to be cracking from the floor level and is actually where a pre-existing surface mounted conduit has been removed.</i>	Patch and paint to match existing ceiling.	Low

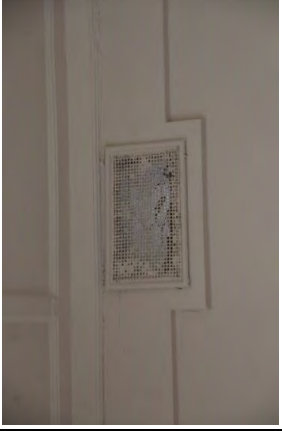
___/___/___
G.16	Wall	Vents have been poorly painted.	Strip and repaint vent.	Low

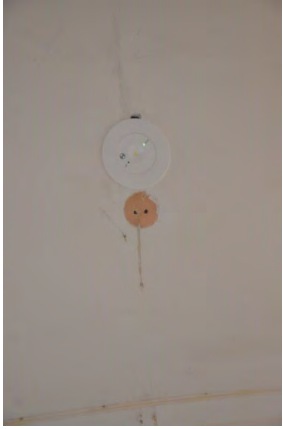
Location Code	Element	Description/Defect Notes	Action	Priority	Image Reference	Revision Date
G.16	Ceiling	Previous paint scheme where previous fitting was located.	Patch and paint to match existing ceiling.	Low

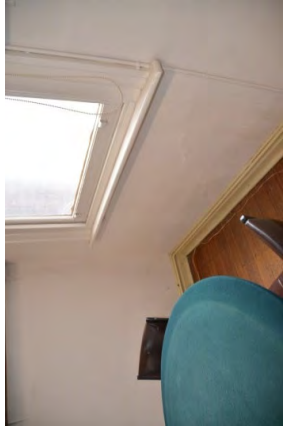
___/___/___
G.16	Wall	Drummy hard plaster in the majority of this space.	Monitor drummy hard plaster.	Low

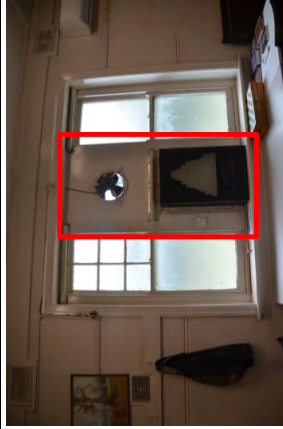
___/___/___
G.16	Mechanical	Ventilation of a later date. Why was it installed?	Review ventilation/ heating/ cooling. Reinstate window to match original?	Low

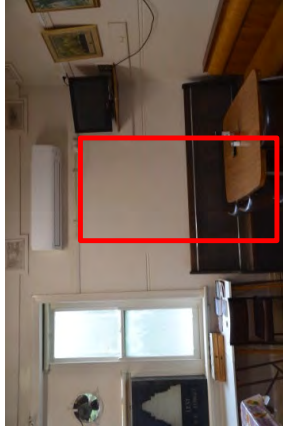
___/___/___
G.16	Wall	Diagonal crack coming down west side of north wall. Outline of filled in original door.	Monitor. Consider reinstating original door opening.	Low

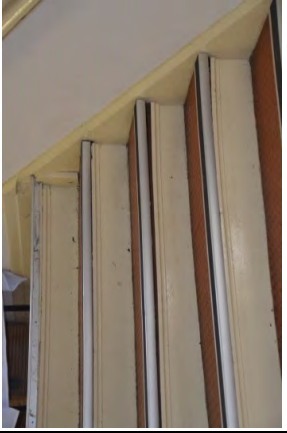
1.01	Floor	<p>Slight movement to treads in general. Significant movement in localised areas.</p>	Wedge and re-wedge treads.	Medium

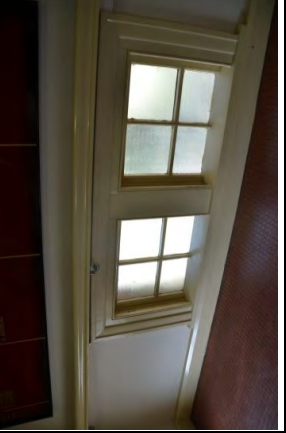
___/___/___
1.01	Compliance	<p>Lower windows to landing are a public liability risk and are non-compliant.</p>	Provide balustrade/barrier between stair landing and window to prevent fall. Balustrade openings to be a minimum of 125mm.	High

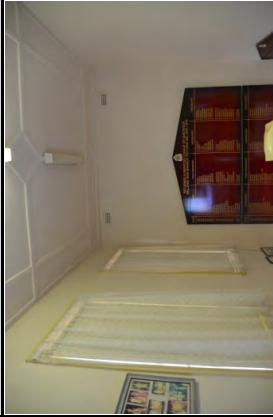
Location Code	Element	Description/Defect Notes	Action	Priority	Image Reference	Revision Date
1.02	Wall	Wall has been relined in plasterboard. Possibly due to falling damp. There is a risk that falling/penetrating damp may have impacted on the recent lining battens and fixings. Possible mould growth and/or efflorescence inside the cavity.	Monitor. Do we need to investigate?	Medium

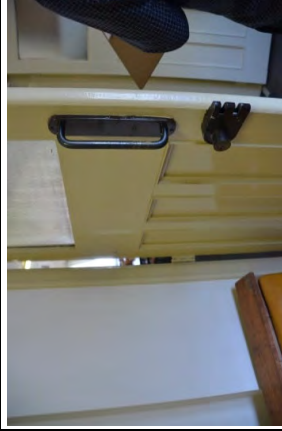
1.02	Compliance	Dead lock to door is non-compliant. A clear path of egress is required in case of an emergency.	Remove deadlock. Door to be unlockable from the inside in the event of an emergency.	High

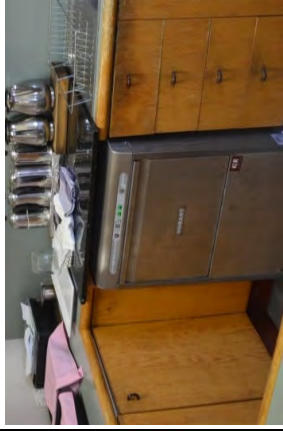
1.03	Floor	Dishwasher possibly contributing to ceiling damage downstairs.	Dishwasher to be checked for leaks.	Low

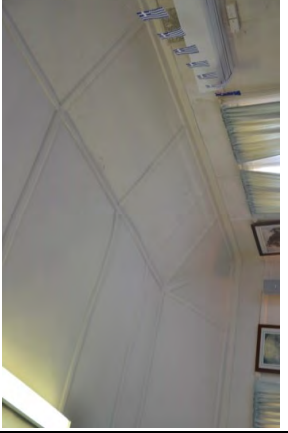
1.04	Ceiling	Sagging of fibrous plaster ceiling significant in localised areas. It was noted that a piece of fibrous plaster ceiling fell recently.	Localised repair of fibrous plaster ceiling required. Ensure stability of all plaster ceiling panels and straps.	High

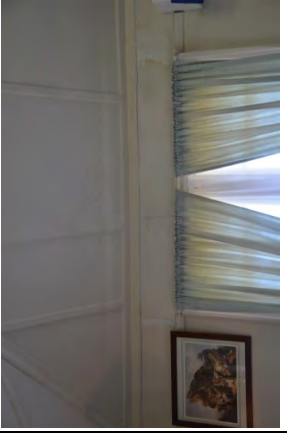
1.04	Wall	Minor cracking above window on east wall, possibly due to movement of concrete lintel. Looks to be significantly repaired in the past.	Monitor cracking. If cracks become more significant, install tell-tales to monitor movement and consult with Structural Engineer. Update: Defect generally inspected by structural engineer. Refer to report prepared by Mark Hodgkinson dated 18th June 2021 - 3.4 <i>Internal Brickwork Wall</i>	Low

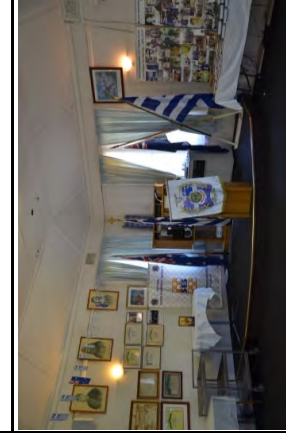
1.04	Compliance	Step to stage is non-compliant (too high)	Consider lowering stage height.	Low

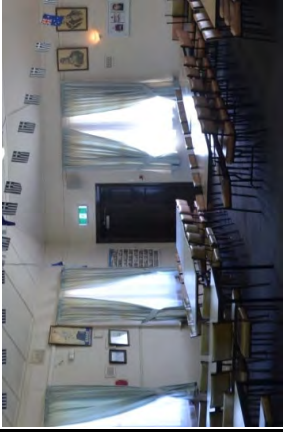
Location Code	Element	Description/Defect Notes	Action	Priority	Image Reference	Revision Date
1.04	Door	Emergency egress is non-compliant. Door is fixed in closed position and difficult to open.	Update emergency egress door to be compliant with National Construction Code. Emergency exit signs to be reviewed. Egress to be re-evaluated by Building Surveyor. Possibly reinstate original egress door and stairs if required.	Urgent

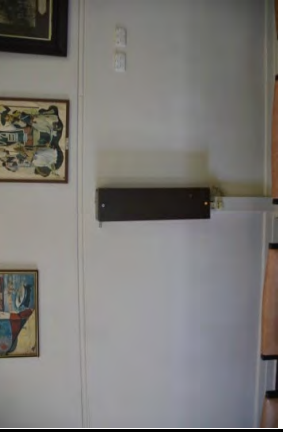
___/___/___
1.04	Telecommunication	Telecommunications services in inconvenient location. Is it still required?	Remove redundant services.	Low

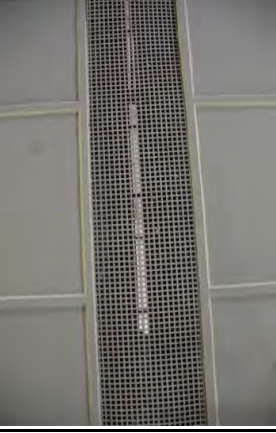
1.04	Ceiling	Fair amount of crazing. The probable movement of the ceiling could be due to mechanical movement as a result of workman, presence of moisture and/or potential buffeting of air pressure from windows, doors etc. Therefore pushing and pulling the plaster ceiling lining.	Further investigation required.	Low

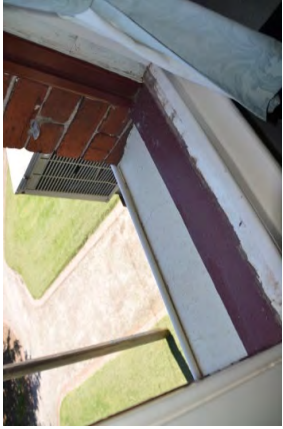
Location Code	Element	Description/Defect Notes	Action	Priority	Image Reference	Revision Date
1.04	Window	Windows in ok condition. Some windows appeared to be painted over, therefore windows were difficult to open.	General servicing of all windows required. All sills to be checked for decay from exterior. Update: Defect generally inspected by structural engineer. Refer to report prepared by Mark Hodgkinson dated 18th June 2021 - 4.5 First Floor Window.	Low

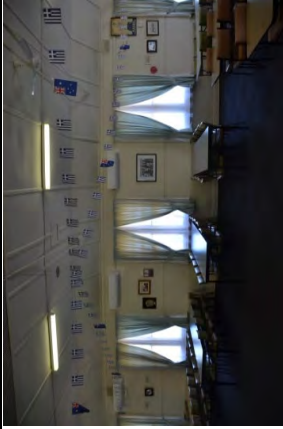
1.04	Wall	General drumminess to hard plaster walls.	Monitor.	Low

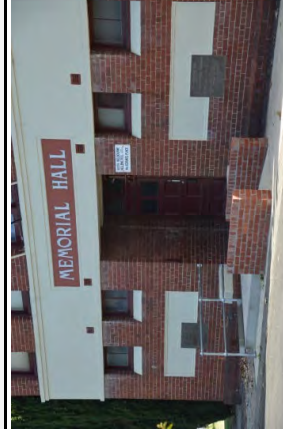
___/___/___
East Elevation	Compliance	Recent upgrade to front step and ramp is non-compliant.	Install hand rails, tactile indicators and luminant nosing strips to DDA requirements.	High

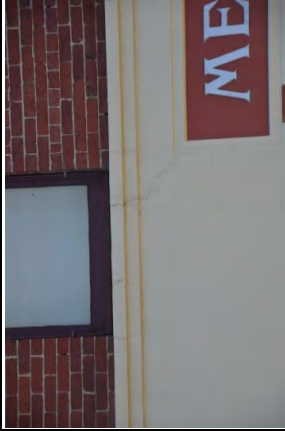
___/___/___
East Elevation	Wall	Minor cracking to front façade is evident around larger apertures (doors and windows). Possibly due to differential movement of the building over time.	Monitor cracking. Update: Defect generally inspected by structural engineer. Refer to report prepared by Mark Hodkinson dated 18th June 2021 - 3.5 External Brickwork Walls	High

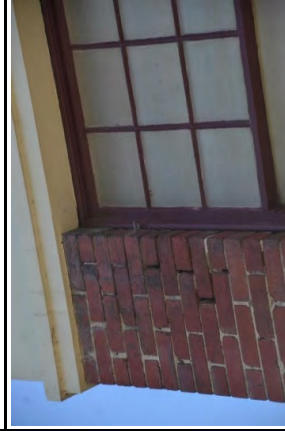
___/___/___
East Elevation	Wall	Significant loss of mortar around windows. Possibly due to falling damp from box gutter behind parapet. Note larger/open perpendes.	Inspect box gutter for leaks and repair if required. Repoint brickwork once water ingress has been addressed.	High

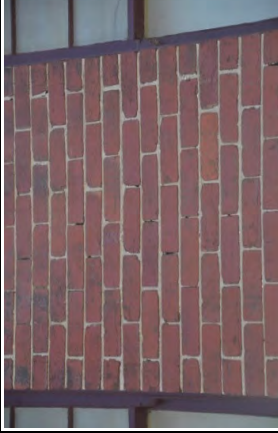
Location Code	Element	Description/Defect Notes	Action	Priority	Image Reference	Revision Date
East Elevation	Wall	Brickwork perpends cracked and opening up.	Repoint. As the perpends are narrow, ensure an adequate amount of mortar is applied to fill entire gap.	Low

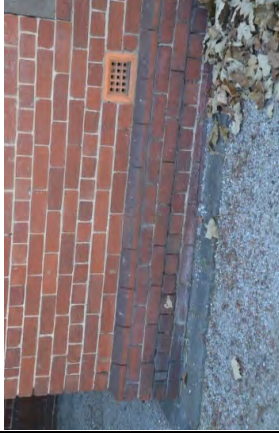
___/___/___
East Elevation	Wall	Loss of mortar to plinth indicates rising damp is breaching the damp proof course. This could also be contributing to moisture to sub floor.	Provide additional subfloor ventilation to allow adequate airflow to subfloor. Once subfloor moisture issues have been addressed, repoint plinth ensuring DPC's are not breached and monitor.	Low

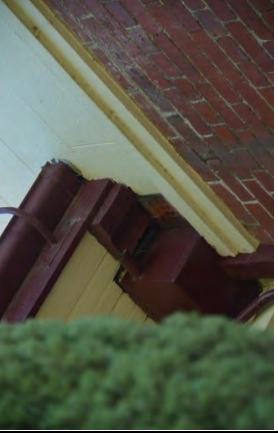
___/___/___
East Elevation	Wall	Brick vent adjacent to sump could contribute to water ingress into building. Water staining on brickwork below could indicate eaves gutter/rainhead is leaking/overflowing.	Check downpipe and rainhead for leaks and/or blockages. Re-arrange rainhead if required to prevent water ingress through brick vent.	Low

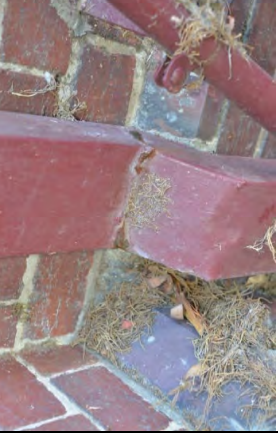
East Elevation	Roof Plumbing	Downpipes showing signs of corrosion.	Treat or make good all downpipes for corrosion and repaint.	Low

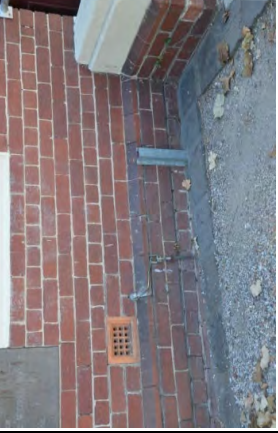
___/___/___
East Elevation	Wall	Inadequate subfloor ventilation. This will be contributing to moisture/damp issues in the timber subfloor.	Provide additional subfloor vents to improve subfloor ventilation.	High

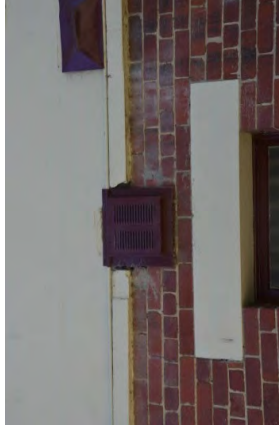
___/___/___
South Elevation	Wall	Gap between opening and vent.	Seal between opening and vent. Ensure all penetrations in masonry wall are properly sealed.	Low

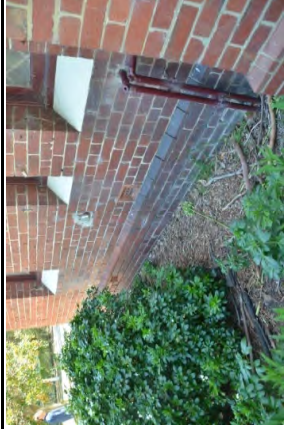
___/___/___
South Elevation	Wall	Loss of mortar to plinth indicates rising damp is breaching the damp proof course. This would also be contributing to moisture to sub floor.	Provide additional subfloor ventilation to allow adequate airflow to subfloor. Once subfloor moisture issues have been addressed, repoint plinth and monitor. May need to pull garden bed back away from building. Ground to fall away from building.	Low

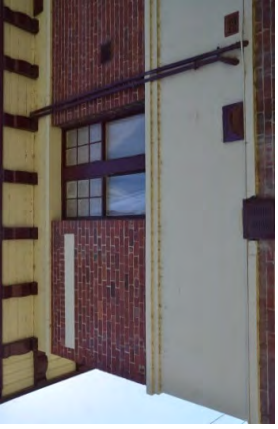
Location Code	Element	Description/Defect Notes	Action	Priority	Image Reference	Revision Date
South Elevation	Wall	Filled in original opening.	Note: egress may need to be reviewed. Consider reinstatement of original staircase and door. Consult Building Surveyor.	Low

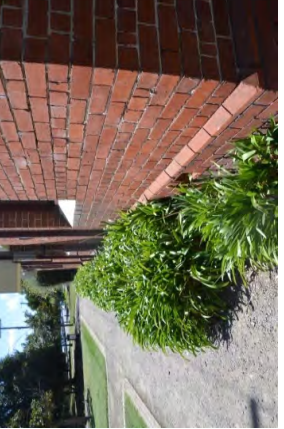
___/___/___
West Elevation	Wall	Garden bed adjacent to building could contribute to moisture issues in subfloor.	Remove garden bed/ pull away from building.	Low

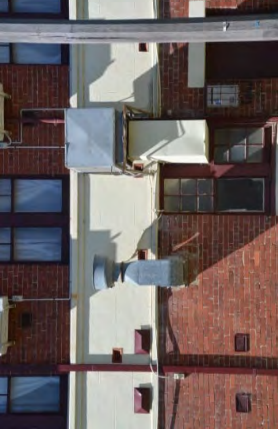
___/___/___
West Elevation	Wall	Service reticulation to be addressed. General appears untidy.	Review of service reticulation required. Ensure penetrations in masonry wall are properly sealed. All pipes and wiring reticulation to be reviewed and tidied up.	Low

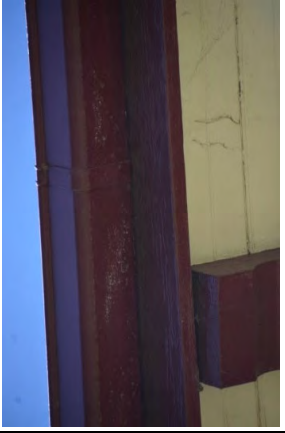
___/___/___
West Elevation	Roof Plumbing	Oxidisation to underside of gutter indicates water collecting in gutter & corroding guttering.	Adjust eaves gutter to ensure adequate fall to outlets. Renew all guttering and other roof plumbing.	High

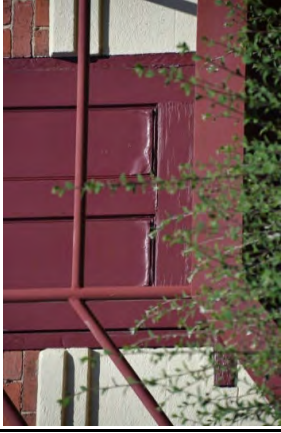
Location Code	Element	Description/Defect Notes	Action	Priority	Image Reference	Revision Date
North Elevation	Door	Significant deterioration of emergency exit door.	Refurbish door and paint to match original.	Medium

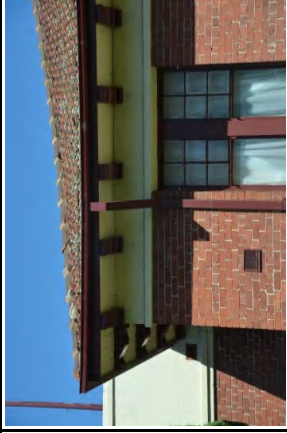
___/___/___
North Elevation	Roof Plumbing	Sagging eaves gutter. It appears low point of gutter is not where downpipe is.	Adjust eaves gutter to provide adequate fall to outlet/downpipe. Review roof plumbing.	High

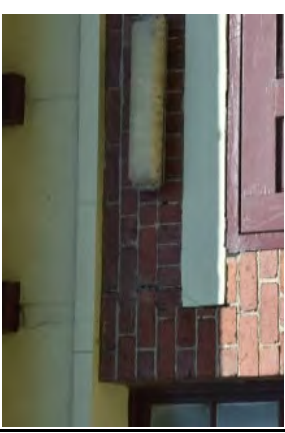
___/___/___
North Elevation	Wall	Brickwork opening up above emergency exit door. Loss of pointing to brickwork. Opening could contribute to water ingress.	Caulk opening to prevent water ingress. A flexible caulking will allow for movement.	Medium

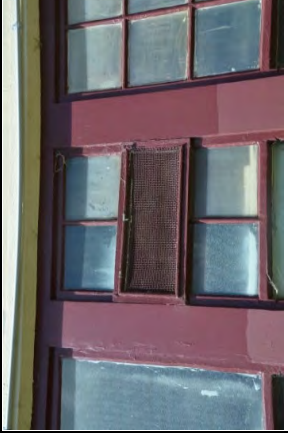
___/___/___
North Elevation	Wall	<p>Vents missing straps.</p>	<p>Repair straps.</p>	Low

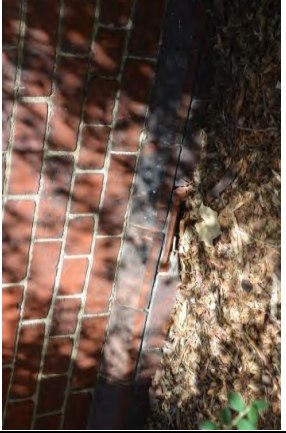
North Elevation	Wall	<p>Leaves are blocking subfloor ventilation. Additionally, the height of the garden bed could be contributing to moisture issues in the timber subfloor.</p>	<p>Lower the height of the garden bed in this area. Ensure ground falls away from building.</p>	High

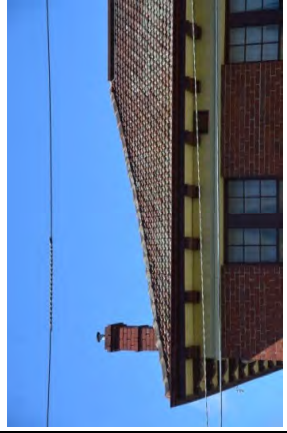
___/___/___
Roof	Roof	Hip appears to be bowing slightly. Possibly related to spreading trusses.	Further investigation of the roof structure required. Consult with Structural Engineer. Structural Engineer to determine if this is a problem or not. Update: Roof structure inspected by structural engineer. Refer to report prepared by Mark Hodgkinson dated 18th June 2021 - 3.1 Roof Structure	High

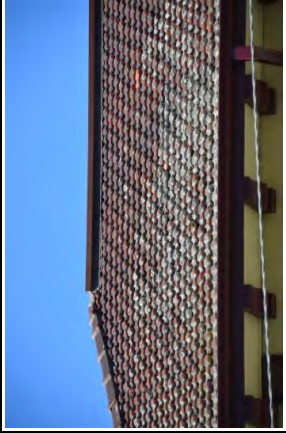
___/___/___
Roof	Roof	Tiles have a moderate amount of lichen which will be releasing organic acids, this accelerates corrosion of roof gutters.	Ongoing issue. Monitor guttering for corrosion. As it is suspected that current guttering will require renewing due to corrosion.	Low

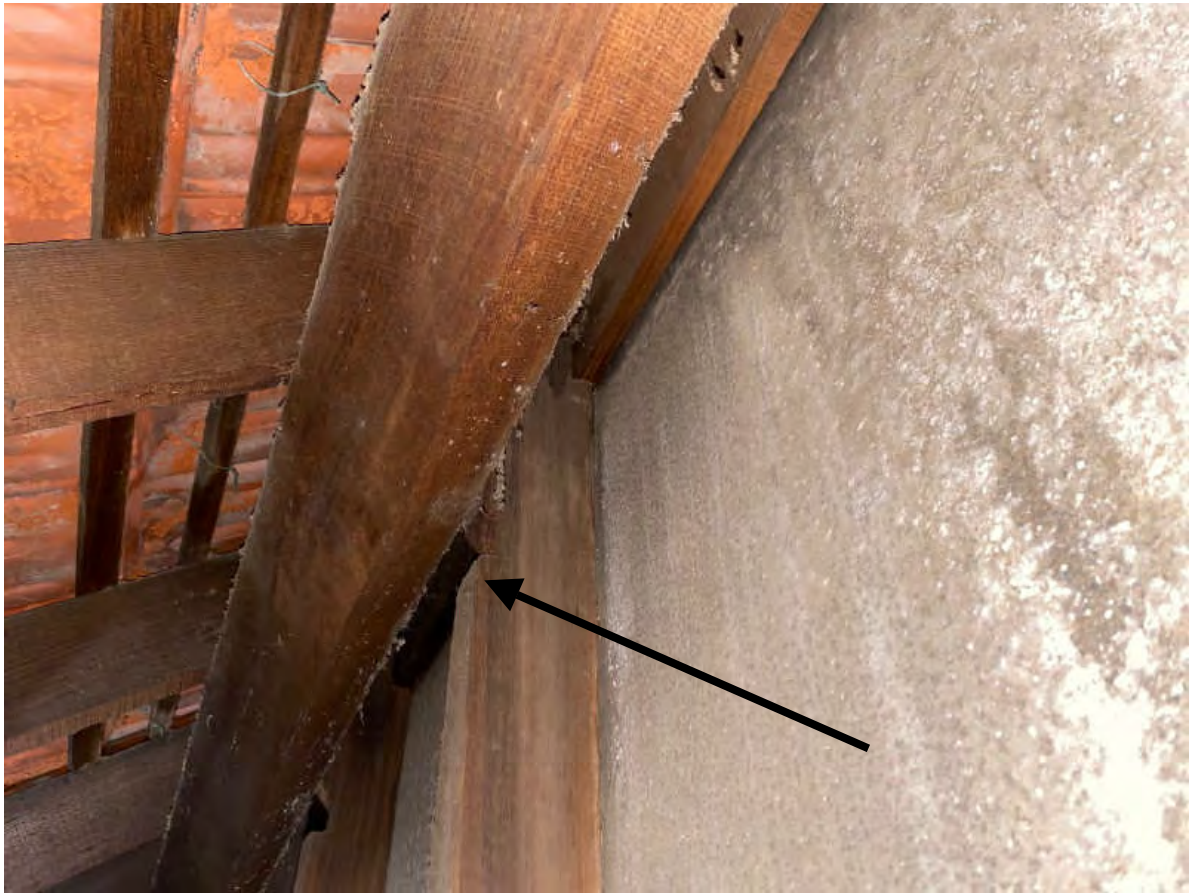
It would seem that the rafters that bear on the eastern and western walls of the ventilator shaft that runs along the north / south ridge of the roof may have moved down the roof slope at some time as the waling plate does not rest on the studwork birdsmouths. Refer to Photograph 10 Appendix A

A view of the waling plate and ventilation shaft dislocated joint. Note that the waling plate should presumably be resting on the birdsmouth in the stud.

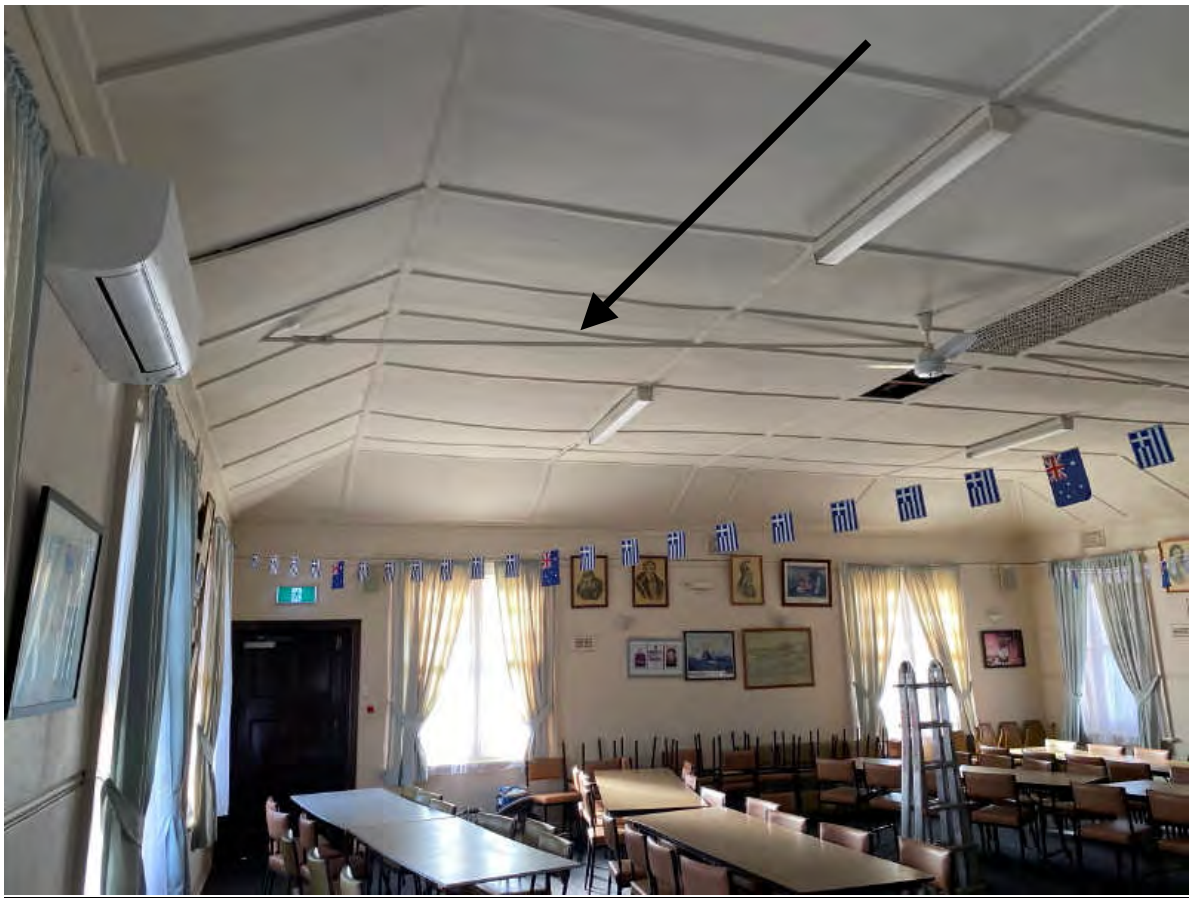
It would seem that steel tie rods have been retrofitted between the top chords, below the flat ceiling in order to prevent horizontal 'spread' of the top chords. Refer to Photograph 11 Appendix A

A view of a tie rod that may have been retrofitted to stabilise the roof spread.

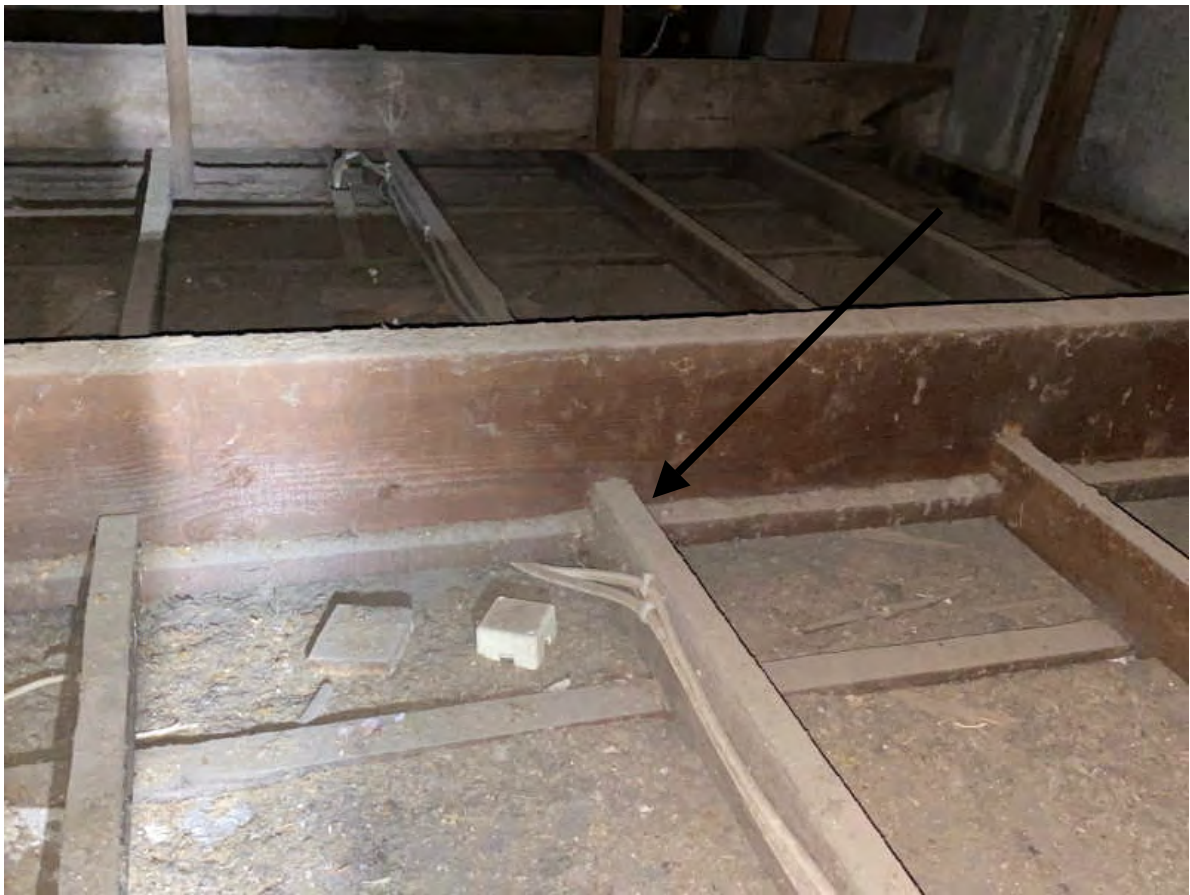
Photograph 12

The ceiling joists are supported from waling plates that have been fixed to the sides of the trusses and the ceiling joists have been notched over the waling plate. This common detail can be problematic as the joint can crack if the ceiling joist is overloaded. Refer to Photographs 12 and 13 Appendix A

A view of the ceiling structure showing the waling plate that supports the ceiling joists.

- Remediate the first floor ceiling joist connection at the waling plates by installing metal straps to hang the ceiling joists.
- Remediate the top of the northern chimney stack by repointing the mortar and relaying the brickwork capping and mortar.
- Inspect the concrete lintels for concrete cancer.
- Remove some areas of the external brickwork walls to allow the wire wall ties to be inspected.
- Either replace or remediate the first floor fibrous plaster ceiling.

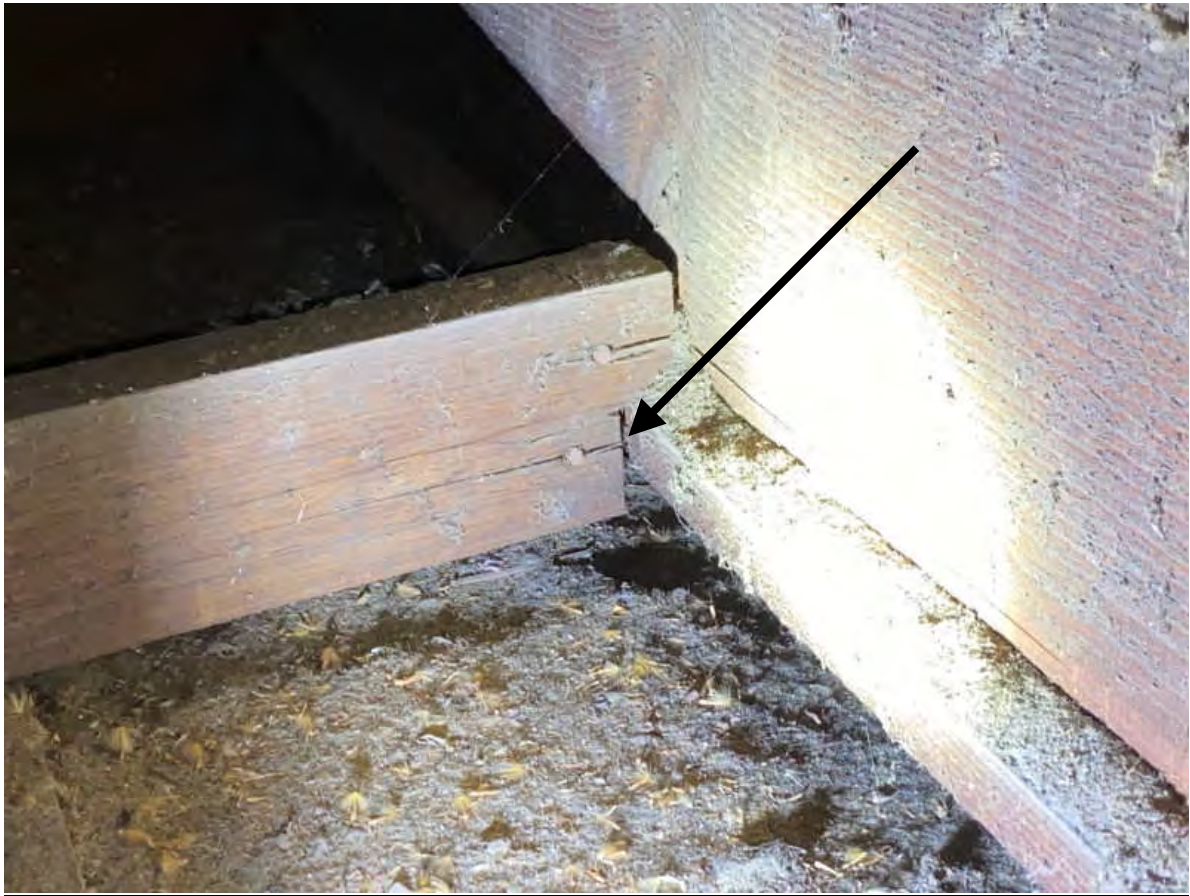
Photograph 13

A close up view of a waling plate and notched ceiling joist showing the splitting at the end of the joist.

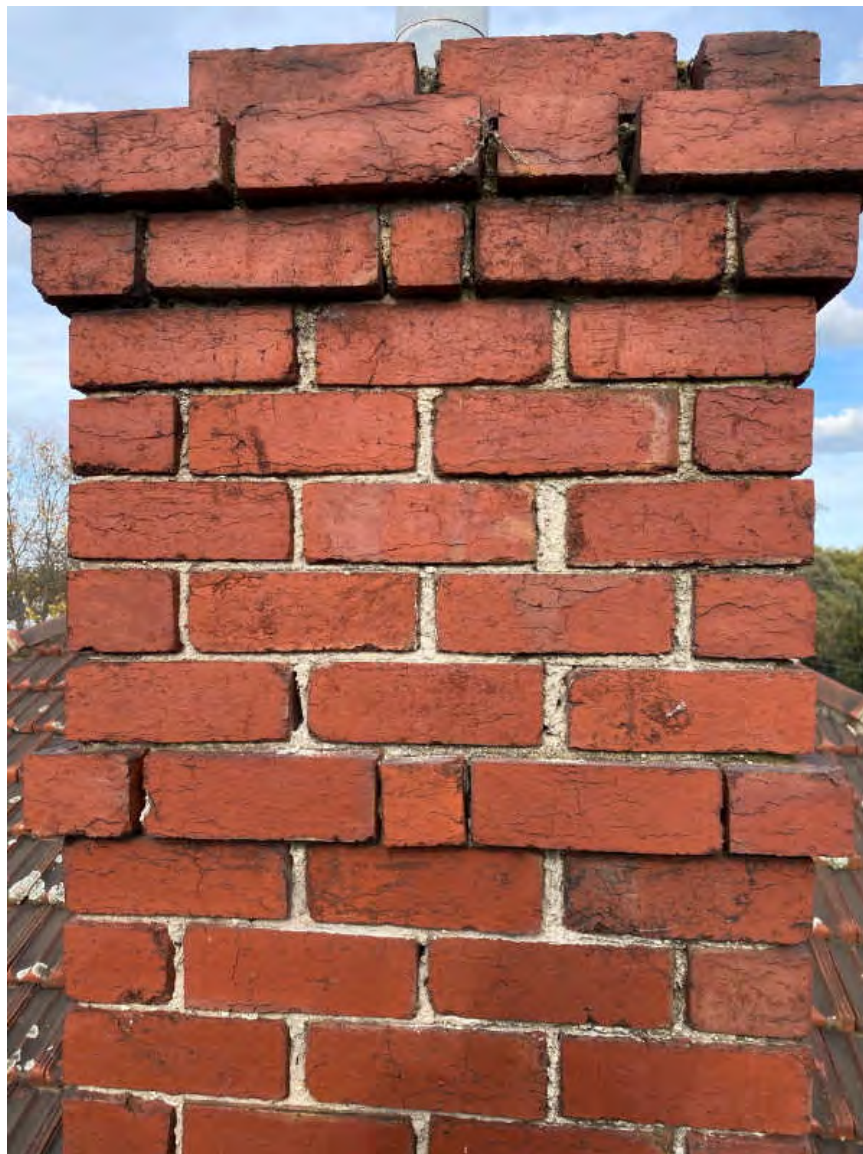
Photograph 14

The mortar at the top of the brickwork chimney stack has fretted and the mortar capping has weathered and is in poor condition. A brick was missing from the southern side of the top of the stack and a loose brick was removed from the northern side of the stack during the inspection. Refer to Photographs 14 and 15 Appendix A

A view of the top of the northern chimney showing the fretted mortar.

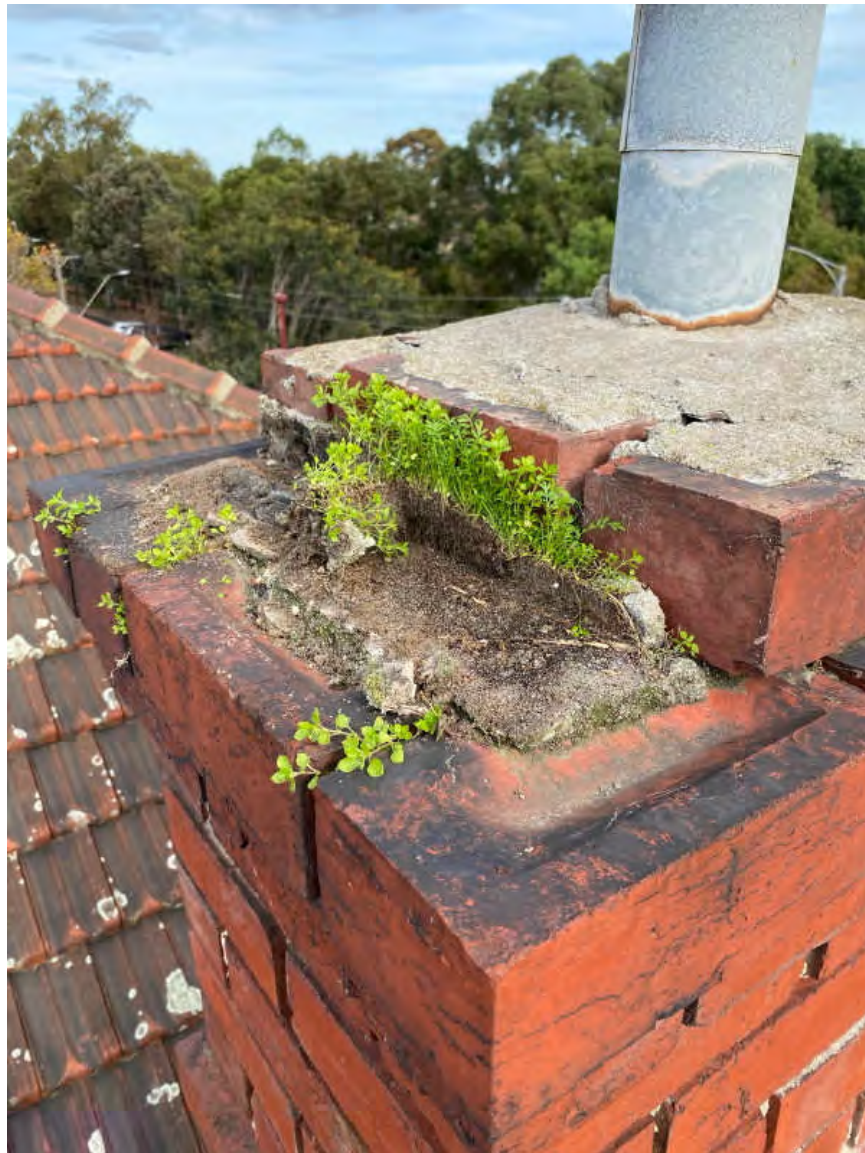
Photograph 15

Another view of the top of the northern chimney showing where the loose brick was removed.
