CONSERVATION MANAGEMENT PLAN

MEMORIAL HALL SOUTH MELBOURNE

PREPARED BY ANDRONAS CONSERVATION ARCHITECTURE
IN ASSOCIATION WITH LANDMARK HERITAGE

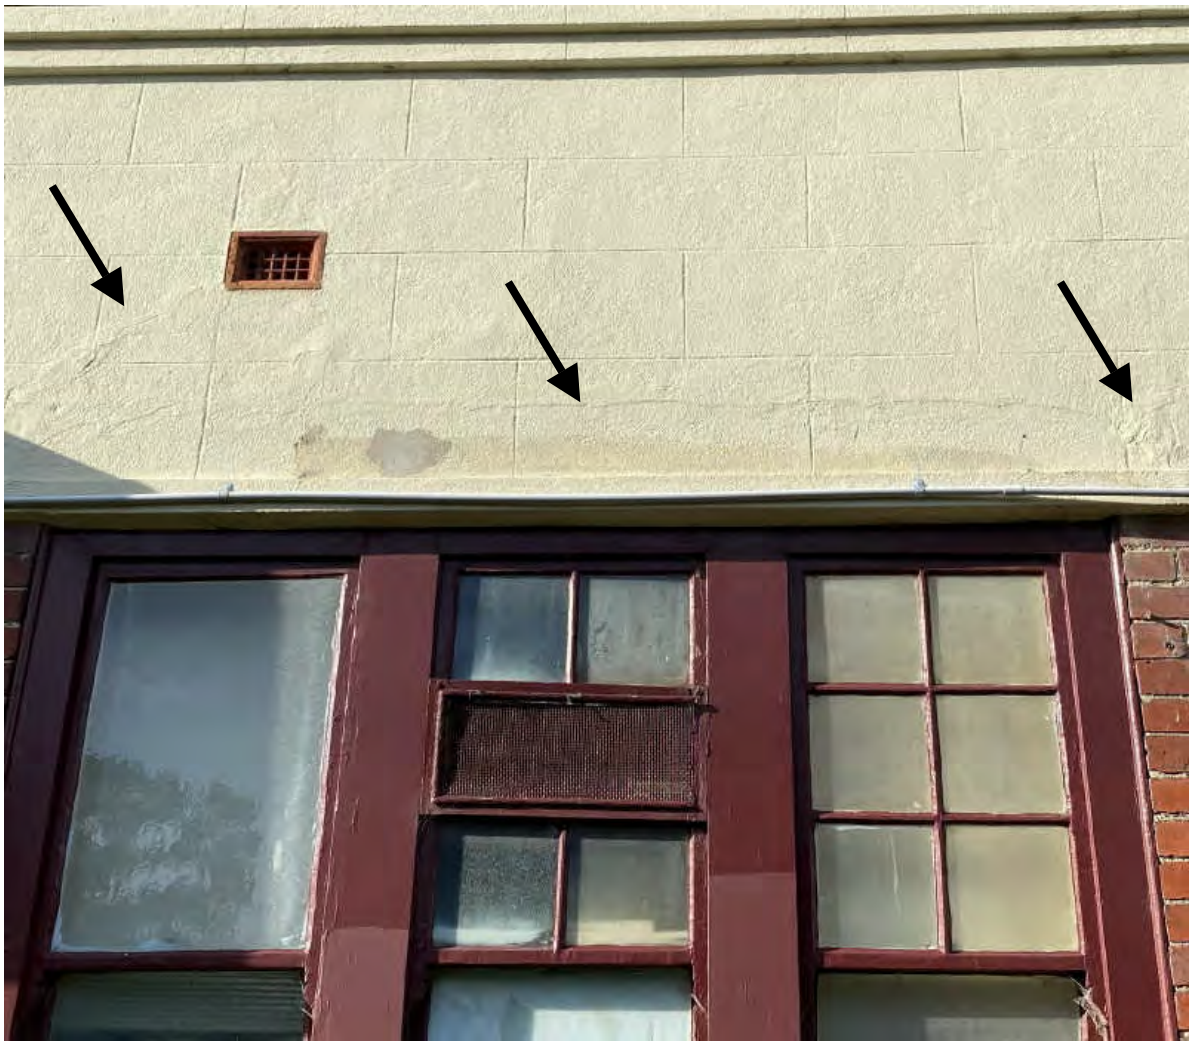
The cracking in the concrete lintels in the external walls has been caused by differential movement between the brickwork and the concrete, ie long term expansion of the brickwork via brick growth, and long term shrinkage of the concrete. It is also possible that some 'concrete cancer' may be present in some of the concrete lintels, that is corrosion and expansion of the lintel rebar and consequent cracking of the concrete as a result of carbonation of the concrete, poor quality concrete, and/or inadequate reinforcement cover. Refer to Photograph 16 Appendix A.

A view of the render above a western façade window showing the old patching.

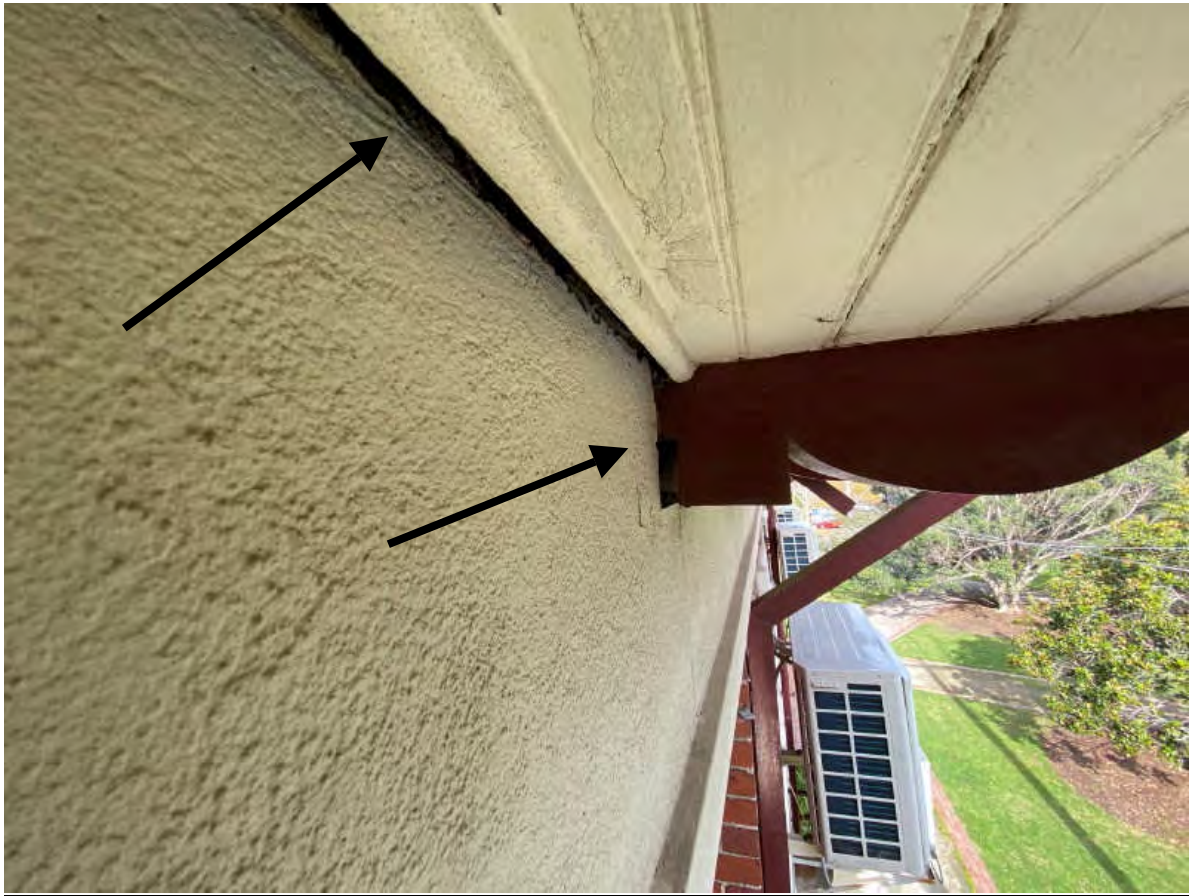
Photograph 17

The timber corbels and lining board eaves along the western façade are securely fixed to the underside of the timber eave framing. At more-or-less the mid-length of the wall there is a ~ 30 mm gap between the scotia moulding, the ends of the corbels, and the face of the wall, and the gap diminishes towards the northern and southern ends of the western façade. The cause of the movement is spread of the top chords of the roof trusses discussed above. Refer to Photographs 17 and 20 Appendix A

A view of the movement between the western façade wall and the scotia moulding and the timber corbel.

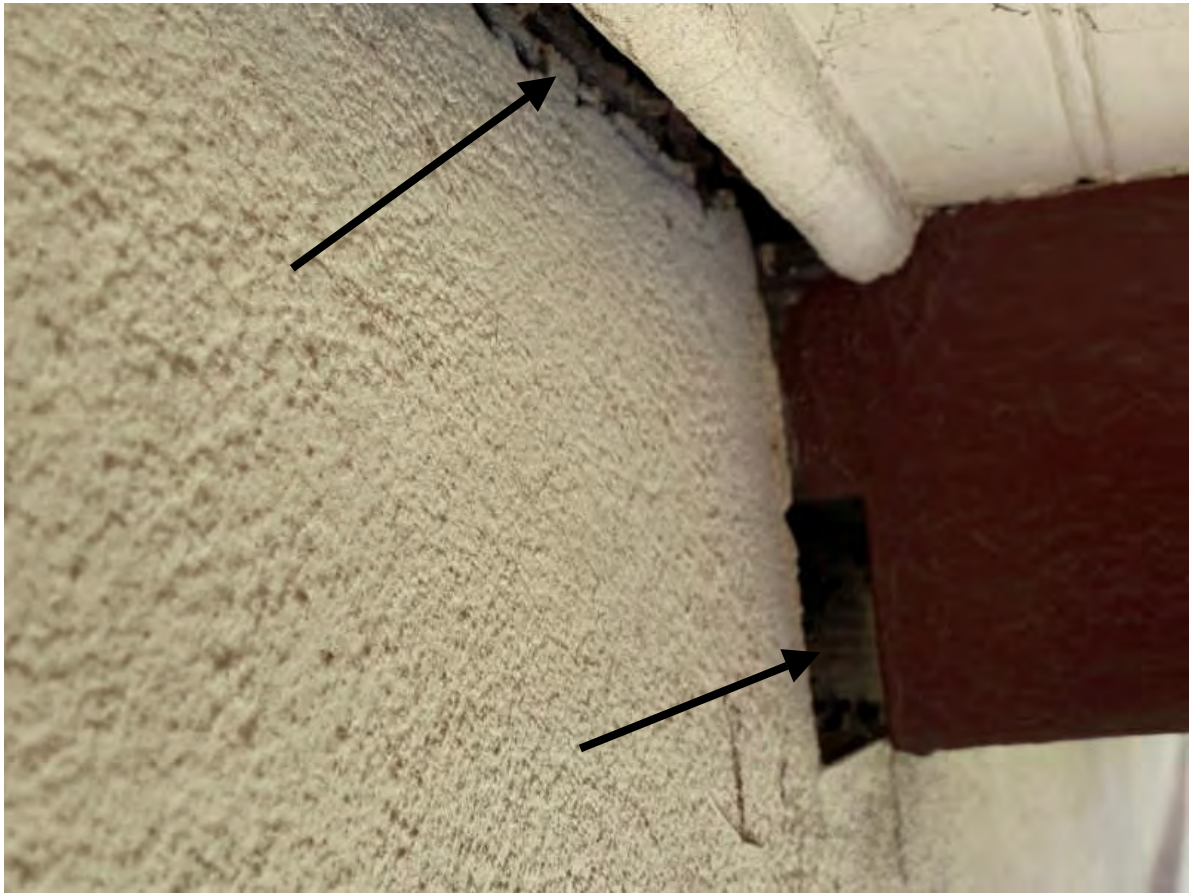
Photograph 18

A close up view of the movement between the western façade wall and the scotia moulding and the timber corbel.

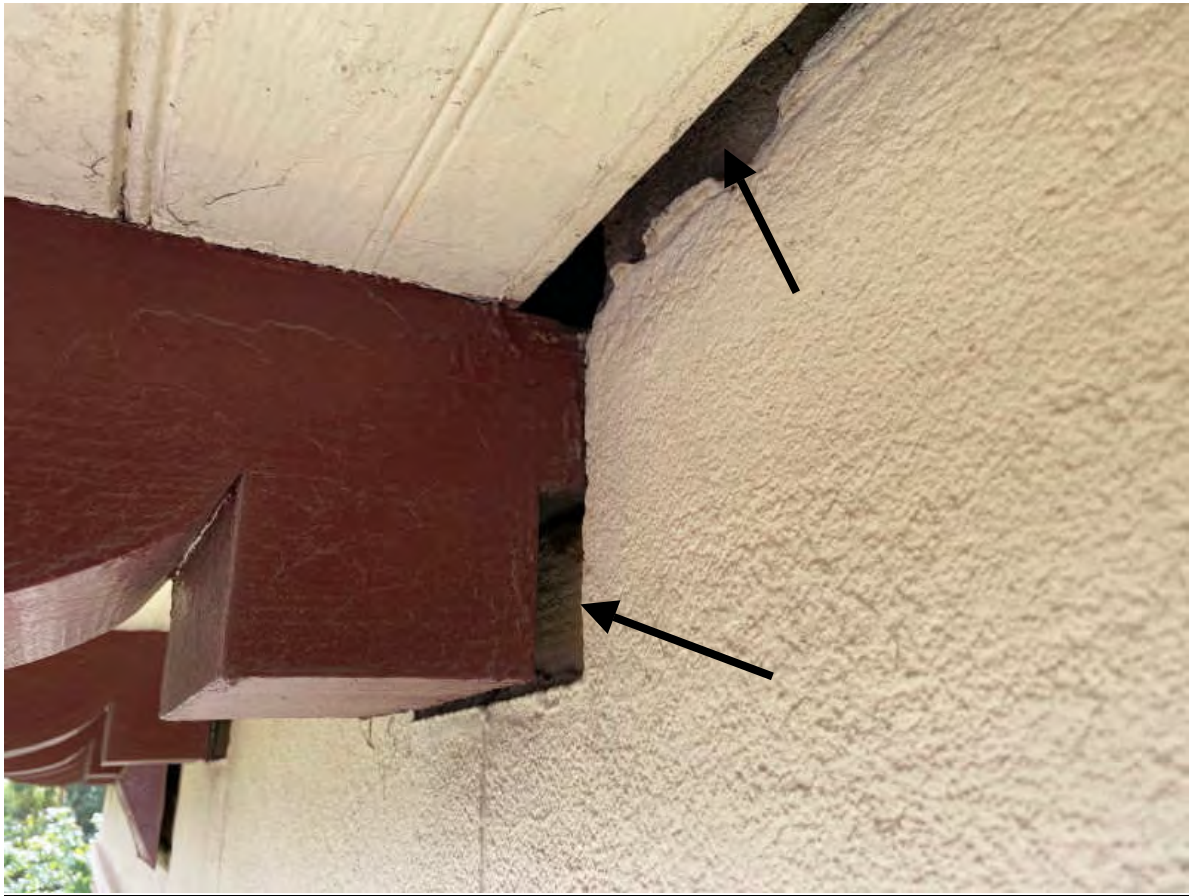
Photograph 19

Another close up view of the movement between the western façade wall and the scotia moulding and the timber corbel.

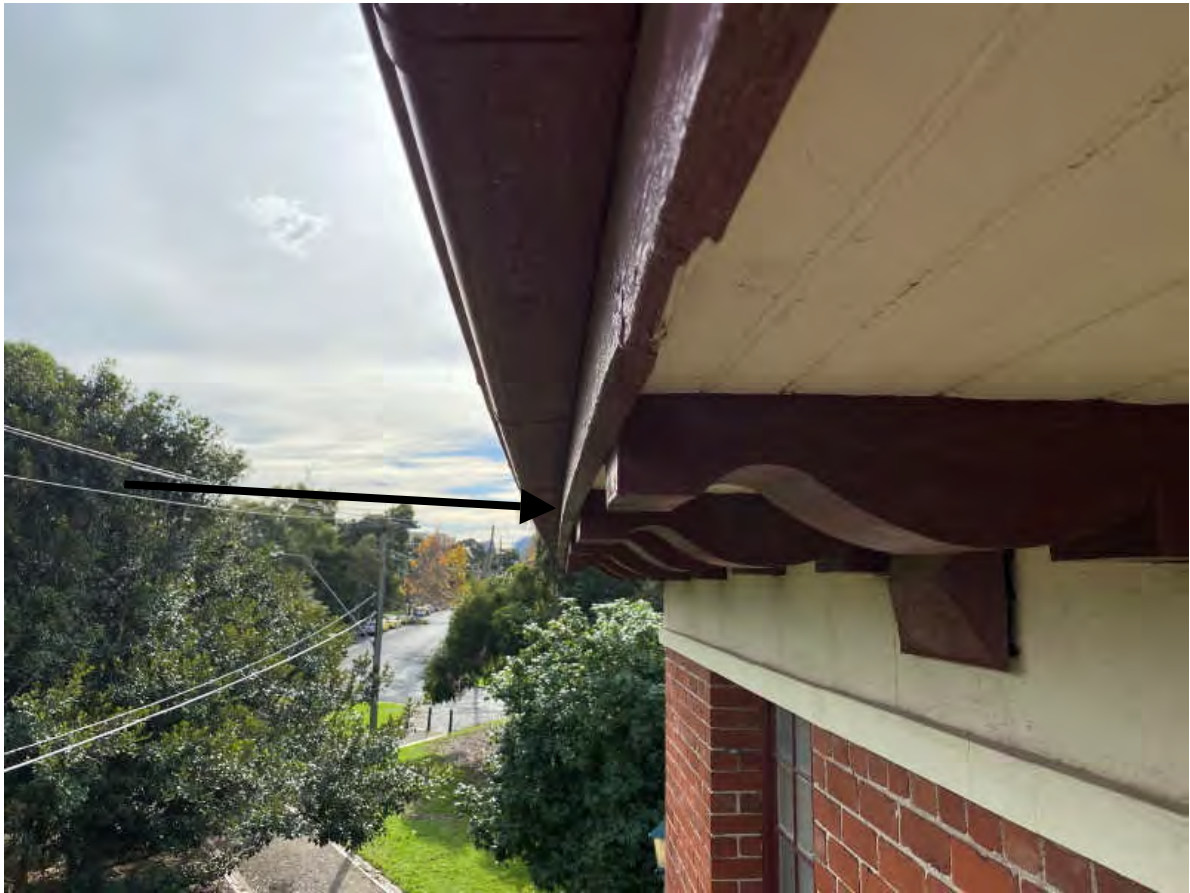
Photograph 20

A view of the outward bow in the western façade fascia.

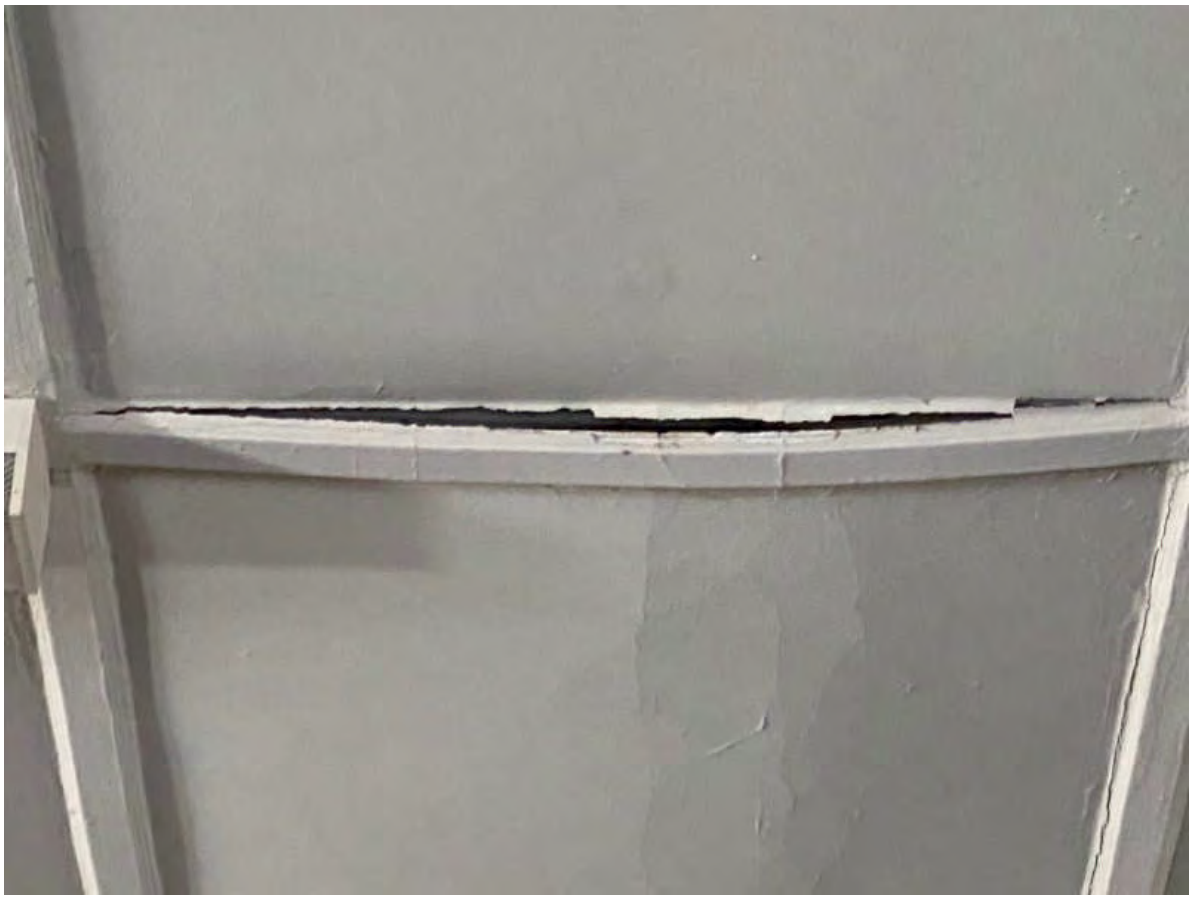
The fibrous plaster first floor ceiling is generally in poor condition and the timber cover straps have become dislodged and deflected at some locations. Refer to Photograph 21 Appendix A. Normally fibrous plaster ceilings are nailed to the ceiling battens and then plaster 'scrim' is installed above the battens to support the mass of the fibrous plaster in the long term, as without the scrim the nails can pull-out from the battens. As there is no scrim above the battens it is probable that the timber cover straps have been relied upon to support the plaster where they have been installed, and that the nails have been relied upon to support the plaster in between the cover straps.

A view of the first floor ceiling showing a deflected ceiling batten and damaged plaster sheet.

- Remediate the first floor ceiling joist connection at the waling plates by installing metal straps to hang the ceiling joists.
- Remediate the top of the northern chimney stack by repointing the mortar and relaying the brickwork capping and mortar.
- Inspect the concrete lintels for concrete cancer.
- Remove some areas of the external brickwork walls to allow the wire wall ties to be inspected.
- Either replace or remediate the first floor fibrous plaster ceiling.

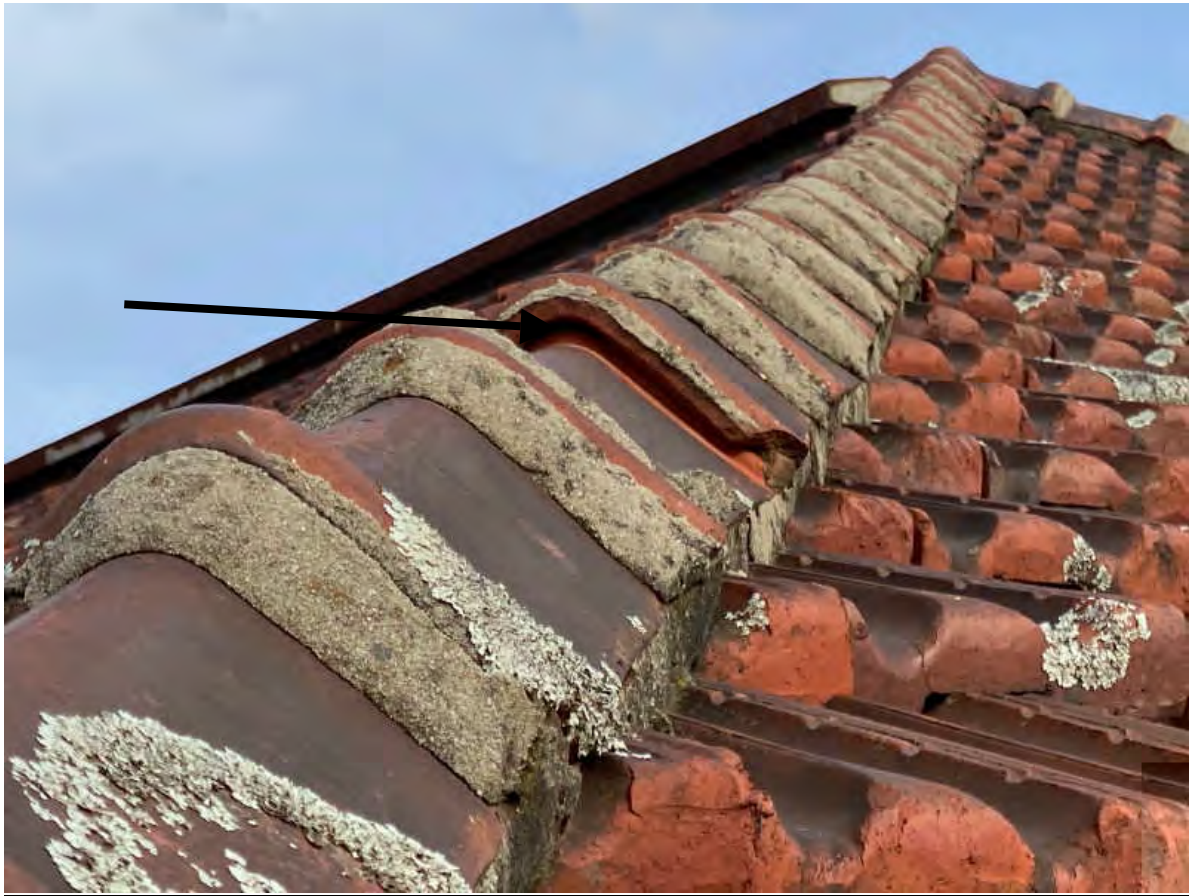
The mortar pointing is missing from some of the terracotta hip capping joints. Refer to Photograph 22 Appendix A.

A view of the loose hip tile at the eastern end of the southern façade.

- Remediate the dry rot.
- Remediate the hip cappings.

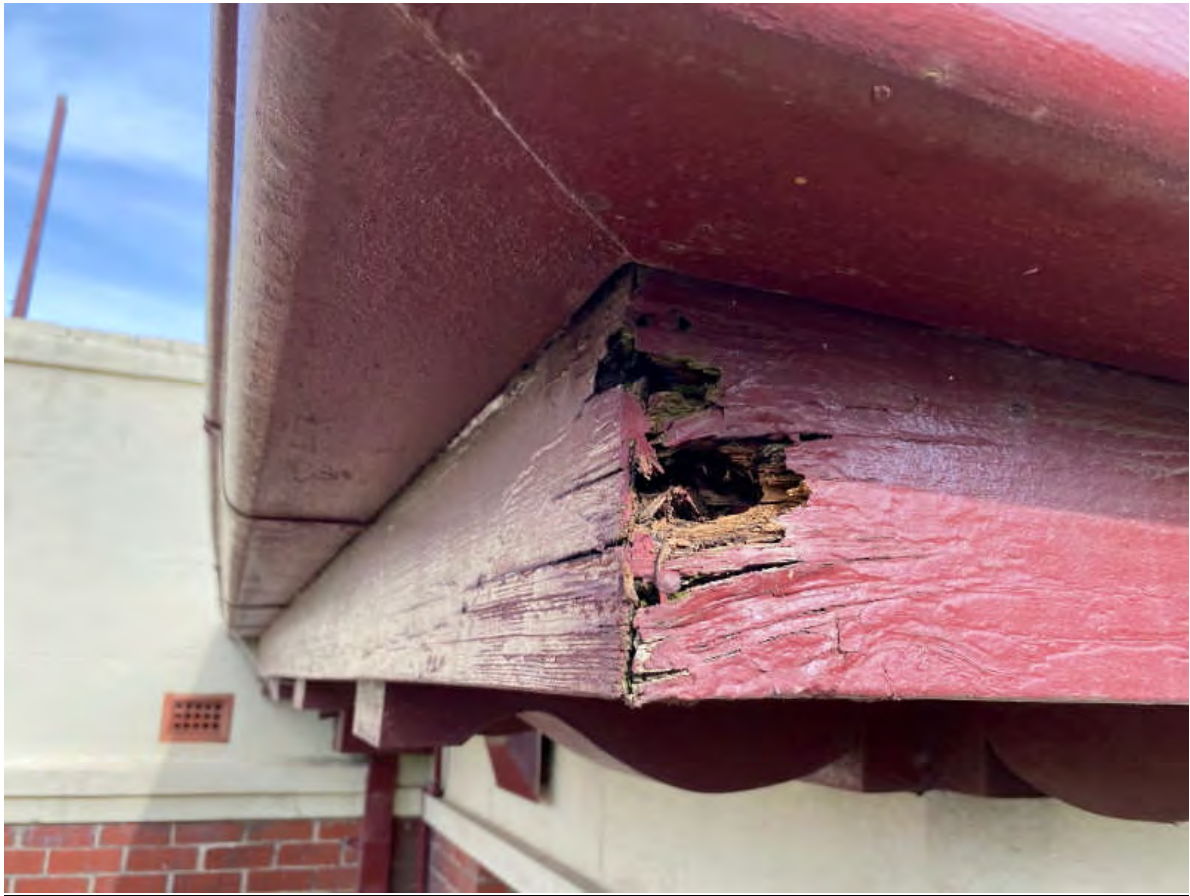
There is extensive dry rot in the fascia joint at the eastern end of the northern façade. Refer to Photograph 23 Appendix A.

A view of the dry rot at the eastern end of the northern façade.

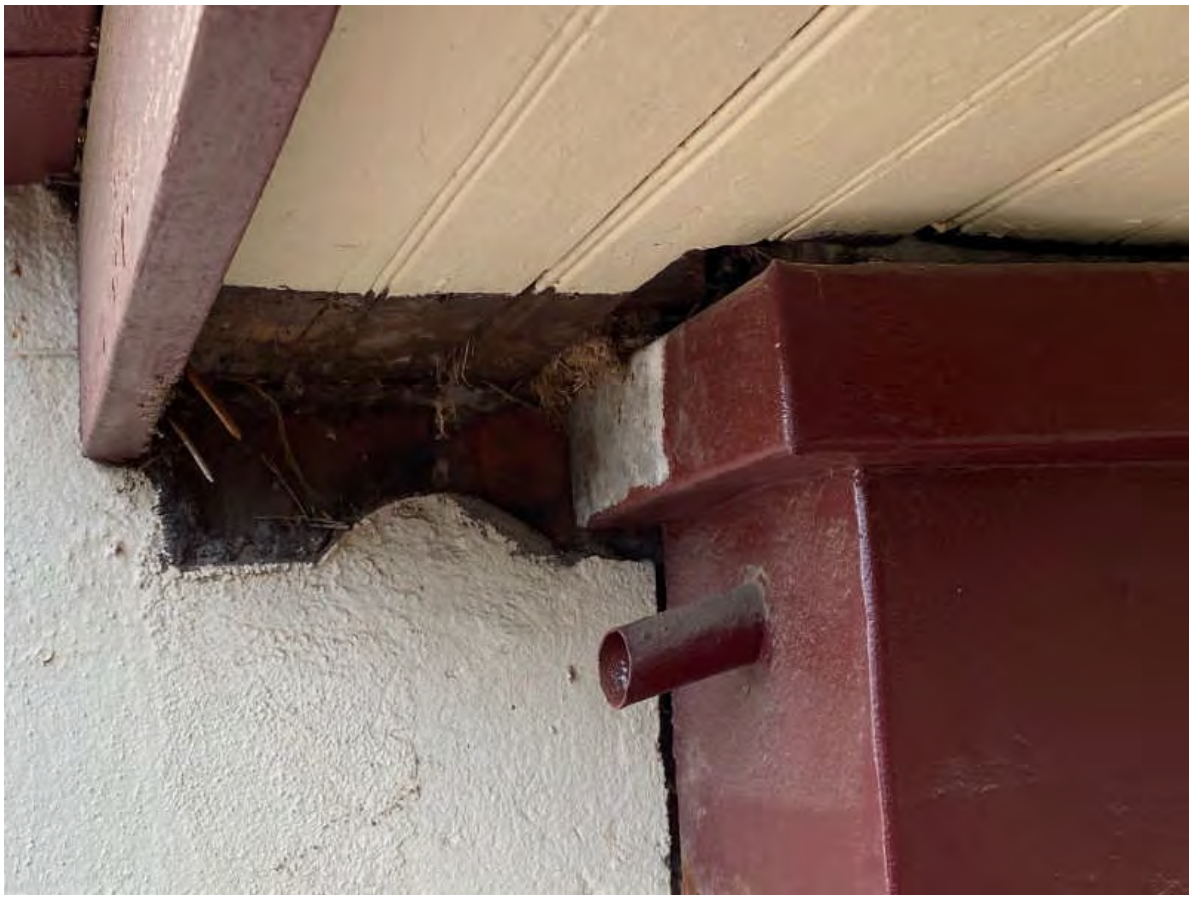
A loose timber corbel was removed from the southern end of the northern end of the eastern façade. It was apparent that the corbel had been modified to suit the rain water head. Refer to Photograph 24 Appendix A.

A view of where the loose corbel was removed at the southern end of the northern end of the eastern façade.

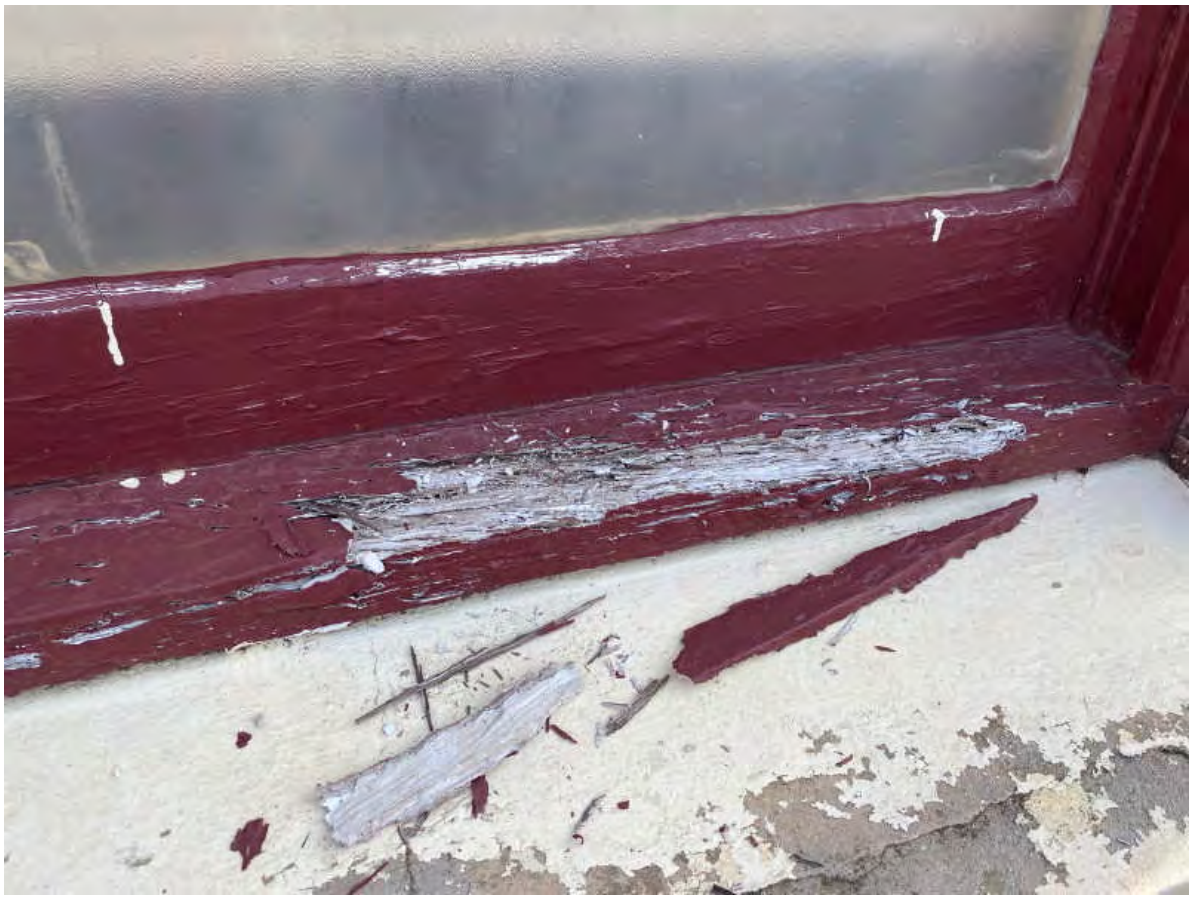
There was dry rot in the sill and frame of the window at the northern end of the eastern façade. Refer to Photograph 25 Appendix A.

A view of the dry rot in a first floor window sill and window frame of the eastern façade.

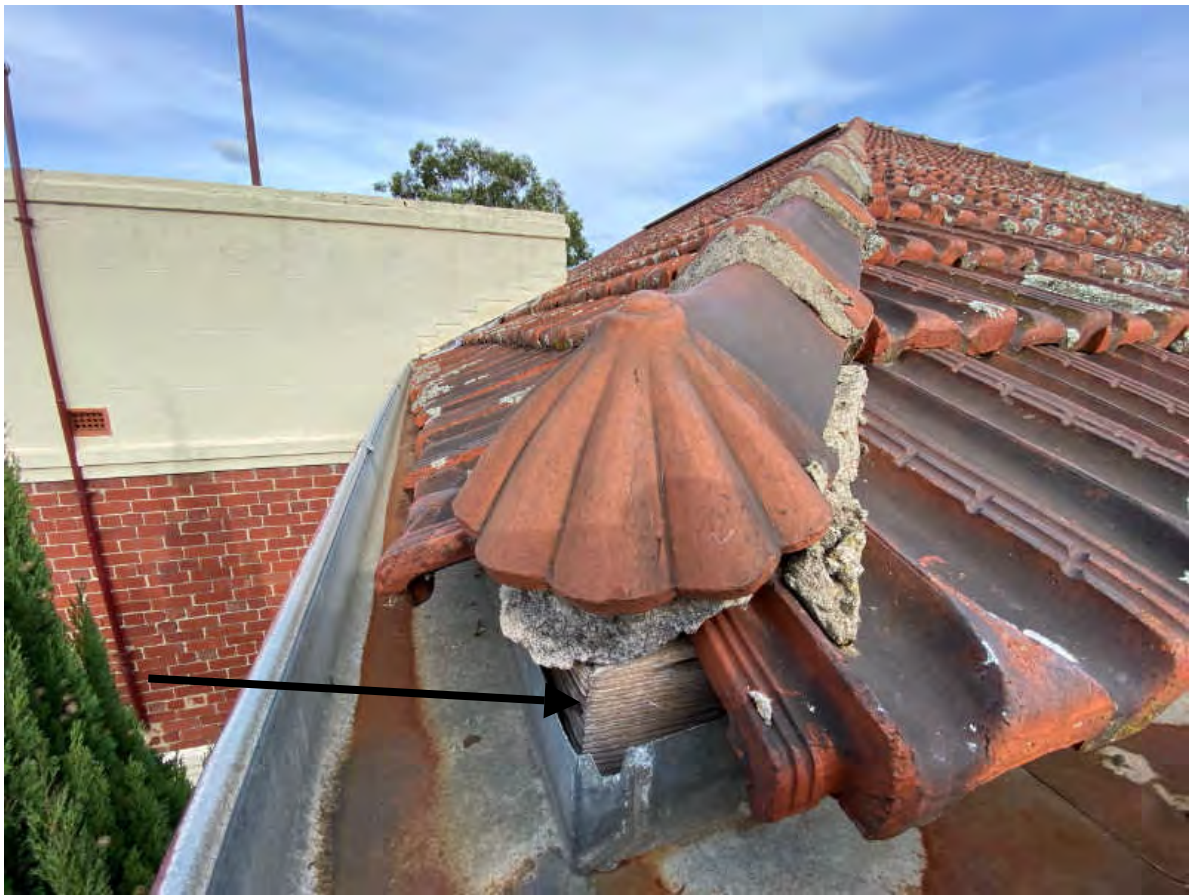
There are terracotta tiles missing from below the hip cappings, above the gutters. Refer to Photograph 26 Appendix A.

A view of the missing tiles and loose hip tile at the eastern end of the northern façade.
