**PRELIMINARY SITE INVESTIGATION:
ELWOOD FORESHORE AREA, ELWOOD, VIC.**

*City of Port Phillip
St Kilda Town Hall
99a Carlisle Street,
St Kilda, Victoria 3182*

*Project Ref.: 1865 Elwood (PSI)
Date: 01 April 2020*

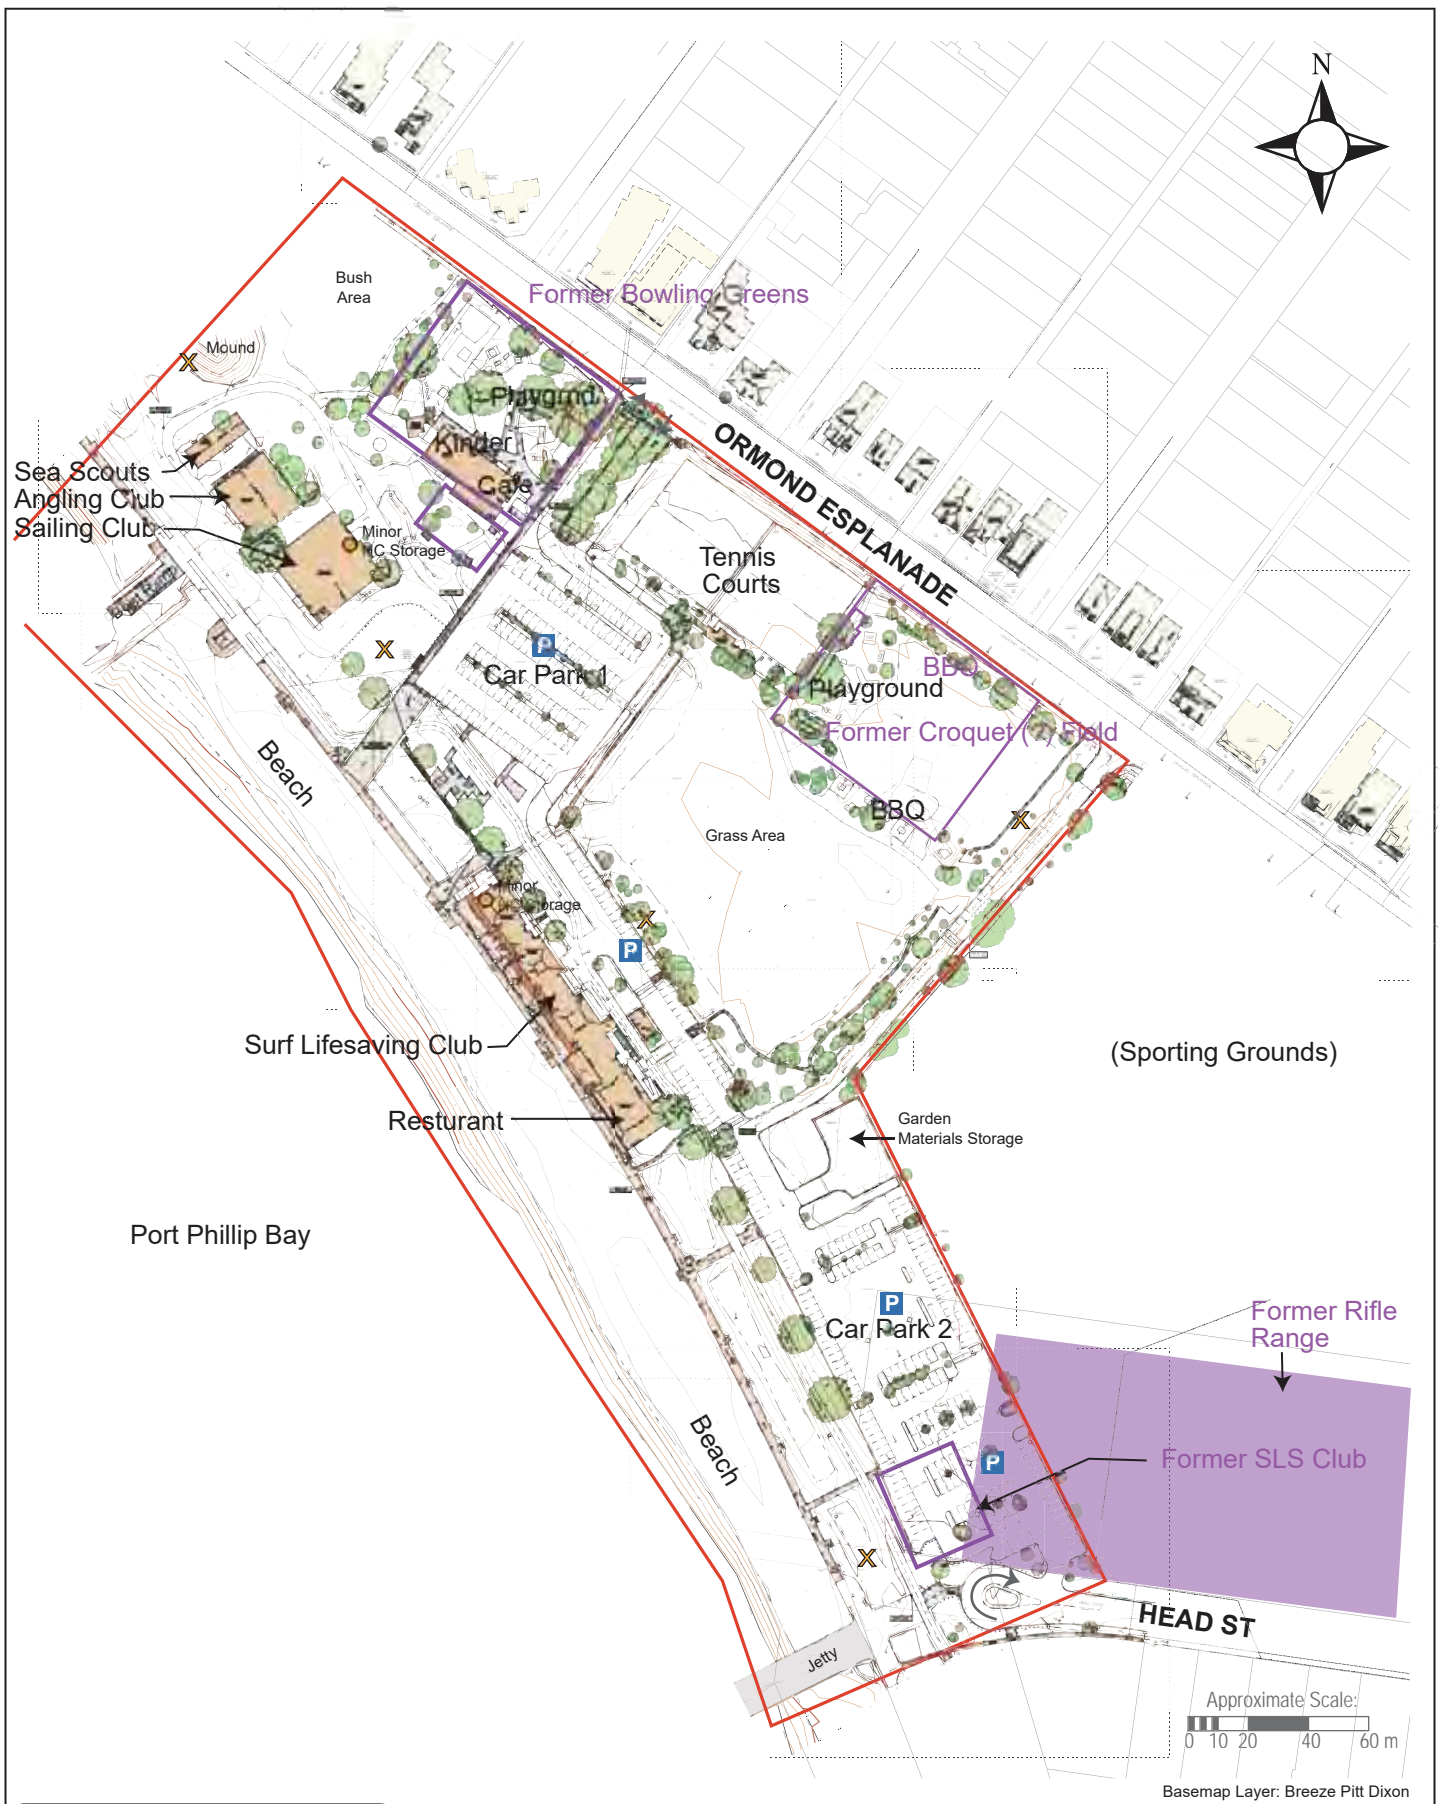
- LEGEND:**
- Investigation Area
 - Building
 - Historical Features
 - X Rubbly/Ashy Materials Noted

The aerial photography review indicates that the locations of a number of possible past structures. These are indicated on Figure 2. No service stations, quarries or landfills were noted in close proximity to the site.

Weather conditions during the site inspection were fine and warm, however, the inspection was limited by the absence of internal building inspections. Refer to Figure 2 for site details and to Appendix D for photos of the site inspection. Observations made are summarised on Table E.
