Heritage Advisory Service

HSPN 02. ROOFING & RAINWATER GOODS

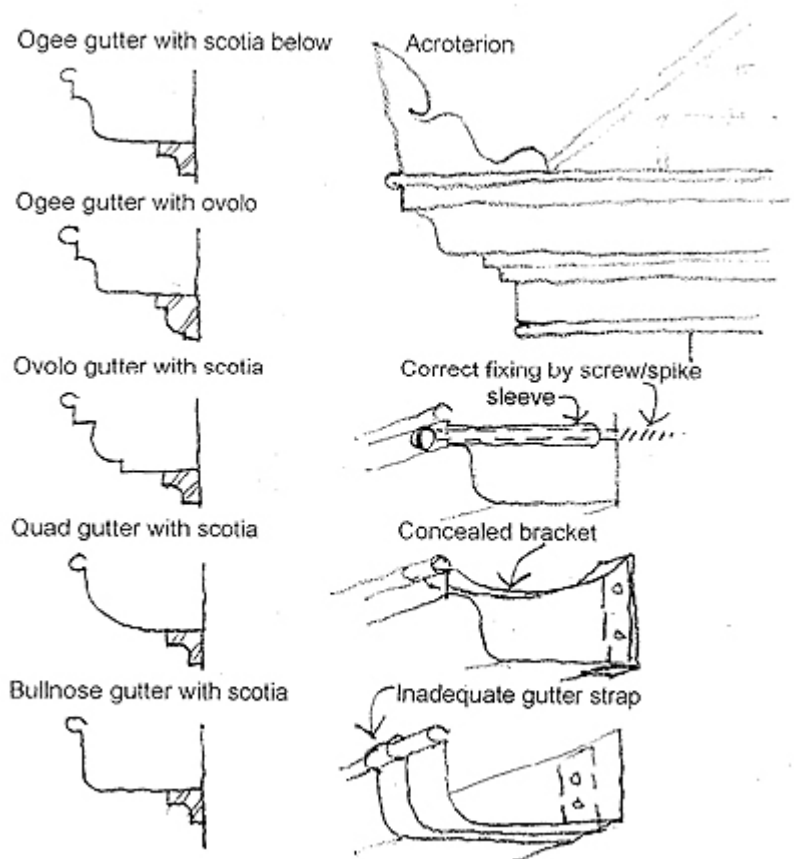
VICTORIAN AND FEDERATION BUILDINGS

Use ogee profile gutters with a timber scotia mould below. Cast iron gutters were used on high quality buildings.

FEDERATION BUILDINGS

Use ogee profile gutters with an ovolo mould below. Ovolo gutters (no longer available) are also appropriate using a scotia mould below.

INTERWAR BUILDINGS

For Californian Bungalows, Mediterranean villas, etc, use quad or bullnose gutters with scotia or ovolo below. Quad is the more appropriate gutter, but will need to be made specially.

POST WAR BUILDINGS

Immediate post war buildings should generally be treated as for the Interwar period. However, special gutters, sometimes with a splayed front were sometimes used on more consciously modern buildings. Often, gutters were fabricated specially and located behind splayed or vertical fascias.

All eaves gutters carried on a gutter board or exposed rafter ends should have a timber mould (see period/style) below the gutter to align and help support the gutter.

The recommended fixings for eaves gutters are gutter screws (or spikes) that go through the whole gutter to the gutter board or rafter end behind. The modern equivalent (less effective) is the concealed bracket. Either of these should be used instead of the common gutter strap, which has no load bearing value and which results in the commonly seen twisted gutter. Examples are shown in the illustrations.
